**THE RODUR PROCESS
OF CONCRETE DAM REPAIR:
A RECENT CASE HISTORY**

D.A. Bruce, Nicholson Construction Company
and
P. DePorcellinis, RODIO, Spain

Presented at International Conference on
Structural Faults and Repair,
London, June 27 - 29, 1989

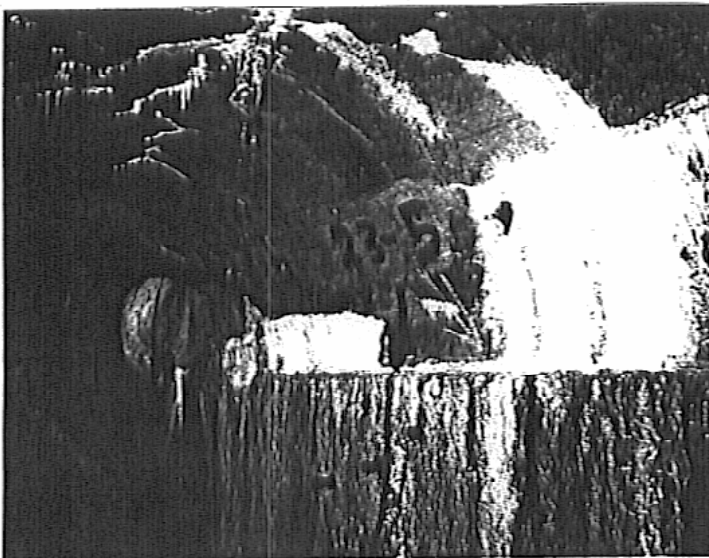
The flow was recorded mainly below the Upper Gallery between Points S-6 (E1 1730') and S-7 (E1 1700') and was entering the Lower Gallery principally through the horizontal lift joints, and the large diameter (300mm) chimney drains linking the two Galleries (Photograph 1). The water chemically was very pure, and there was considerable deposits of calcite on both upstream and downstream sides of the Gallery. By 1987, there was also considerably more seepage from longitudinal secondary fissures in the roof, and from the downstream side of the Gallery than previously. (Photograph 2)

Photograph 1. Water inflow into Lower Gallery from large diameter chimney drain (left). Note also calcification on walls from seepage through horizontal joint.

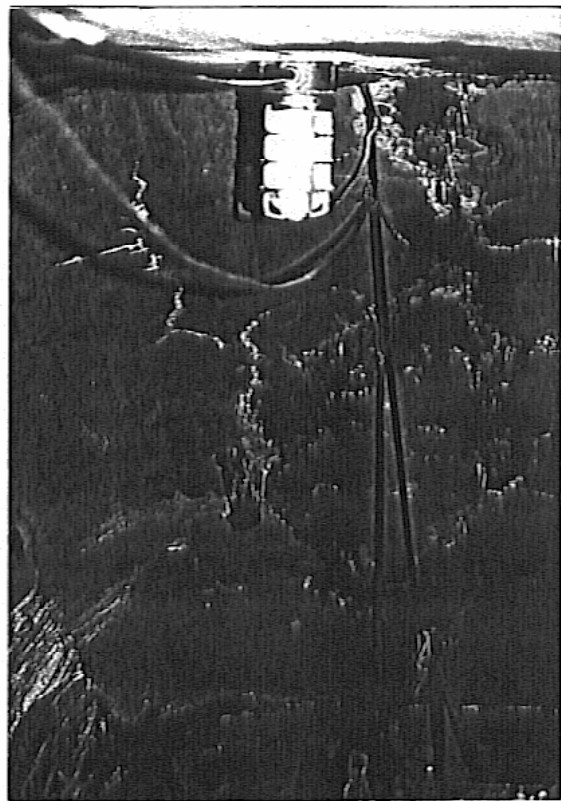
Photograph 2. Water seepage from longitudinal secondary roof fissure in Lower Gallery.

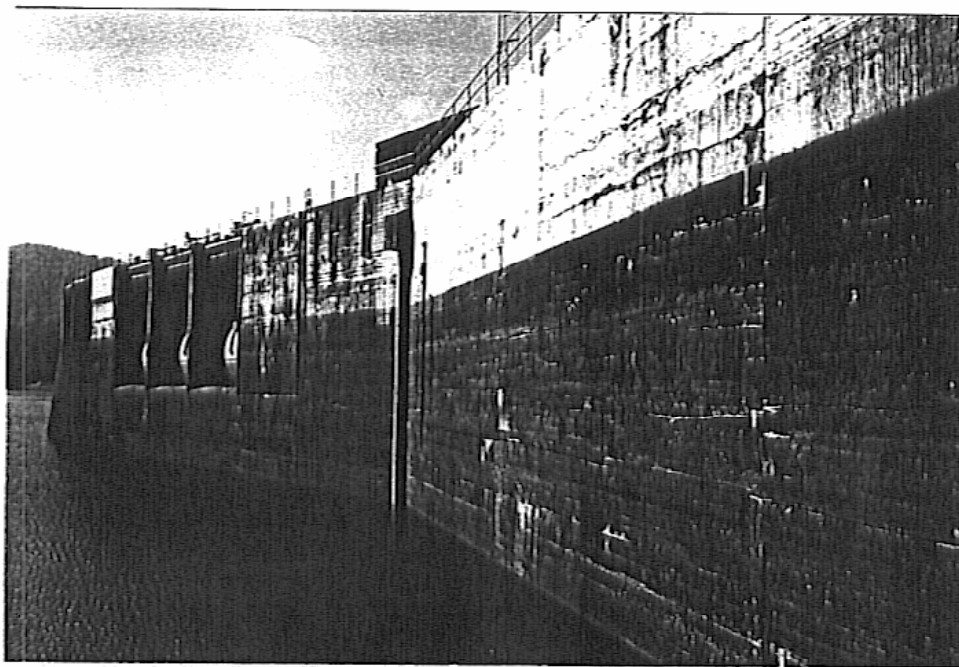
The very pure lake water also had a high potential for solution which would gradually increase the fissure aperture and further reduce the frictional characteristics of the joints (Photograph 3).

Photograph 3. Upstream face of dam showing clearly horizontal lift joints, and vertical construction joints between blocks.

Departures from the intended pattern of hole intersections on any one joint were caused by the variability of the elevations of the original concrete surfaces when cast. This is summarised in Table 3 which shows that whereas the average figures were in close accordance in each phase, and in relation to the theoretical, the overall range in elevation across any one joint was 1.1' to 1.8' (330 to 533mm). This scale of variation could be observed on the joints exposed at the dam's upstream face. (Photograph 3)

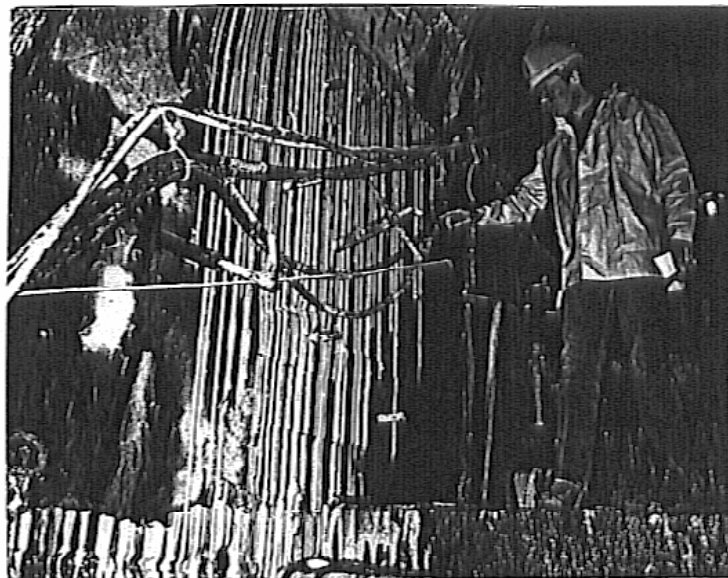
Photograph 5. Resin flowing back into Gallery through horizontal joints from points of injection 3m distant.

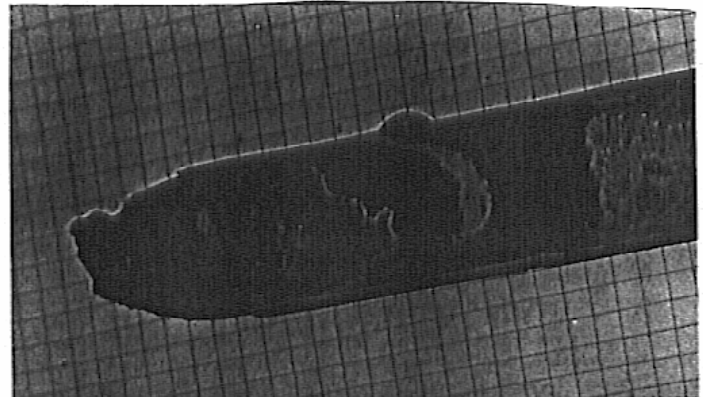
Plotting the evidence of resin recovery from the Secondary and Tertiary holes provided data on joint widths, as summarized in Table 9. In most of the Primary specimens the resin was poorly bonded to the usually dirty concrete surfaces. The resin either debonded during drilling or could be easily prised off during subsequent handling. However, all of the eight Tertiary hole samples showed good resin adhesion, especially in the five samples containing both Primary (thick) and Secondary (thinner) samples. (Photograph 6)

Photograph 6. Core from Tertiary hole showing resin bonding across the (oblique) joint. Note also resin penetration of secondary microfissure to left of main joint.

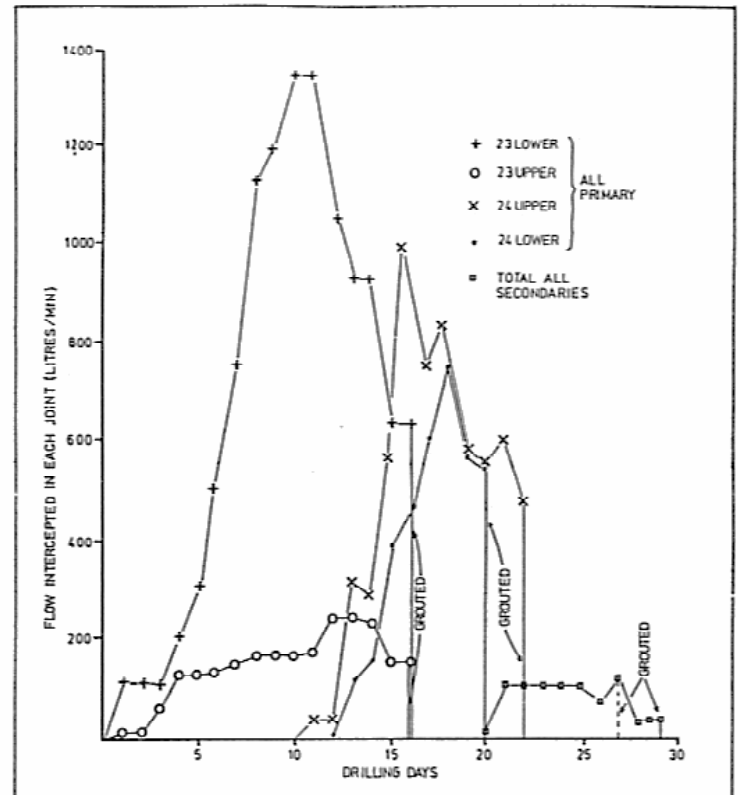
Figure 8. Water flows encountered by grout holes into each joint.

The routine seepage measurements were maintained in the Left side of the dam during the works (Table 10). In addition, twice daily readings were taken of the flow from each borehole open at that time (Figure 8). Holes with particularly strong flows (over 200 liters/min) were fitted with packers and the pressure head noted. Typically this corresponded exactly to the theoretical hydrostatic pressure acting at the level of the fissure.
