**SEALING CRACKS IN CONCRETE DAMS
TO PROVIDE STRUCTURAL STABILITY**

Hydro Review

July, 1991

Sealing Cracks in Concrete Dams To Provide Structural Stability

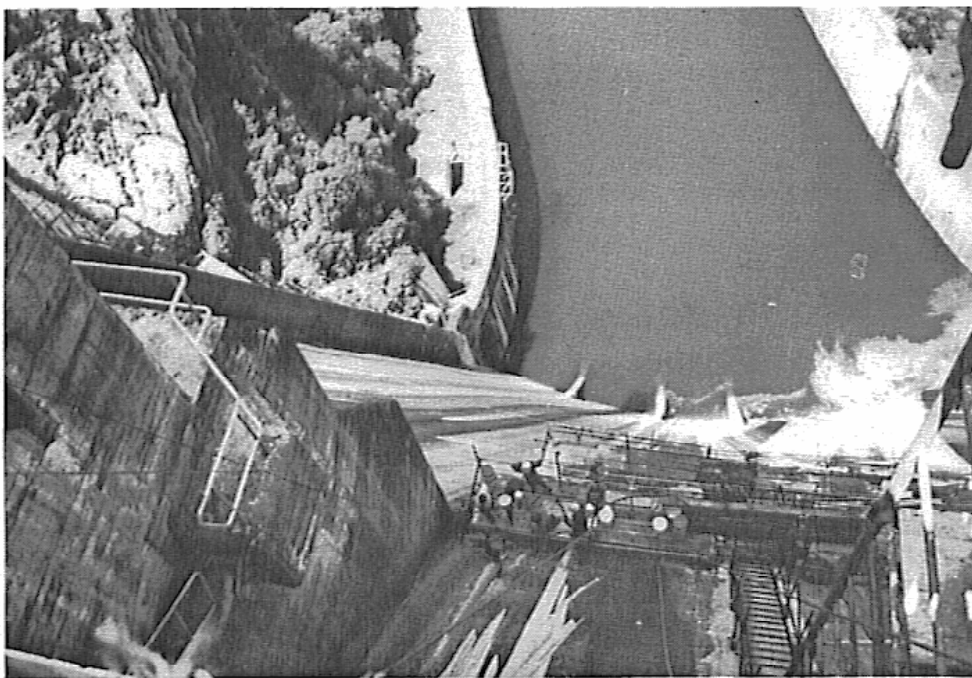
The drilling program at the San Esteban Dam was conducted mainly from fixed scaffolding on both faces of the dam. Some drilling was also performed from the galleries to minimize hole lengths. RODUR series resin was then injected into the drilled holes.

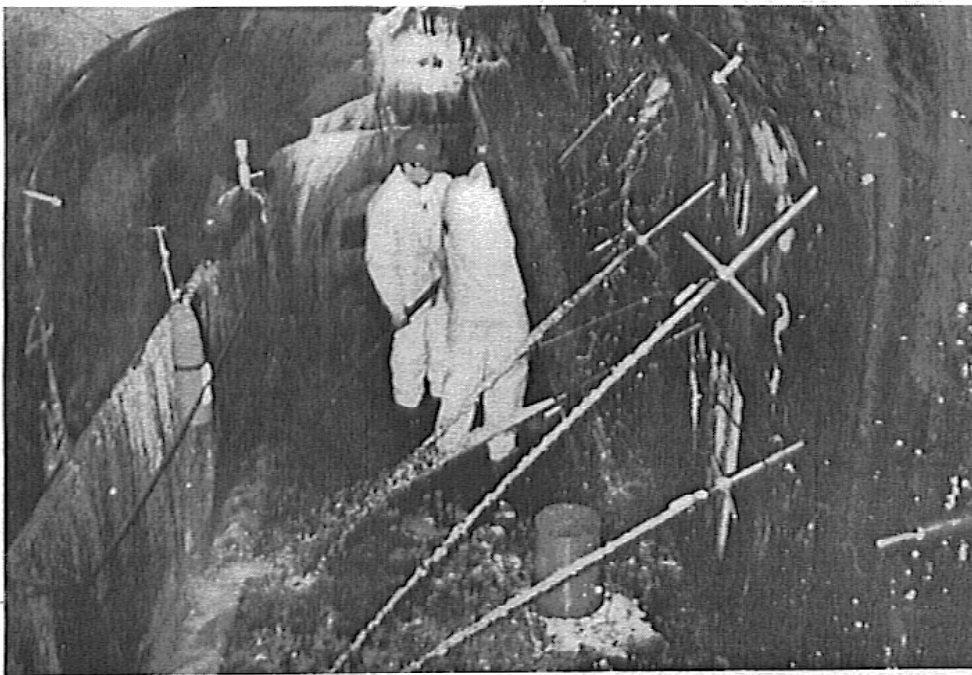
Holes drilled upstream of the lower gallery of the Santeetlah Dam intercepted individual flows of up to 400 liters per minute at full hydrostatic head seeping through joints. The fissures intercepted by the holes were subsequently sealed with epoxy resin using the RODUR system.

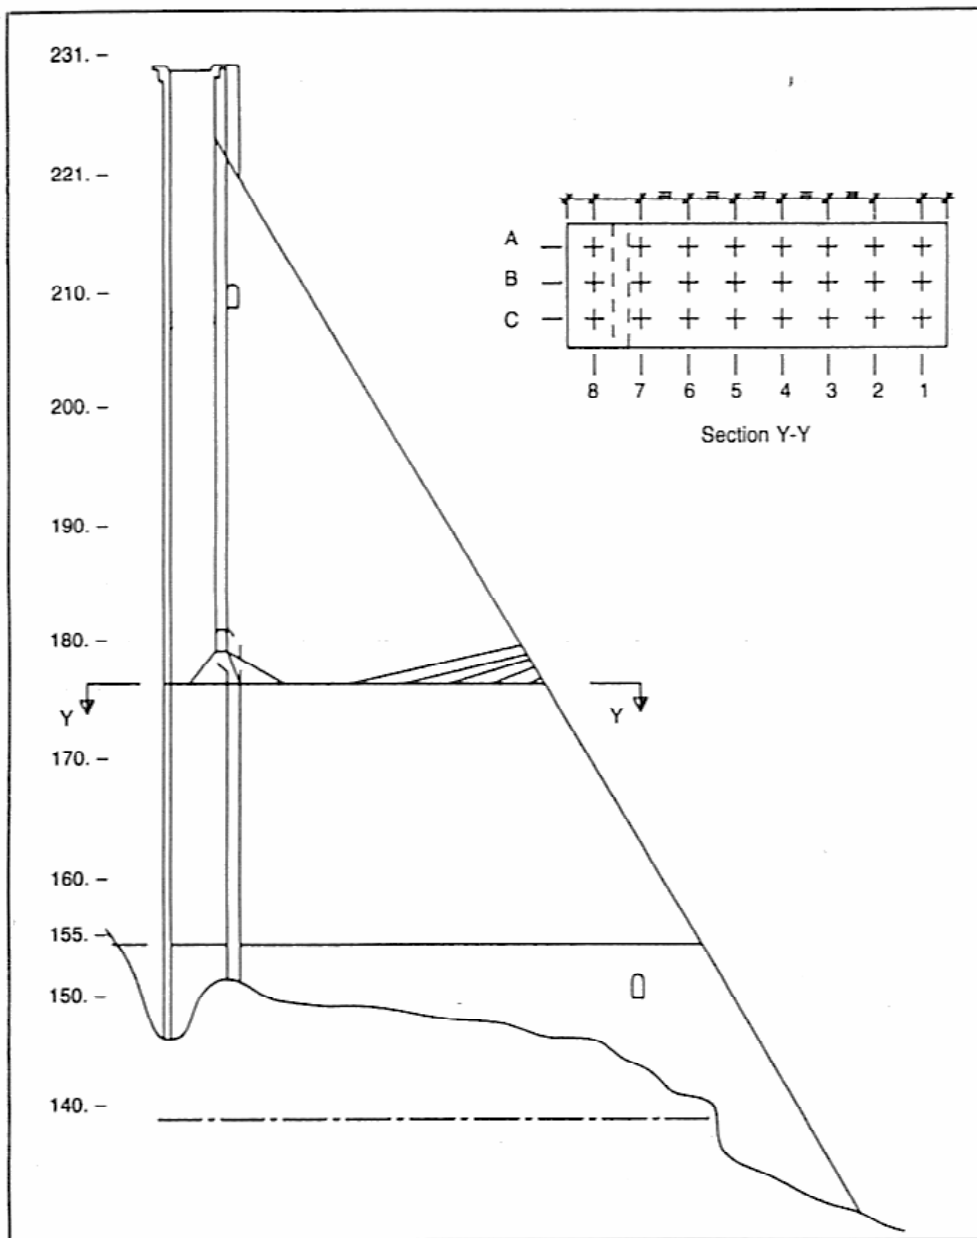
Figure 1: The drilling program on the San Esteban Dam consisted of drilling 46-millimeter-diameter holes on a 3-meter by 3-meter grid, as shown in Section Y-Y. Holes were drilled along horizontal lift joint and cross joint surfaces—a total area of 5,370 meters.

lifting of the central part of the dam. In addition, engineers noted seepage on the upper 50 meters of the downstream face associated with lift joints. When the reservoir level was dropped, the engineers found small zones of localized cracking around the lift joints on the upstream face.

Engineers' analyses proved the movement was caused by an alkali aggregate reaction (a chemical reaction among the cement, water, and aggregate in the concrete that causes the concrete to swell from within). Engineers decided to pursue two types of remediation:

The RODUR treatment commenced with a full-scale trial, which confirmed fissure apertures throughout the dam in the 2- to 3-millimeter range. In addition, the engineers discovered that there were seepage paths called "worm holes" in the concrete and secondary cracking connected to the horizontal lift joints.

- Restore the mechanical integrity of the structure by re-bonding the joints with a RODUR series epoxy resin; and
- Attempt to inhibit the swelling reaction by waterproofing the upstream

Drillers used diamond coring rigs to drill holes for the epoxy resin injection. A total of 5,370 meters of 46-millimeter-diameter holes were drilled on a 3-meter by 3-meter grid. This drilling program is illustrated in Figure 1.

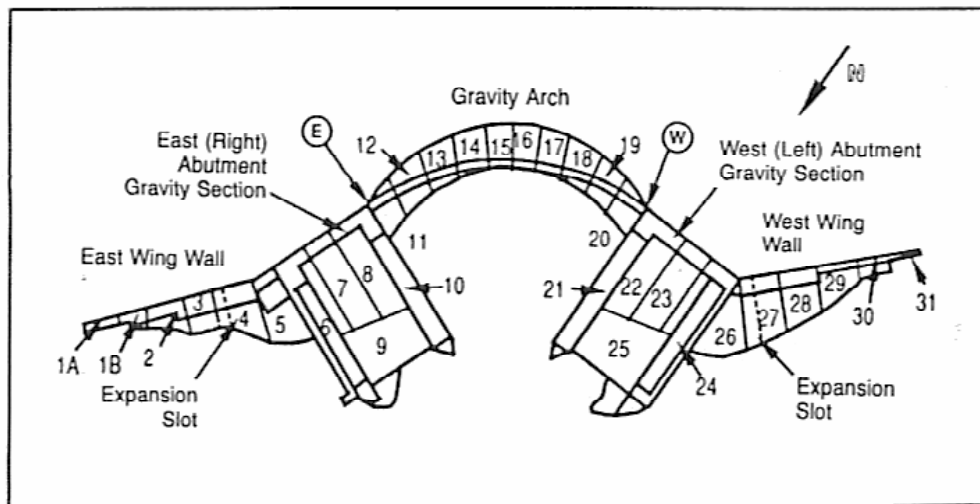
During the past 25 years, the dam owner has routinely measured deformation of the dam crest as well as seepage into the galleries. The deformation data indicate that the crest has been ratcheting (moving upstream in a cyclically increasing manner) since the 1930 and 1938 modifications. The seepage volume has increased in a similar manner. In 1987, seepage in the west abutment had reached over 4,000 liters per minute, and was entering the lower gallery at higher pressures and over larger areas than ever before. In addition, seepage from the downstream side of the gallery was also apparent.

Through investigation of old construction records, engineers discovered that the construction techniques used for the 1930 and 1938 modifications did not provide a structural connection between the old and new concrete, except near the crest. Therefore, the engineers suspected that the seasonal thermal expansion of this added concrete was pushing the crest vertically up and horizontally upstream. The steady increase in ratcheting was attributed to permanent

Figure 2: Modifications to the Santeetlah Dam after initial construction involved the placement of massive amounts of concrete on the gravity abutment blocks (blocks 6 and 10 on the east abutment and blocks 21 and 24 on the west abutment). Later modifications added concrete to blocks 7, 8, 9, 22, 23, and 25, and prestressed rock anchors in the wing walls.

displacements in each seasonal cycling due to slip along the interface between original and additional concrete. These upward deformations also opened construction joints seasonally, introducing the possibility of concrete leaching.

The treatment was concentrated on a 23-meter-long section in the most critical area comprising blocks 23 and 24 (see Figure 2), and was conducted from within the 2.4-meter by 2.2-meter lower gallery, which runs about 3 meters above the foundation. Fans of primary holes, up to 6 meters long, were cored at regular intervals upstream from the gallery to investigate the suspect horizontal lift joints about 1.5 meters vertically apart. The primary core holes confirmed that water seepage was only traveling through the joints: the concrete itself was structurally sound.
