Remedial Grouting using "Responsive Integrationsm"

Jocassee Dam
Oconee County, South Carolina

by D.A. Bruce*, E.C. Luttrell†, and
L.J. Starnes†

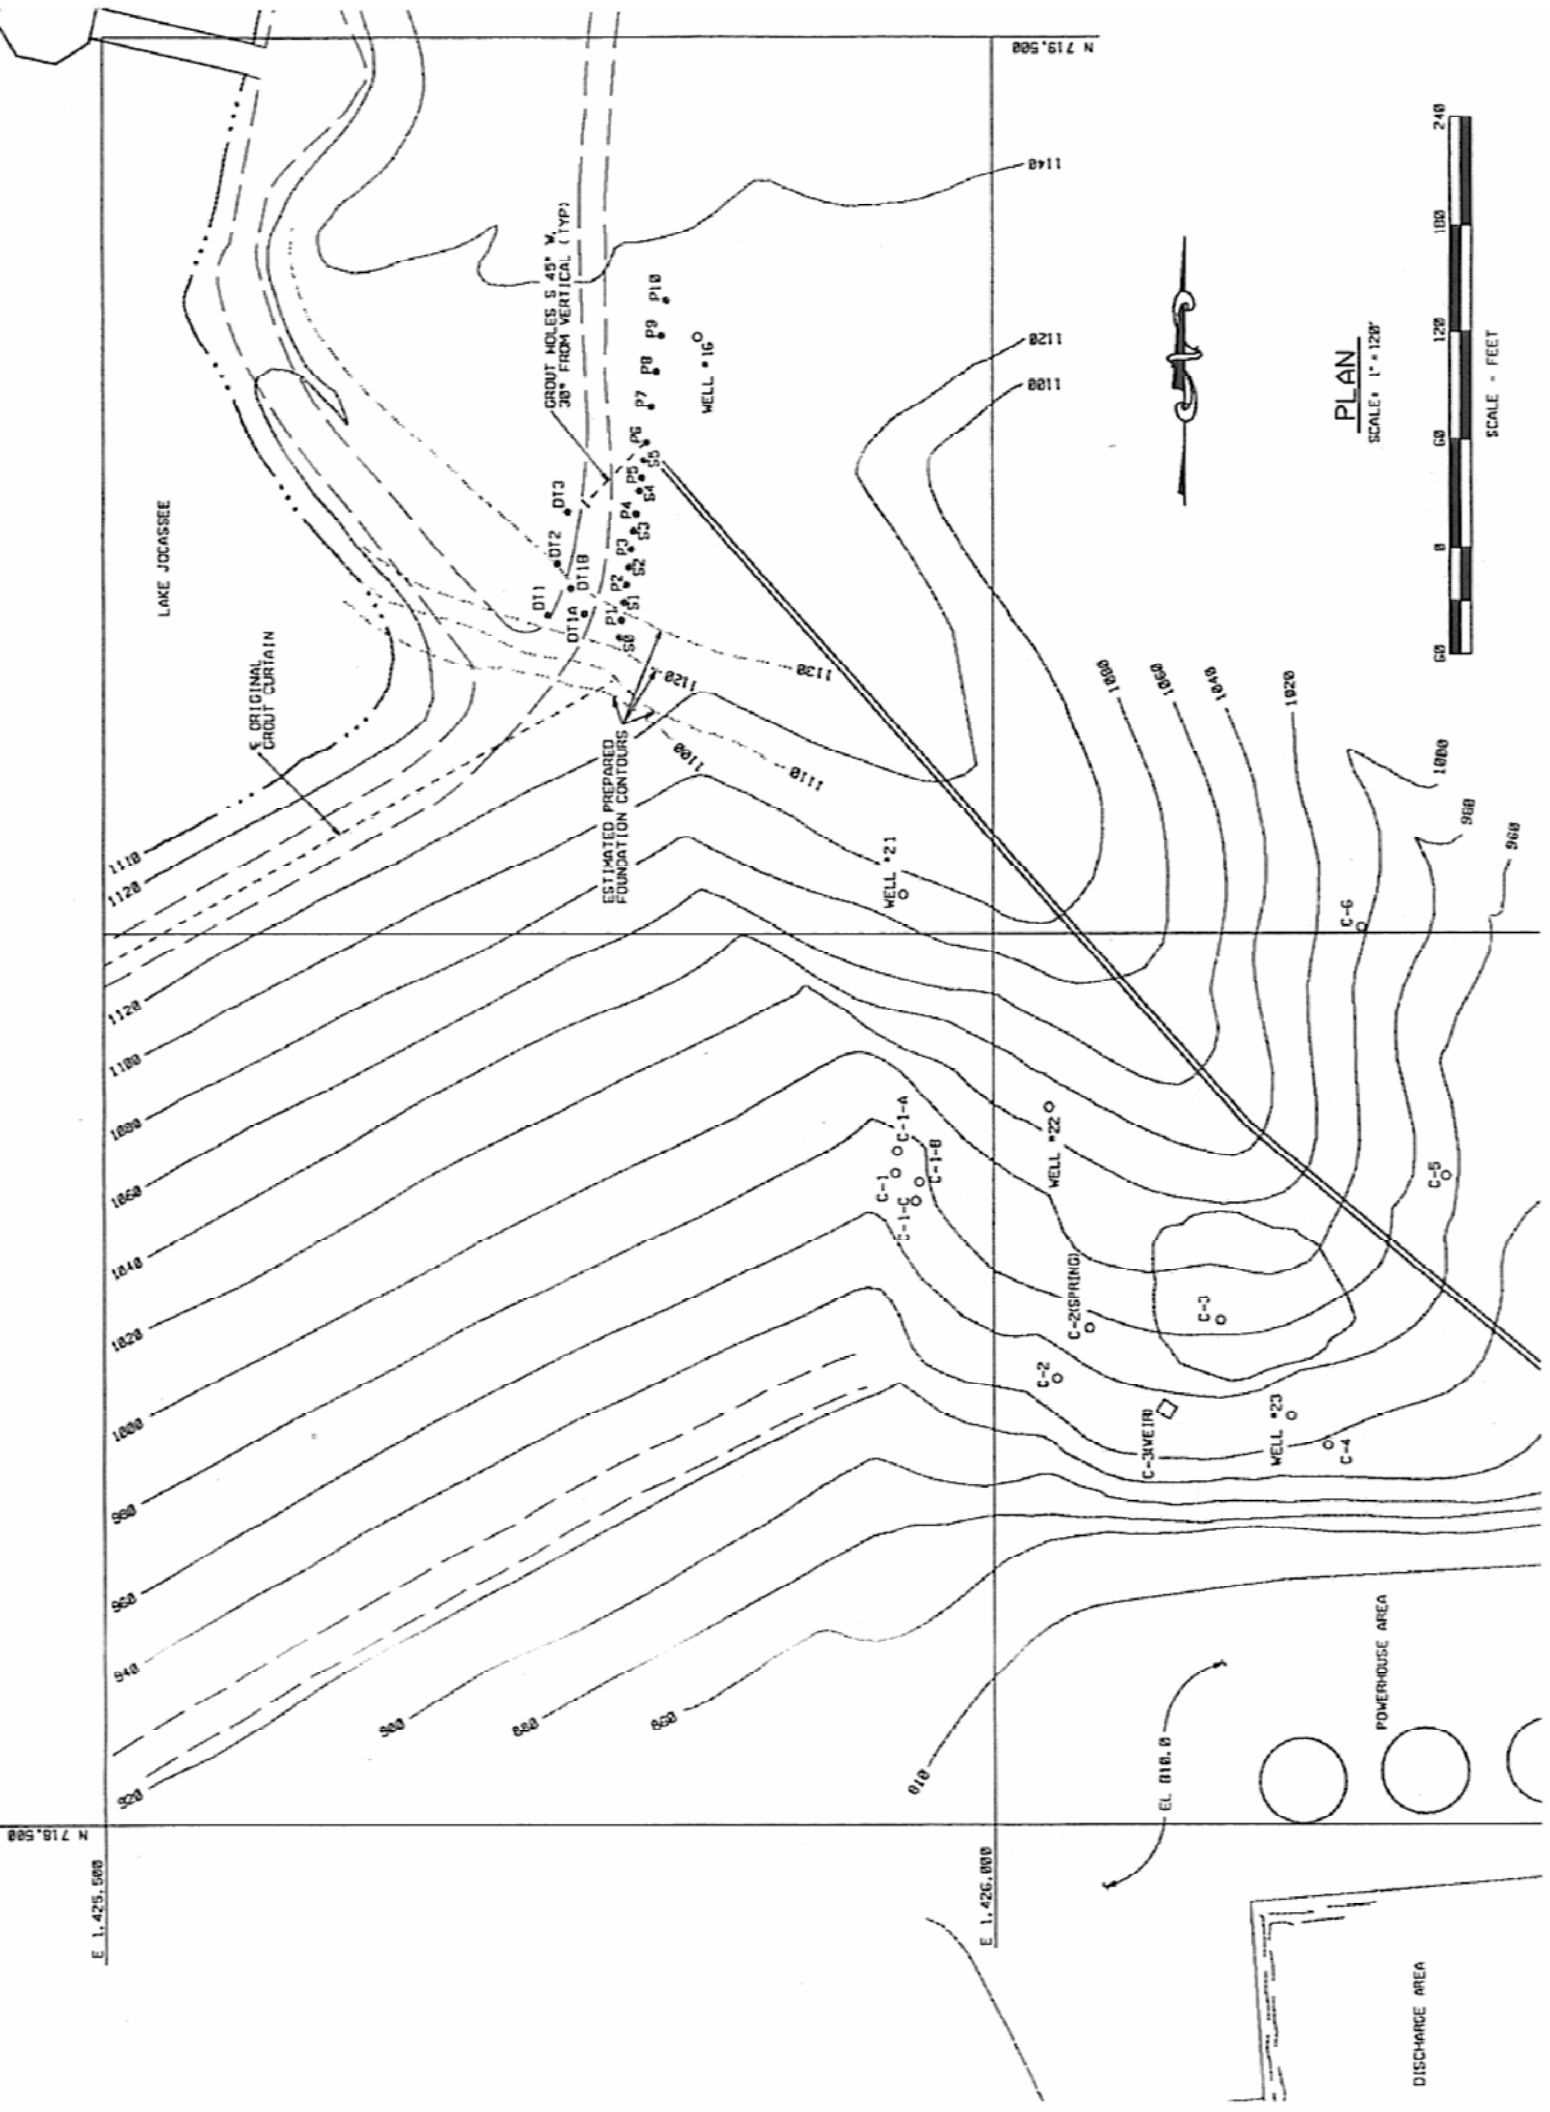
Following first reservoir filling in late 1973, a number of springs and seeps were observed on both downstream abutments. The first evidence of substantial seepage occurred in May, 1976 at spring C-3 located about one-third of the way down the left abutment. (Figure 1) A small subsidence was noted and repaired by station personnel by replacing the disturbed material with gravel ballasted by surge stone. A perforated pipe was embedded in the gravel to collect the flow and route it to a collection and measurement weir. Small quantities of silt and sand were periodically observed in the C-3 weir, with occasionally larger amounts of material movement occurring at sporadic intervals. The flow from C3 (at El 986 feet) was directly dependent on the reservoir level in the range of El 1080 to 1110 feet and varied from 0 to 50 gpm.

Figure 1. Location of grout holes, Dye Test holes, and springs.

Using the projection of the N45W joints from C-3, locations were established for three primary and two alternate drill holes along the upstream left abutment adjacent to the dam. (Figure 1) Holes were oriented S45W and inclined 30 degrees from vertical. These holes provided additional geologic and other subsurface information useful in designing the planned grout curtain.

As a result of this Exploratory Phase, the orientation, depth and length of the new curtain were initially determined (as shown in Figure 1), and important information was made available for the design of the grout mix.

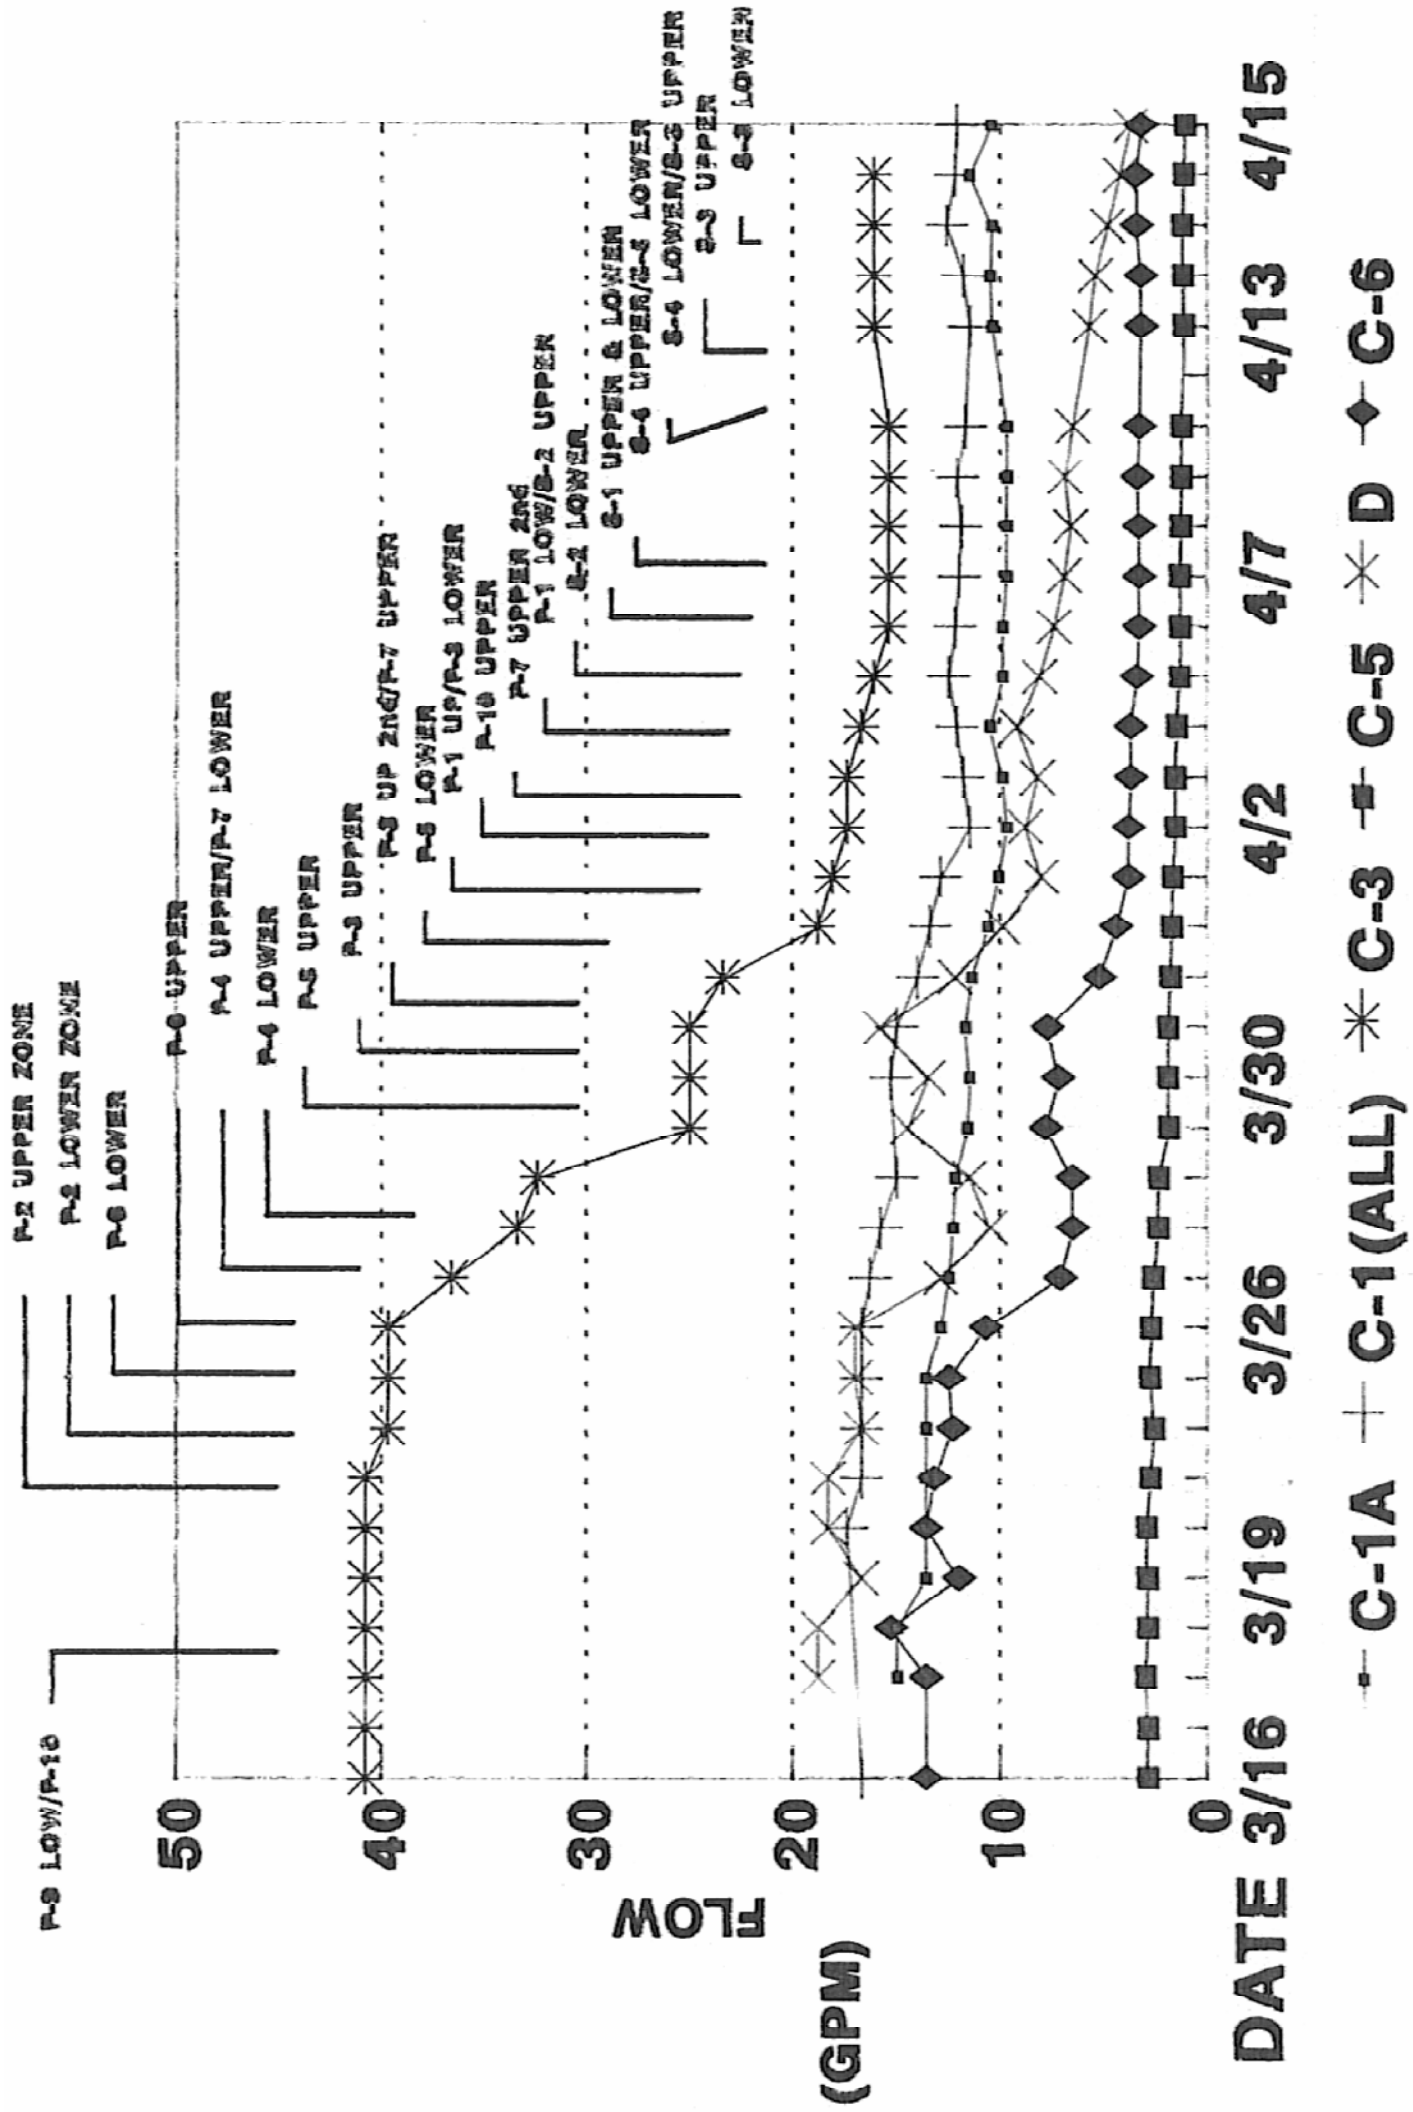
As shown in Figure 2, all spring flows, and especially those in C-3 were reduced by the grouting. During the grouting, the lake level was relatively constant, from El 1107.4 to 1109 feet. The change in C-3, when monitored against the progress of the work is most interesting: the greatest rate of flow reduction was accomplished by the grouting of holes P6 to P3, highlighting the location of the most significant flow paths. Thereafter, the other holes, including the Secondaries did have high permeability values and did have appreciable grout takes, without, however, causing much further reduction in flow, except at point D. This indicates that these remnant flows were not occurring through this new curtain, but either around or below it. Overall, though, the total flows had been reduced from 107 gallons per minute to just over 30 gallons per minute, and the owner judged this an acceptable, cost-effective result.

Figure 2. Spring flows measured during grouting (Reservoir level relatively constant 1107.4 to 1109.0 feet. Elevations of flow points: C1 = 980'; C3 = 986'; C5 = 956'; C6 = 1000'; D = 1000').

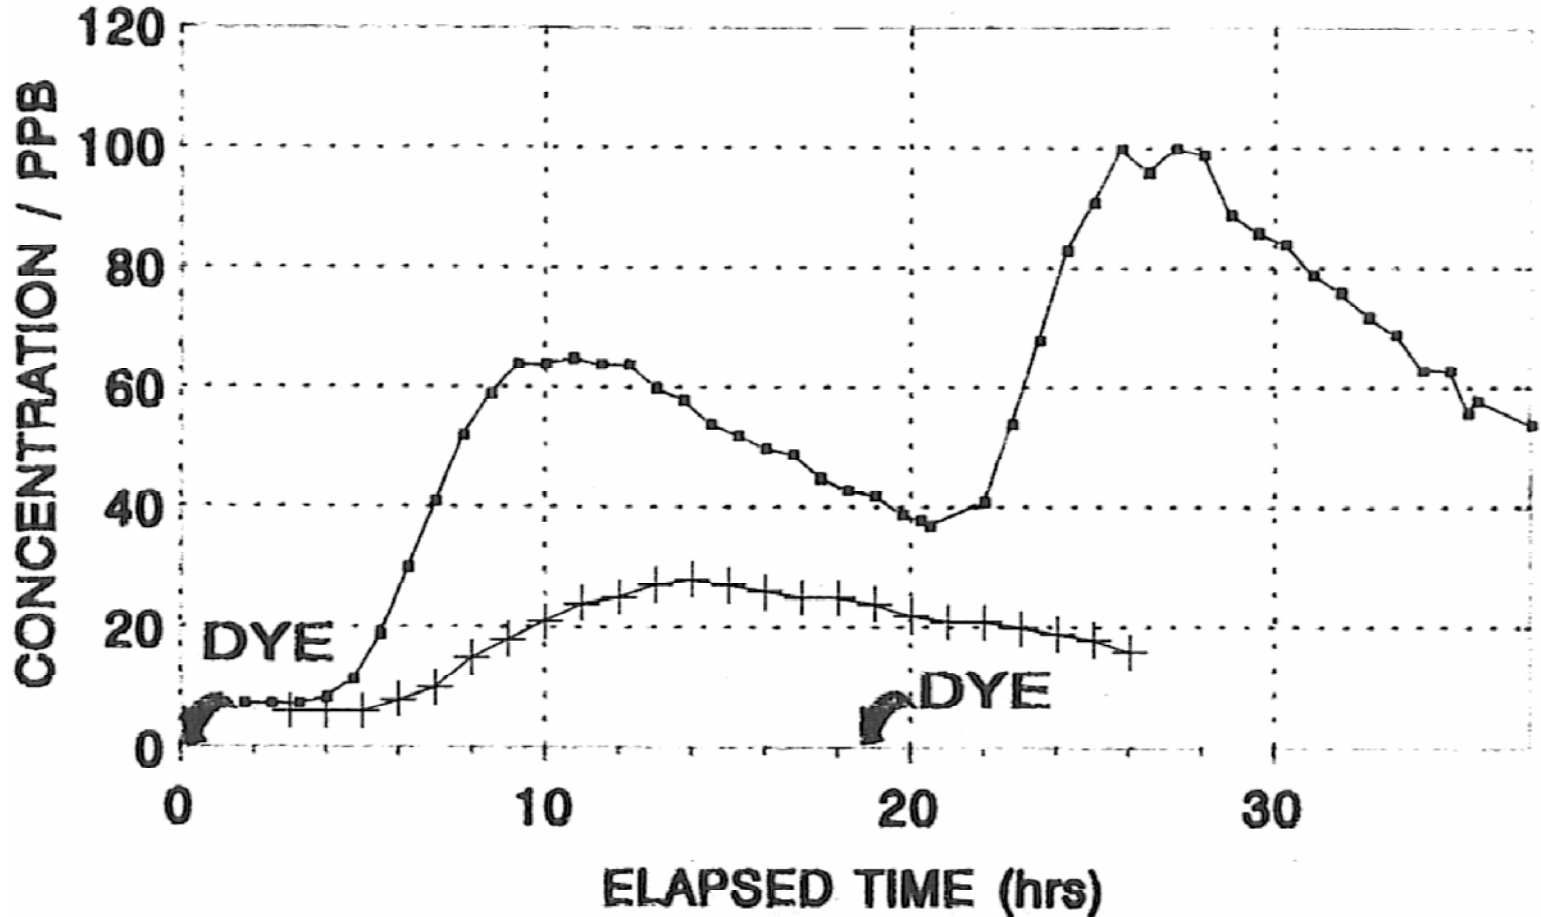
After grouting was completed, the Phase 1 test holes DTI-3 were cleaned out and dye testing repeated. Typical data (from the DT3 test) are shown in Figure 3. Now, while it is not feasible to control exactly the injection concentrations themselves, the key feature is the time of maximum response. Prior to grouting, the peak retrieval period at Spring C3 occurred within 9 hours of dye injection. After grouting, this peak, much less marked, was noted 14 - 15 hours after dye injection. This is a clear indication of the reduction in seepage velocities across the line of the new curtain, and so confirmation that the pre existing open paths had been sealed. The straight line slope distance from DT3 to C3 is 596 feet.

Figure 3. Dye concentrations measured at Spring C-3, following injection at DT3. Upper curve is prior to grouting (10/14-15/91); Lower curve is after grouting (4/13/92).
