PIN PILES SAVE SILOS

When a deteriorating timber pile foundation threatened to shut down a major West Coast grain-export facility, underpinning with small-diameter, high-capacity pin piles provided new foundation support without interrupting operations.

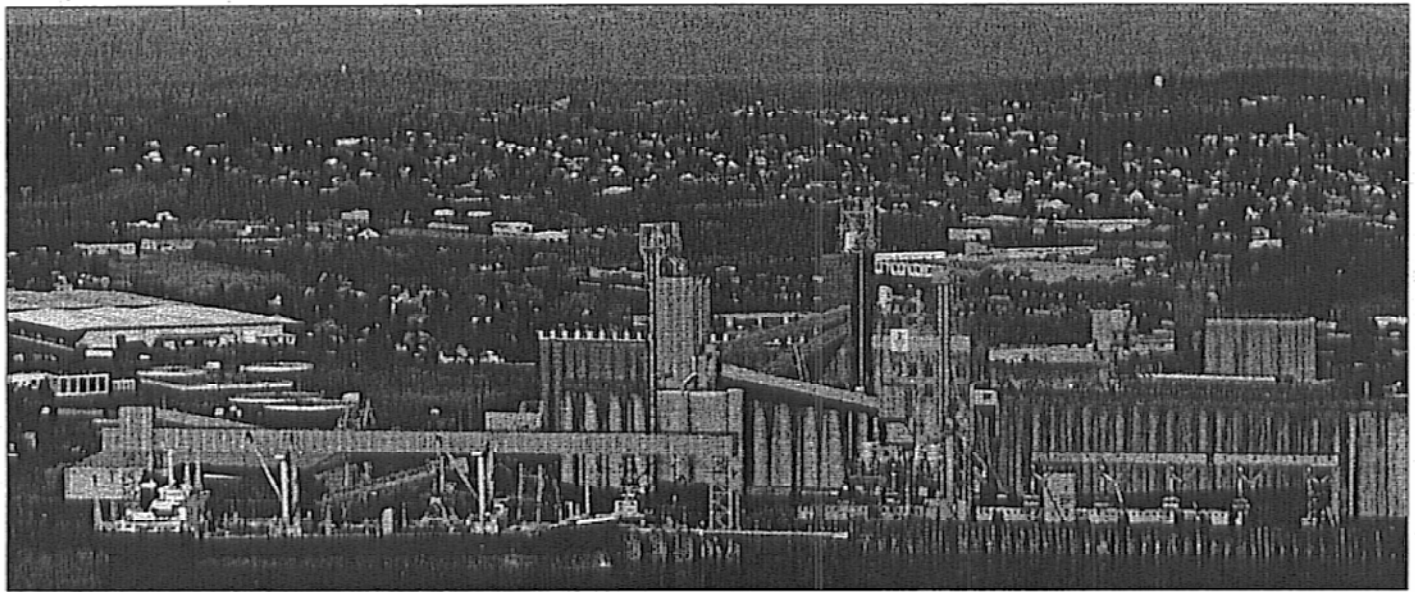
At the time, this was hailed as a record for construction of a facility of this size. However, the emphasis on speed precluded use of treated foundation piling. The absence of preservatives led to progressive deterioration of the timber piles—until, almost 60 years later, they had to be completely replaced or the complex shut down.

CONSTRUCTION OF THE A HOUSE GRAIN-EXPORT FACILITY IN VANCOUVER (ABOVE) SET RECORDS FOR SPEED, BUT USE OF UNTREATED TIMBER PILES FOR THE FOUNDATION LED TO PROGRESSIVE DETERIORATION.

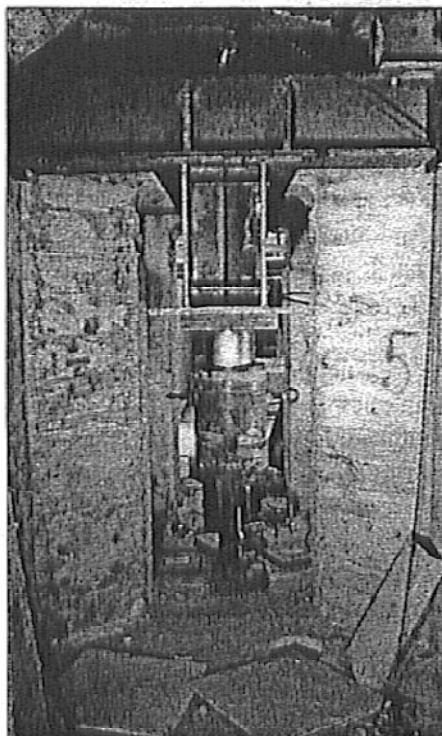
IN A PRODUCTION PILE LOAD TEST (LEFT), A 375 TON HYDRAULIC JACK APPLIES THE LOAD AND STEEL BEAMS BOLTED TO THE ADJACENT BOX-COLUMN WALLS DISTRIBUTE THE LOAD REACTION TO THE STRUCTURE.

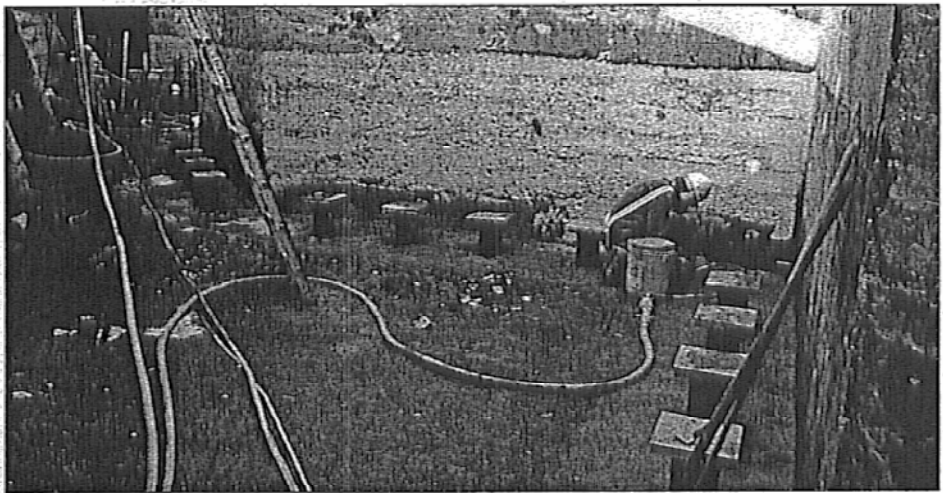
EXTERIOR PILES WITH THE TOP BEARING PLATE INSTALLED (BELOW): THE CONCRETE WALLS HAVE BEEN ROUGHENED AND DRILLED FOR THE DOWELED REINFORCING BARS FOR PILE-CAP INSTALLATION.

Large-track-mounted drill rigs installed exterior piles around the perimeter of the silos. Concrete pile caps doweled to the exterior basement walls and the edge of the basement slab connect the piles to the structure. Where access was difficult, such as between the silo structures, the small indoor rigs were also used for exterior pile installation, with excavation and backfill done with a backhoe or by hand.
