TIMS FORD DAM, TENNESSEE: REMEDIAL GROUTING OF RIGHT RIM

D.A. Bruce, Ph.D., C.Eng.¹, J.A. Hamby, P.E.², J.F. Henry, P.E.³

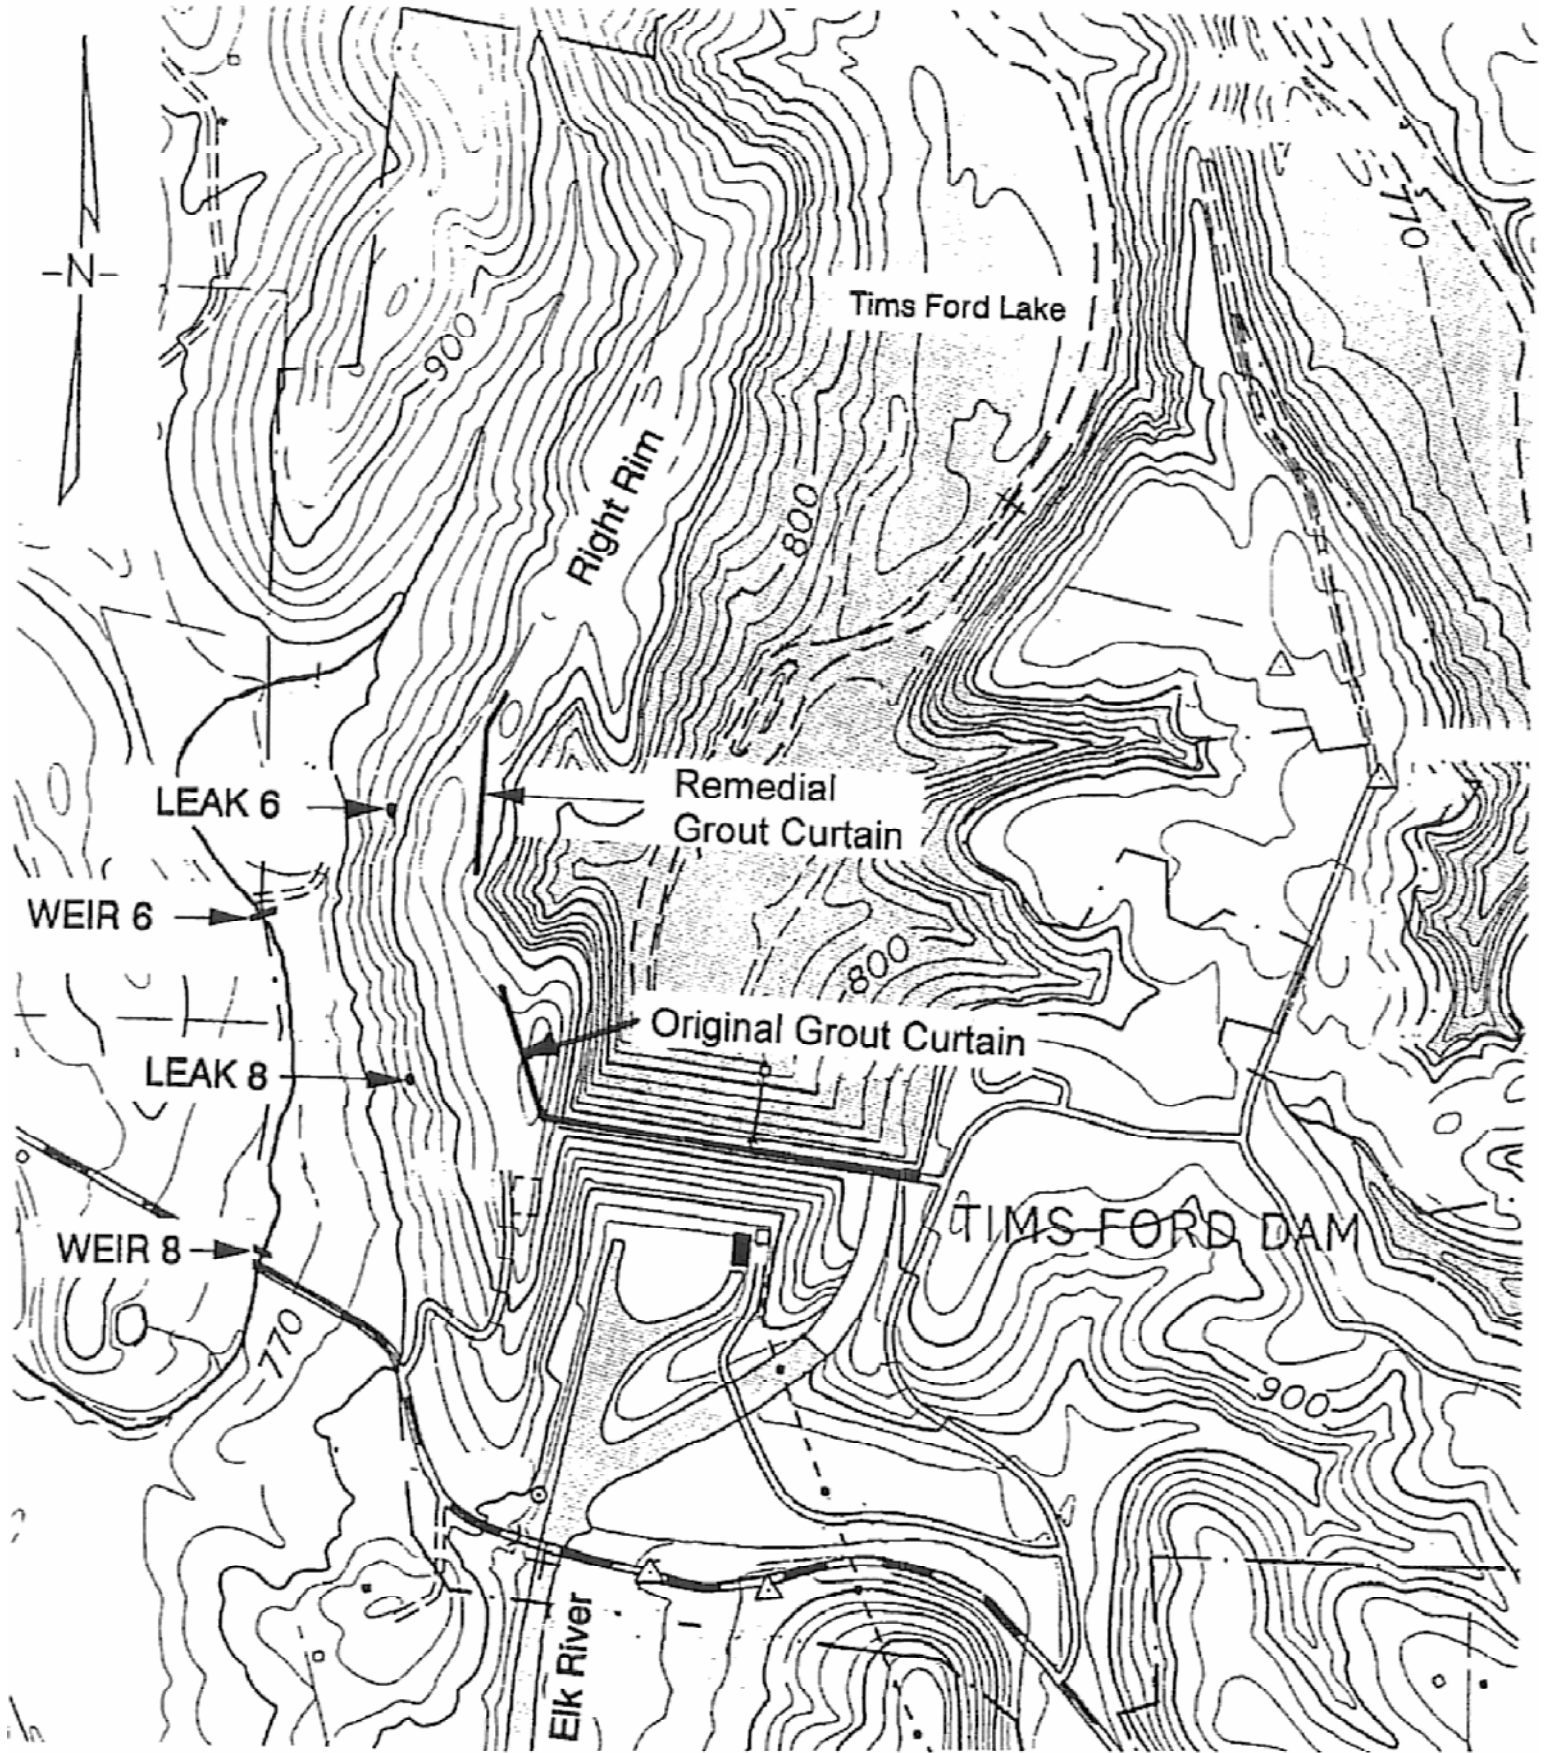
Figure 1. Tims Ford Reservoir plan of dam and reservoir.

Leakage developed in two areas along the west side of the right rim (Figure 1), designated Leaks 6 and 8. Leak 8, near Elevation 857 feet, was approximately 150 feet upstream from the projection of the axis of the dam, while Leak 6 was approximately 1,000 feet upstream from the projection of the axis of the dam. The rim at this location is very narrow, being approximately 450 to 600 feet wide. Flowing springs were found adjacent to Leak 6 and included a spring that was active before reservoir filling. Another minor wet area was located 2800 feet upstream of the dam baseline.

A multirow remedial grout curtain was designed, approximately 800 feet long (Figure 1). The holes were inclined at 30 degrees to the vertical to encourage intersection of (sub)vertical features and were oriented in opposite directions in the two outside rows. Primary holes in each row were foreseen at 40-foot centers, with conventional split spacing methods to be employed (to reduce interhole spacings to 10-foot centers). The central, tightening, row was vertical. The grouting was to be executed between Elevations 888 and 840 feet - locally deeper if dictated by the stage permeability tests conducted prior to the grouting of each stage.

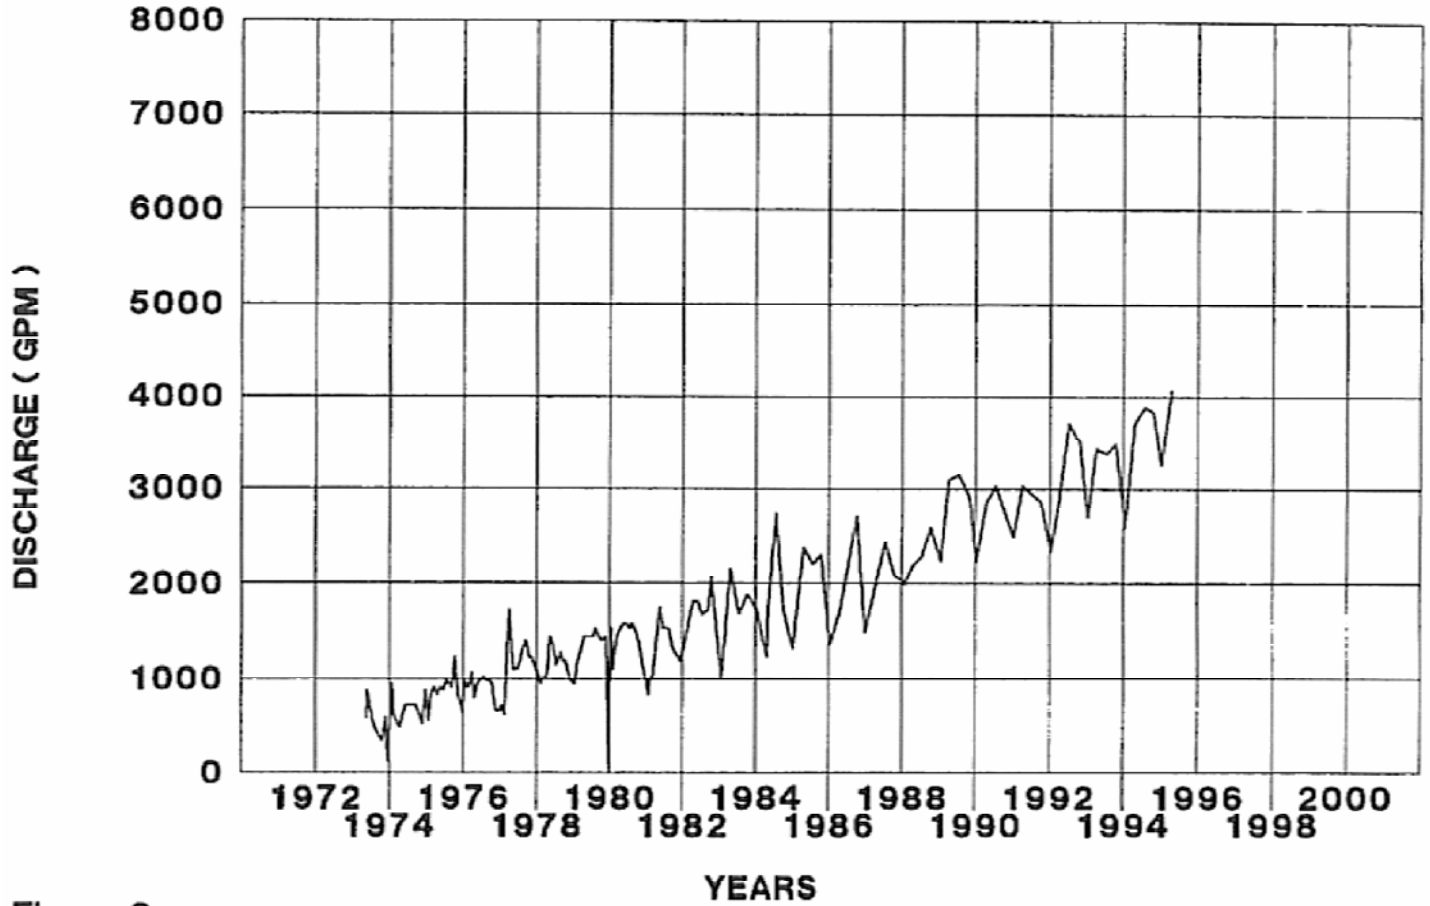
Figure 3a

Leakage did increase steadily at Leak 6, however, reaching approximately 4,000 gpm at maximum pool in 1995 (Figure 3a). However, later that year, following record drawdown of the reservoir, the rate of flow increased dramatically to just under 8,000 gpm at the same pool elevation (Figure 3b). This was followed by a large slide on the hillside around Leak 6, which resulted in several days of muddy flows from the leakage area into the unnamed tributary and the Elk River. Further inspection revealed the overburden at the elevation of discharge was saturated over a 200-foot width of the ridge.

Figure 3. Tims Ford Reservoir leakage discharge at Weir 6.

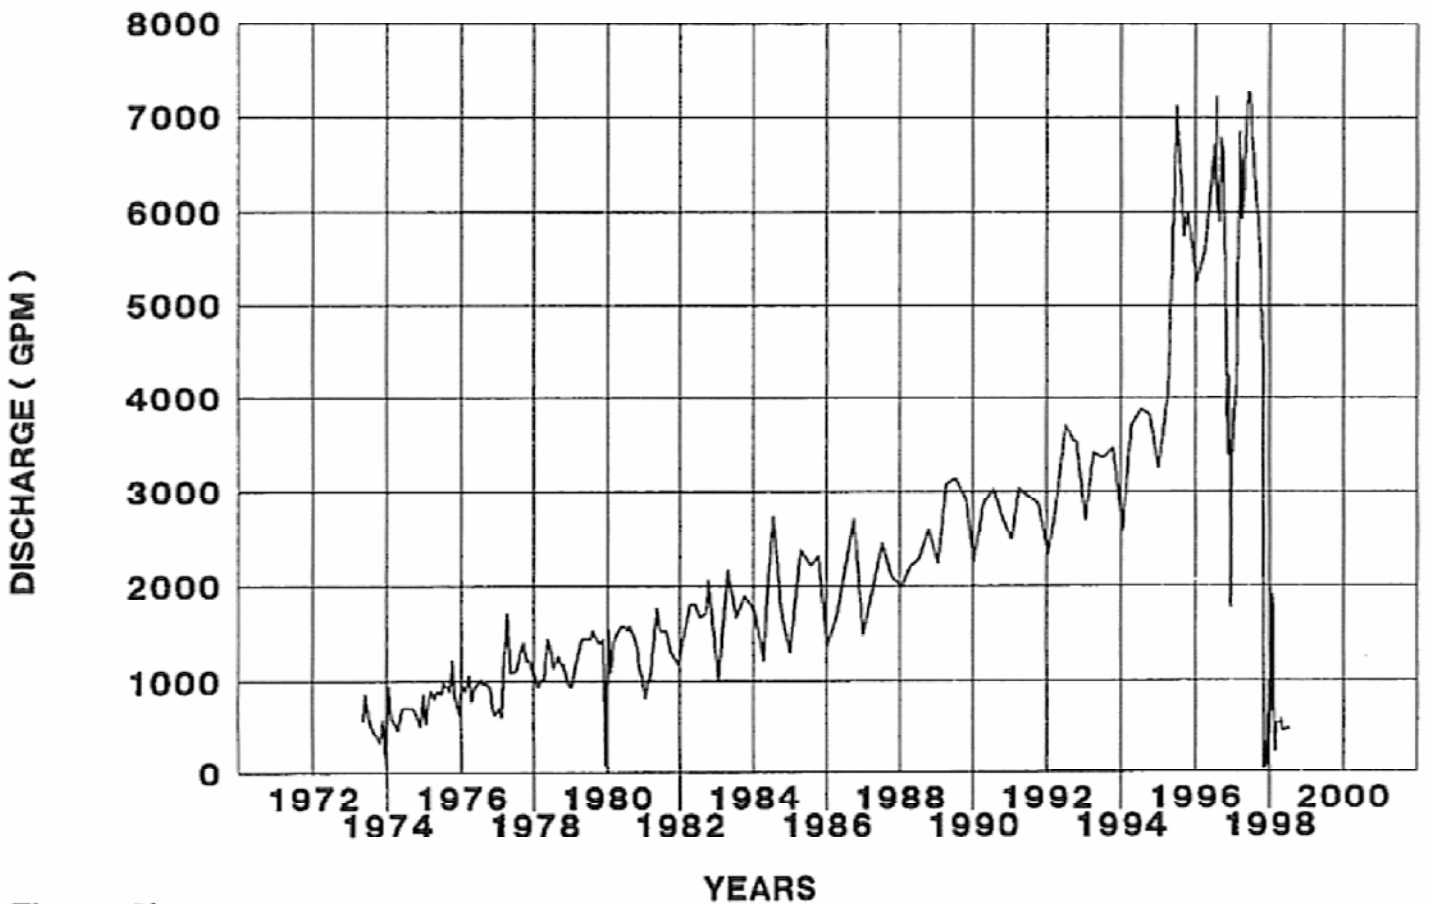
Figure 3b

It was reasoned that the annual reservoir fluctuations had resulted in cycles of wetting and drying of the clays and other degenerated material in the features of the limestones. This had made them more susceptible to erosion at high reservoir levels, thus creating larger flow paths and a rapidly increasing overall rock mass transmissivity.

TVA therefore decided in 1996 to treat the right rim, and initially considered three options:

Option 1 was selected on grounds of cost and constructability, and a target acceptable remnant flow rate of 1,000 gpm at maximum normal pool was set. To facilitate the grouting (i.e., by reducing the hydraulic gradient acting on the rim and so reducing flow rates and velocities), TVA decided to drawdown the reservoir to Elevation 855, equivalent to 10 feet below minimum normal pool.

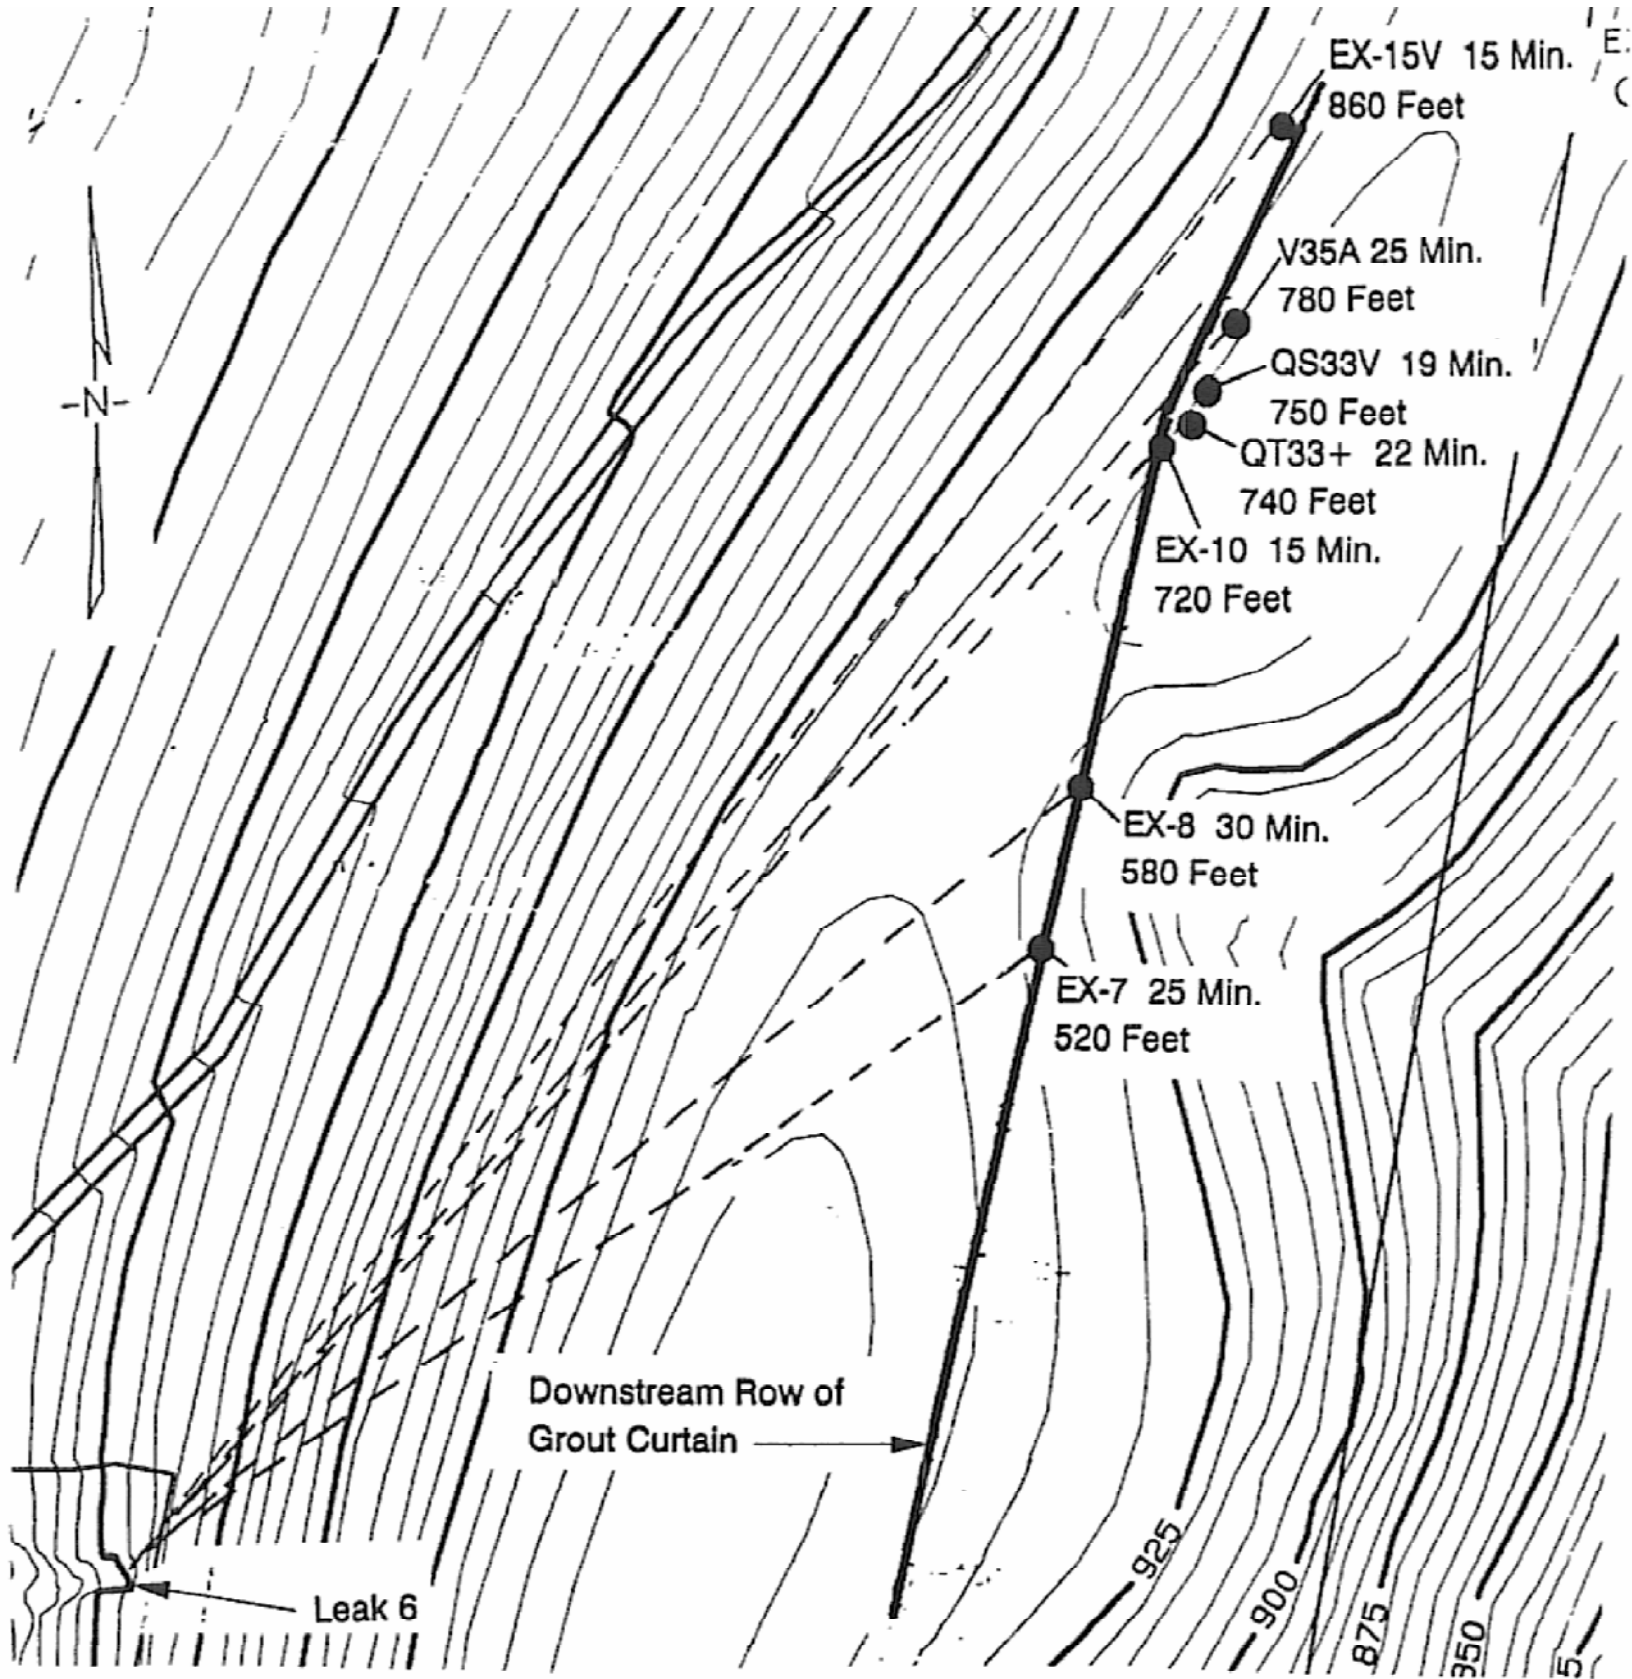
1. Progressive erosion of collapsed and/or desiccated karstic feature infill material was the likely cause of the increased seepage. These features were controlled by solutioning along bedding planes and vertical or near vertical joint sets. Open features in excess of 20 feet deep were detected. Several dye test connection times of only minutes were encountered to the leak.

Figure 4. Tims Ford Reservoir plan of flow paths connection times, and distances (minutes and feet).

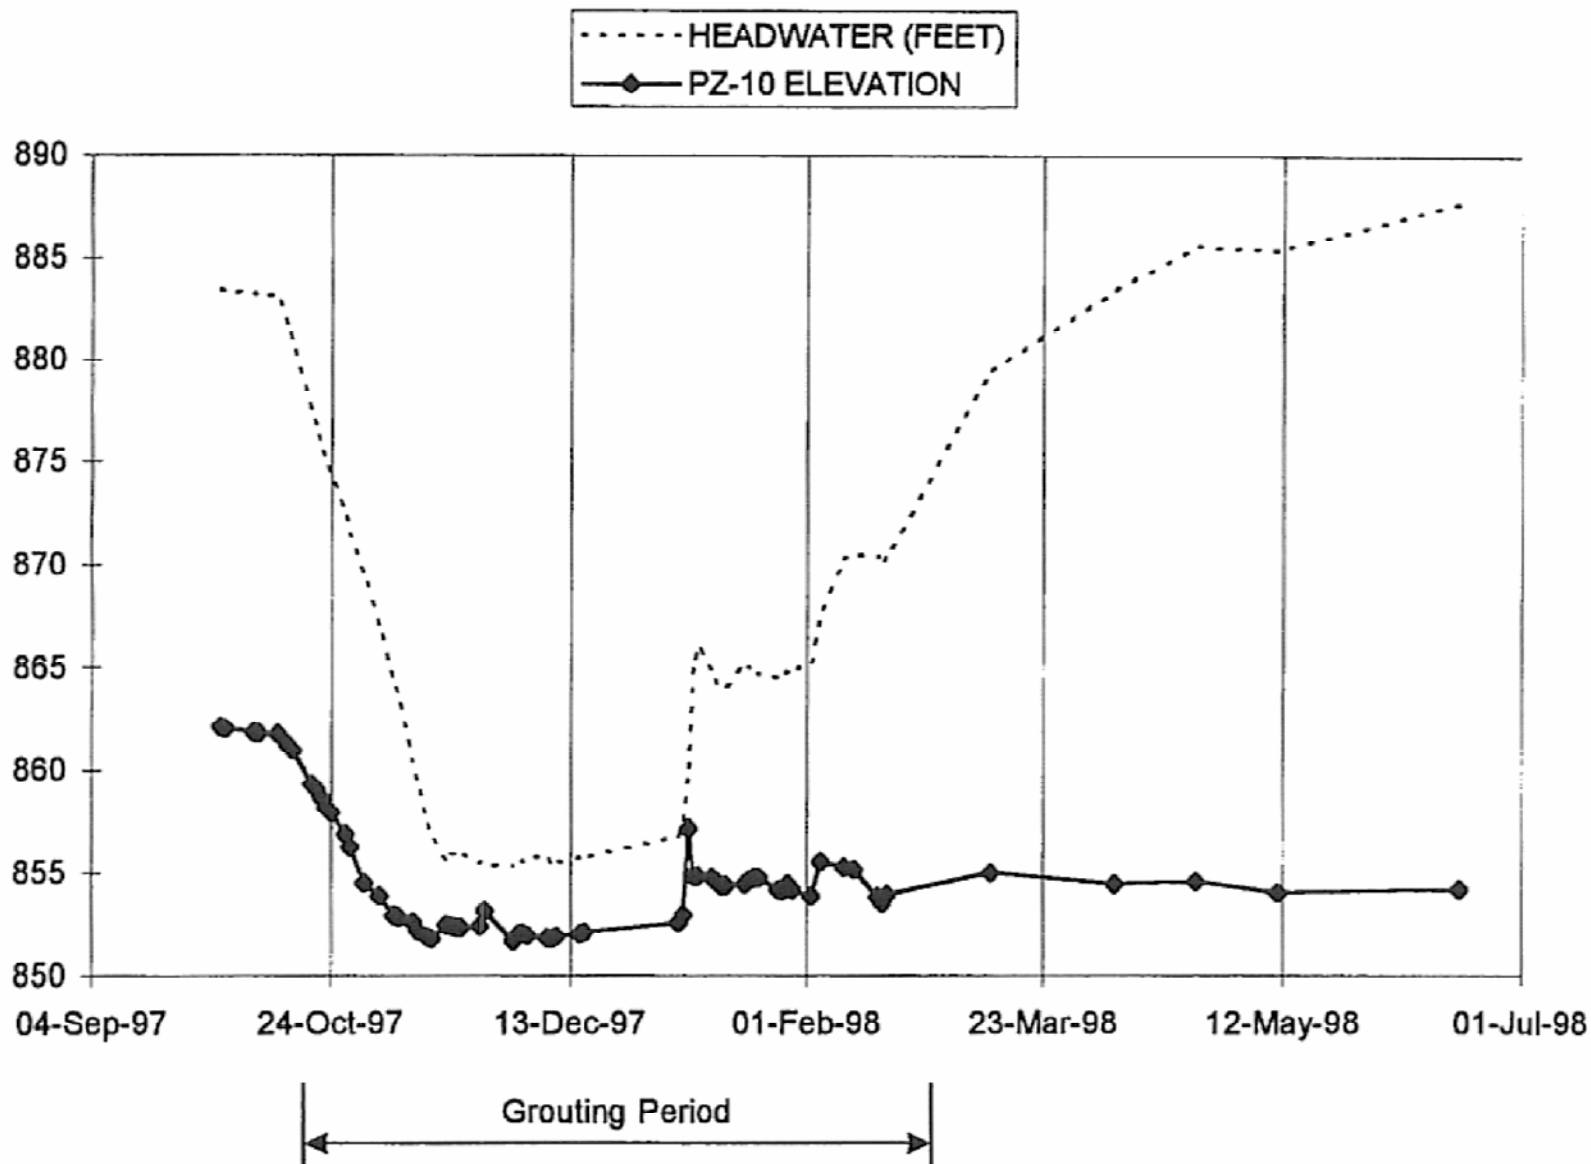
The three piezometers installed during the 1997 investigation program were monitored before, during, and after construction of the grout curtain. The piezometers, designated PZ-9, PZ-10, and PZ-11 ([Figure 4](#)) were installed down-gradient of the proposed grout curtain to monitor the effectiveness of grouting. At all three piezometers, fluctuations of groundwater levels were influenced by reservoir headwater levels prior to grouting. PZ-11 was grouted up early during construction; PZ-9 collapsed soon after construction was complete; and only PZ-10 continued to provide viable data. On February 16, 1998, while injecting compaction grout into a certain quinary hole that had a strong dye connection to the leak, rim leakage decreased in the course of several hours from 1,075 gpm to less than 60 gpm; groundwater levels measured at PZ-10 dropped about 2 feet and ceased to be influenced by reservoir headwater. PZ-10 continues to remain at reduced levels ([Figure 5](#)).

Figure 5. Tims Ford Reservoir Piezometer PZ-10 observations.
