Slab-jacking at Tarbela Dam, Pakistan

by D.A. BRUCE AND G.M. JOYCE

This Paper describes a major slab-jacking programme conducted recently at Tarbela Dam, Pakistan. Some 375m³ of mainly cement-bentonite grouts were injected through 1 302 holes drilled through 39 of the concrete panels forming the protective apron to the upstream clay blanket material of the auxiliary spillway.

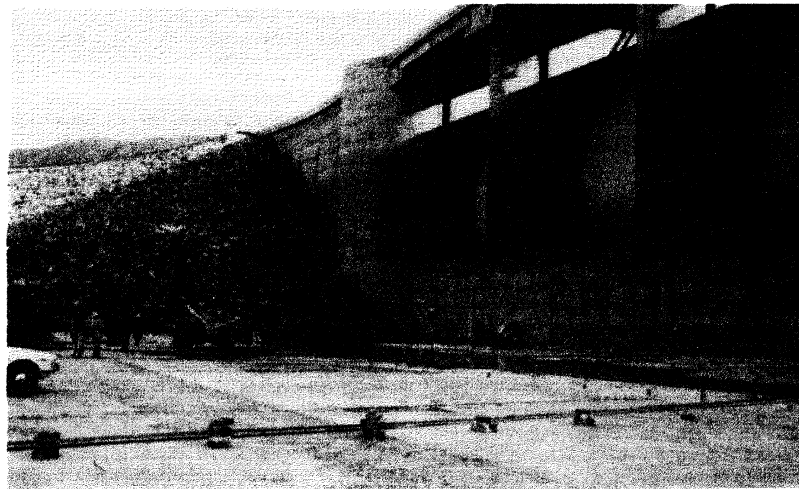
The blanket is capped with a 0.3 - 0.6m thick concrete apron (Fig. 3), constructed in panels, typically 15 × 11m, except at locations permitting articulation so that the slab could follow any differential settlement of the blanket (Fig. 5). Waterstops are installed at all joints between the panels. The purpose of the apron is to prevent erosion of the blanket due to spillway operation and to preclude the introduction of water at full reservoir pressure at the top of the blanket at the soil/concrete interface at the spillway structure.

Investigations disclosed a triangular shaped void about 350mm deep next to the spillway structure. It was continuous and had connection to the reservoir at the left and right slab extremities. The presence of slightly washed zones in the test pits further indicated some movement of fines at the interface. Thus, the intent of the design to preclude having water at full reservoir pressure at the soil/concrete interface had been frustrated. Two phenomena were thought to have led to this situation:

Fig. 3. The concrete panels forming the protective apron on the upstream side of the auxiliary spillway headworks. Auxiliary Dam 1 to the left

As an interim measure the void at the spillway structure was grouted in 1979. Definitive remedial measures were then designed for execution in 1980 and 1981. These measures for the apron included revisions to ensure that the apron could follow differential settlement of the fill without opening voids, and slab-jacking to fill possible voids and to even out the differential settlement which had taken place. The slab-jacking also would automatically check the integrity of the waterstops.

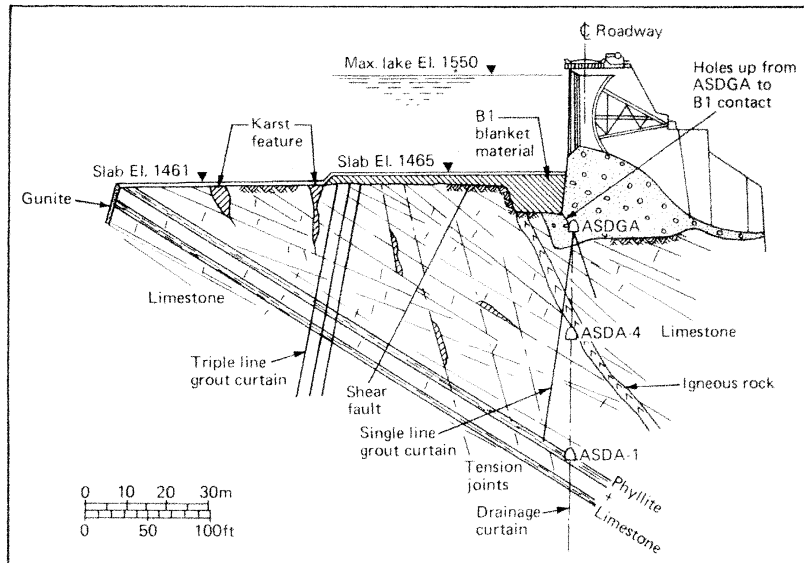
To control seepage and reduce uplift pressures related to these adverse geological conditions, two grout curtains (Fig. 4), and an extensive drainage system were constructed (Szalay, 1976). The upstream triple row curtain and the spillway structure were linked horizontally by a 68m long blanket of compacted B1 material*,

Fig. 4. General cross-section of auxiliary spillway upstream protective works

(i) After completion of the slab-jacking, water and grout injection tests were conducted on the lower contact of the B1 and concrete, through 20 drill holes angled up from ASDGA (Fig. 4). The majority of the holes were completely water-tight and only the lateral monoliths (5 and 22) had any grout consumptions (58 and 250 litres of "A/2 mix" respectively). No open water paths thus existed along this contact. Furthermore, piezometers installed in ASDGA after the slab-jacking recorded zero pressure under full reservoir conditions, and so confirmed the efficiency of the front seal.

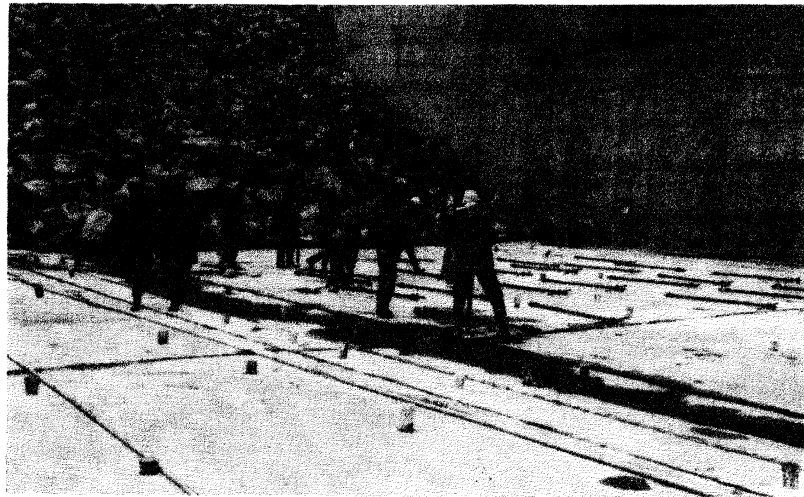
Fig. 5. Wooden bungs placed in holes to arrest grout interconnections. This photograph shows some of the narrow slabs of the articulation

The pressure grouting commenced under Panel 44 (Fig. 7), and progressed from left to right and in a general way towards the headworks. The lifting of the lower slabs was initiated from one of the peripheral holes on one edge only, and continued across the slab. As the grout migrated, wooden plugs were driven into the holes from which grout emerged. Practice was to permit travel of up to 6m before further packers were then installed nearer to the travelling face of the grout and injection transferred to them. When approximately two-thirds of the slab had been so treated, the grout line was returned to the first packer to attempt to lift that part of the slab.

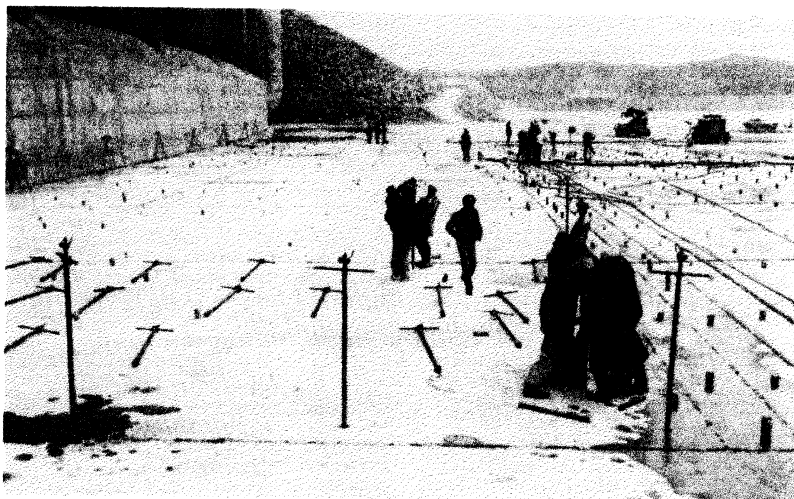
Fig. 6. Mechanical grout packers placed in drill holes in preparation for panel lifting

Injection was made through mechanical packers, set towards the invert of the concrete slab, and 2m long to ensure the pressure of a nominal head of grout between the cessation of pumping and first set of the mix (Figs. 5 & 6).

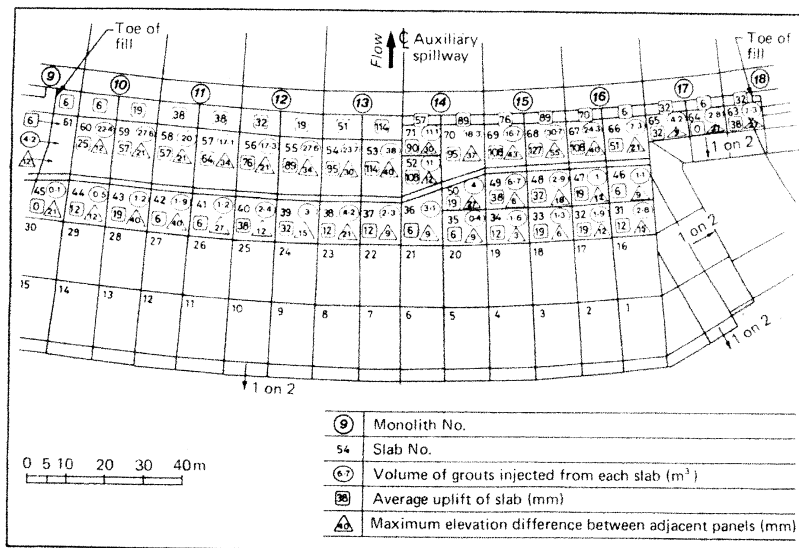
Fig. 7. Grout consumptions, average up-lift and relative attitudes of panels, after slab-jacking

A detailed survey of the slabs after the "visual smooth profile" aim had been achieved (Fig. 7) showed that the average maximum elevation difference on any panel had been reduced to 24mm (from a maximum of 40mm), and the average maximum elevation difference between adjacent large panels had been dropped to 20mm (from 40mm). Differences between the thin panels were higher. A maximum uplift of 127mm was recorded under Panel 67, whilst by far the lowest region (i.e. the thin strips between Panels 46 and 66) was barely 75mm below the nominal apron elevation of 1 460 ft. The slab-jacking had thus reduced the distortion of the individual panels, and had restored a uniformity of elevation.

By considering the area of each panel, and its average elevation difference, the net volume change was about 240m³, which was less than the volume of 375m³ of injected grout. Part of the difference may be due to the filling of voids, with the remainder due to compression by the overlying slab on the bentonite rich mixes, wastage, and lateral travel of the grout beyond the limits of the apron. Evidence of the last item was seen in later work conducted to improve articulation of the apron. In comparing the grout takes per panel with the changes in elevation, those further from the headworks (i.e. Panels 31 to 45) took more than was required for the measured uplift — a feature attributable to grout interconnection with adjacent panels. Significantly, those closer to the headworks in general showed the opposite relation.

The original concept of gravity back-filling was pursued, but early results indicated nominal consumptions with no inter-connections. Indeed, only Panel 38 (Fig. 7) accepted a volume of grout beyond the initial cement-bentonite starting mix. By the same point, it was recognised that the initial pressure grouting with c:b:w — 25: 30: 100 to 70 mixes was easily finding connections with holes up to three slabs distant. It was concluded that the first objective of void infill and contact grouting could be effectively achieved by the methods originally intended for just the uplift grouting. Gravity grouting was, therefore, soon discontinued except for final 'topping up' of holes at the conclusion of the pressure grouting.
