# Boonton Dam: Partnering in a Conventional Bid Climate

by Steve H. Snider, P.E. and Donald A. Bruce, Ph.D.

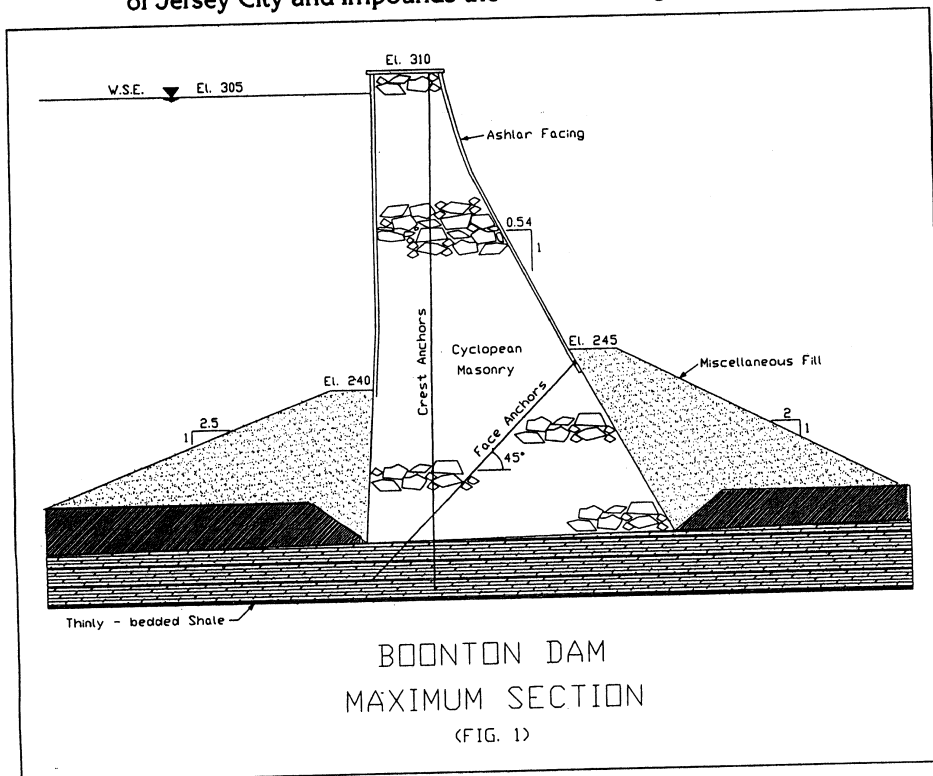
tors thereby ensuring an acceptable number of competitive bids. A combination of face anchors at 45° and near vertical crest anchors at a 5° inclination upstream was found to meet these criteria in the maximum sections (Figure 1). Crest anchors were found sufficient for 450 feet
