**DAM REPAIR BY ANCHORING AND GROUTING:
SOME RECENT NOTABLE CASE HISTORIES**

**Dr. Donald A. Bruce* C. Eng. and
Paul B. Groneck† P.E.**

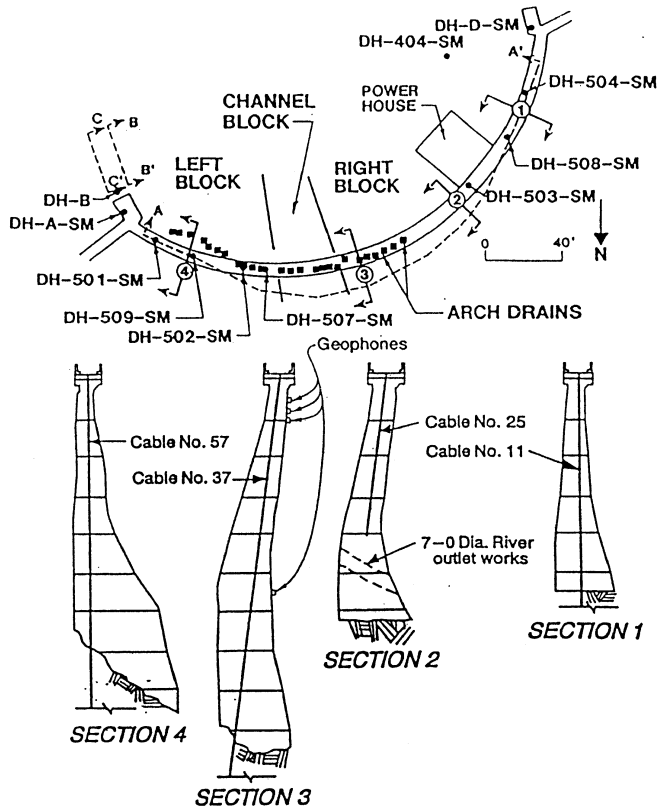
Figure 1. Typical sections through the arch, showing inclination of anchorages, positions of toe drains, and locations of geophones. Stewart Mountain Dam, AZ.

222 feet, while bond lengths ranged from 30 to 46 feet. Inclination varied along the dam, from vertical to 8° 40' upstream (Figure 1). All but 7 of the tendons (located immediately above the river outlet work openings through the dam) were founded into the dam foundation bedrock (32 in the right foundation zone, 15 in the left foundation zone, and 8 in the fault zone). Each tendon consisted of twenty-two 0.6-inch diameter epoxy coated strands. Design working loads averaged 630 kips (range 550 to 750), equivalent to about 50% GUTS (Guaranteed Ultimate Tensile Strength).

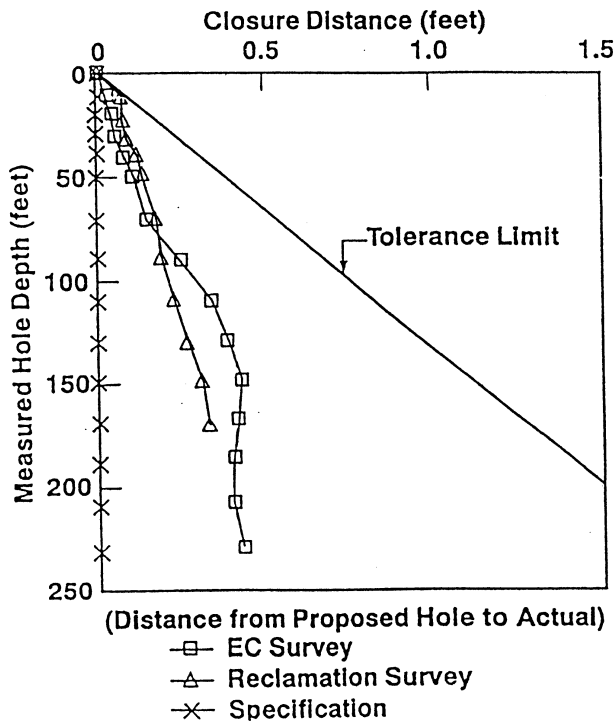
As a further check, Reclamation ran random, independent precision optical surveys in completed holes, using a Pentaprism instrument. These surveys invariably showed that even the rate gyro instrument overestimated the amount of deviation (Figure 2) while every hole proved to be within specified tolerances even despite old steel beams encountered in the concrete in certain places (Bianchi and Bruce, 1992).

Figure 2. Typical hole deviation data, as monitored in Hole 37, Stewart Mountain Dam, AZ.

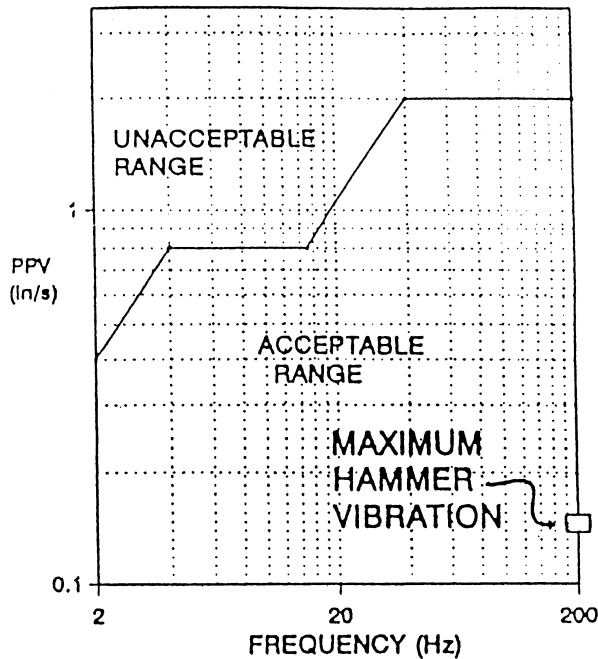
across the lift joints indicated tiny movements at most (Table 1) while the geophones indicated equally insignificant peak particle velocities (Figure 3). During every drilling (and grouting) activity, the dam's underdrain system was flushed with water and monitored closely to ensure that the drains were not compromised. The impact of the drilling and water testing on local piezometric levels was evident only during the period of these activities. Various other structural, environmental and personnel safety issues were addressed, as described by Bruce and Triplett (1992).

Figure 3. Data from geophone monitoring during down-the-hole drilling through concrete. Stewart Mountain Dam, AZ (Reclamation Acceptability Criterion).

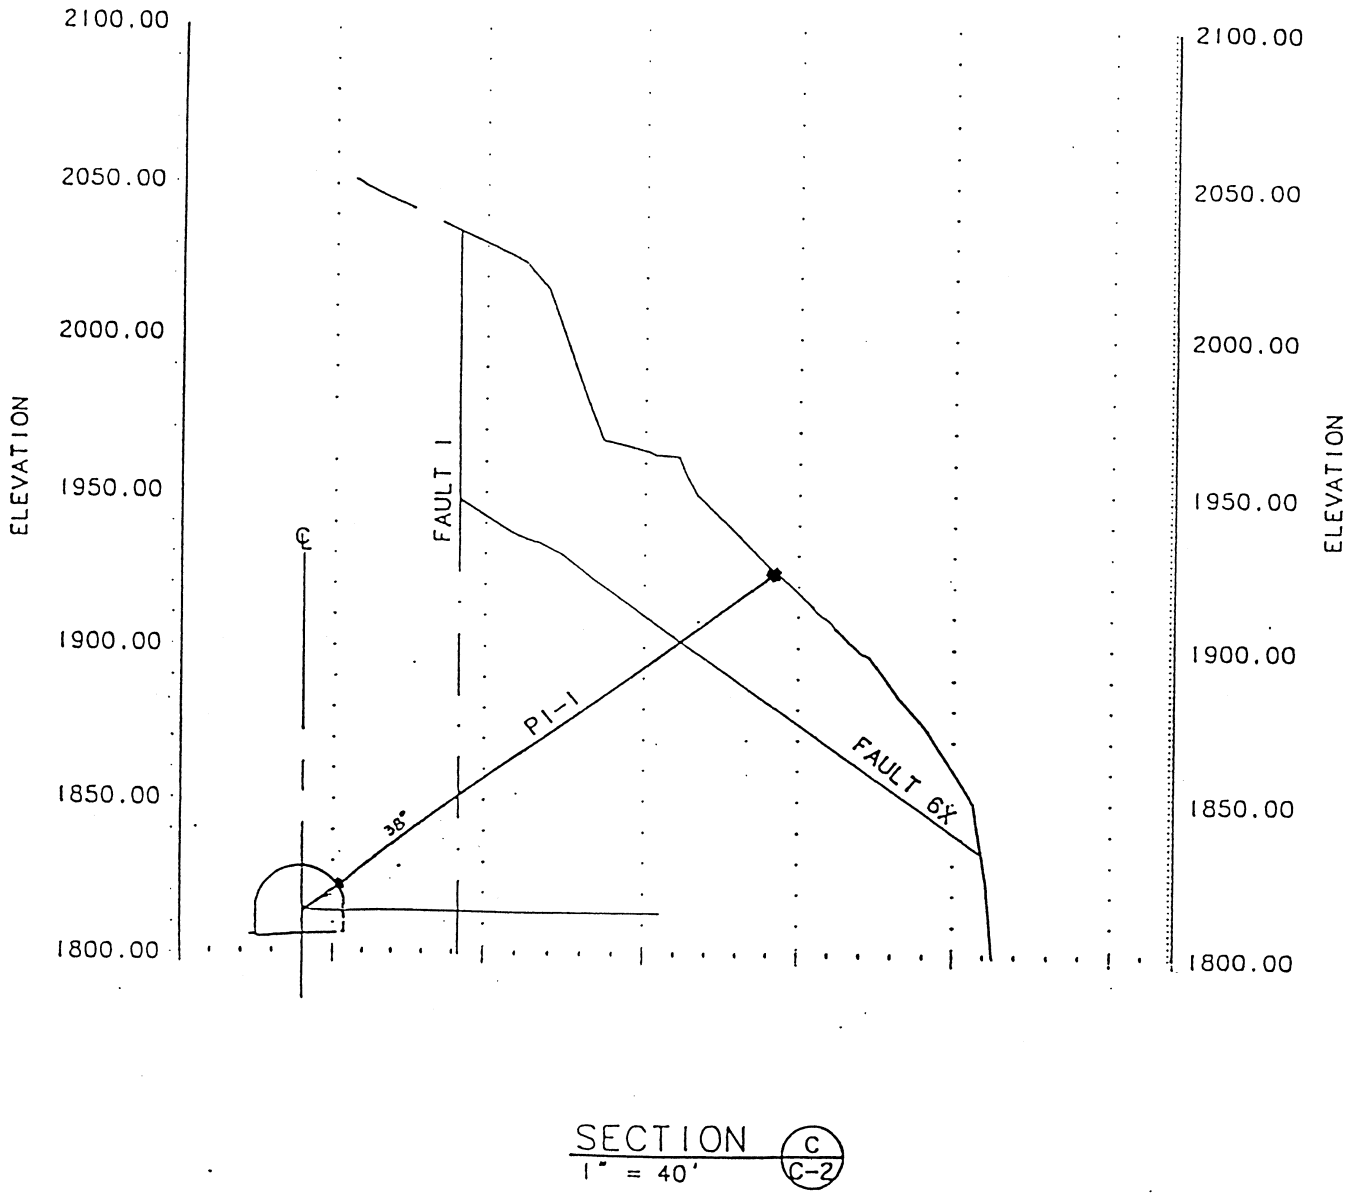
the dam foundation which carries the arch loads. It was determined that the rock wedges were potentially unstable during seismic loading, and that application of a prestress force equal to approximately ten percent of the dead weight of the wedges would be required to provide an adequate stability factor of safety.

Figure 4. Schematic representation of prestressed anchors. Boundary Dam, WA.

The final design completed by Harza Northwest, Inc. Engineers, included installation of six 1,000 kip capacity anchors and seven 500 kip capacity anchors. All of the anchors were to be installed from the gallery access tunnel (Figure 4). All of the anchors had an upward inclination from 19 to 58 degrees above horizontal. The 1,000 kip anchors were designed as double headed anchors (no bond length) due to the end of the anchors being located on or adjacent to the spillway channels, allowing relatively easy access for installation of the outside end bearing plate and anchor head. The 500 kip anchors would exit the rock on the face of the cliff, and were terminated and bonded in the rock wedges in order to avoid work on the cliff face. Total anchor length ranged from 89 feet to 207 feet. The tendons comprised 0.6" diameter strands, 31 for the 1000 kip anchors, and 16 for the 500 kip anchors.

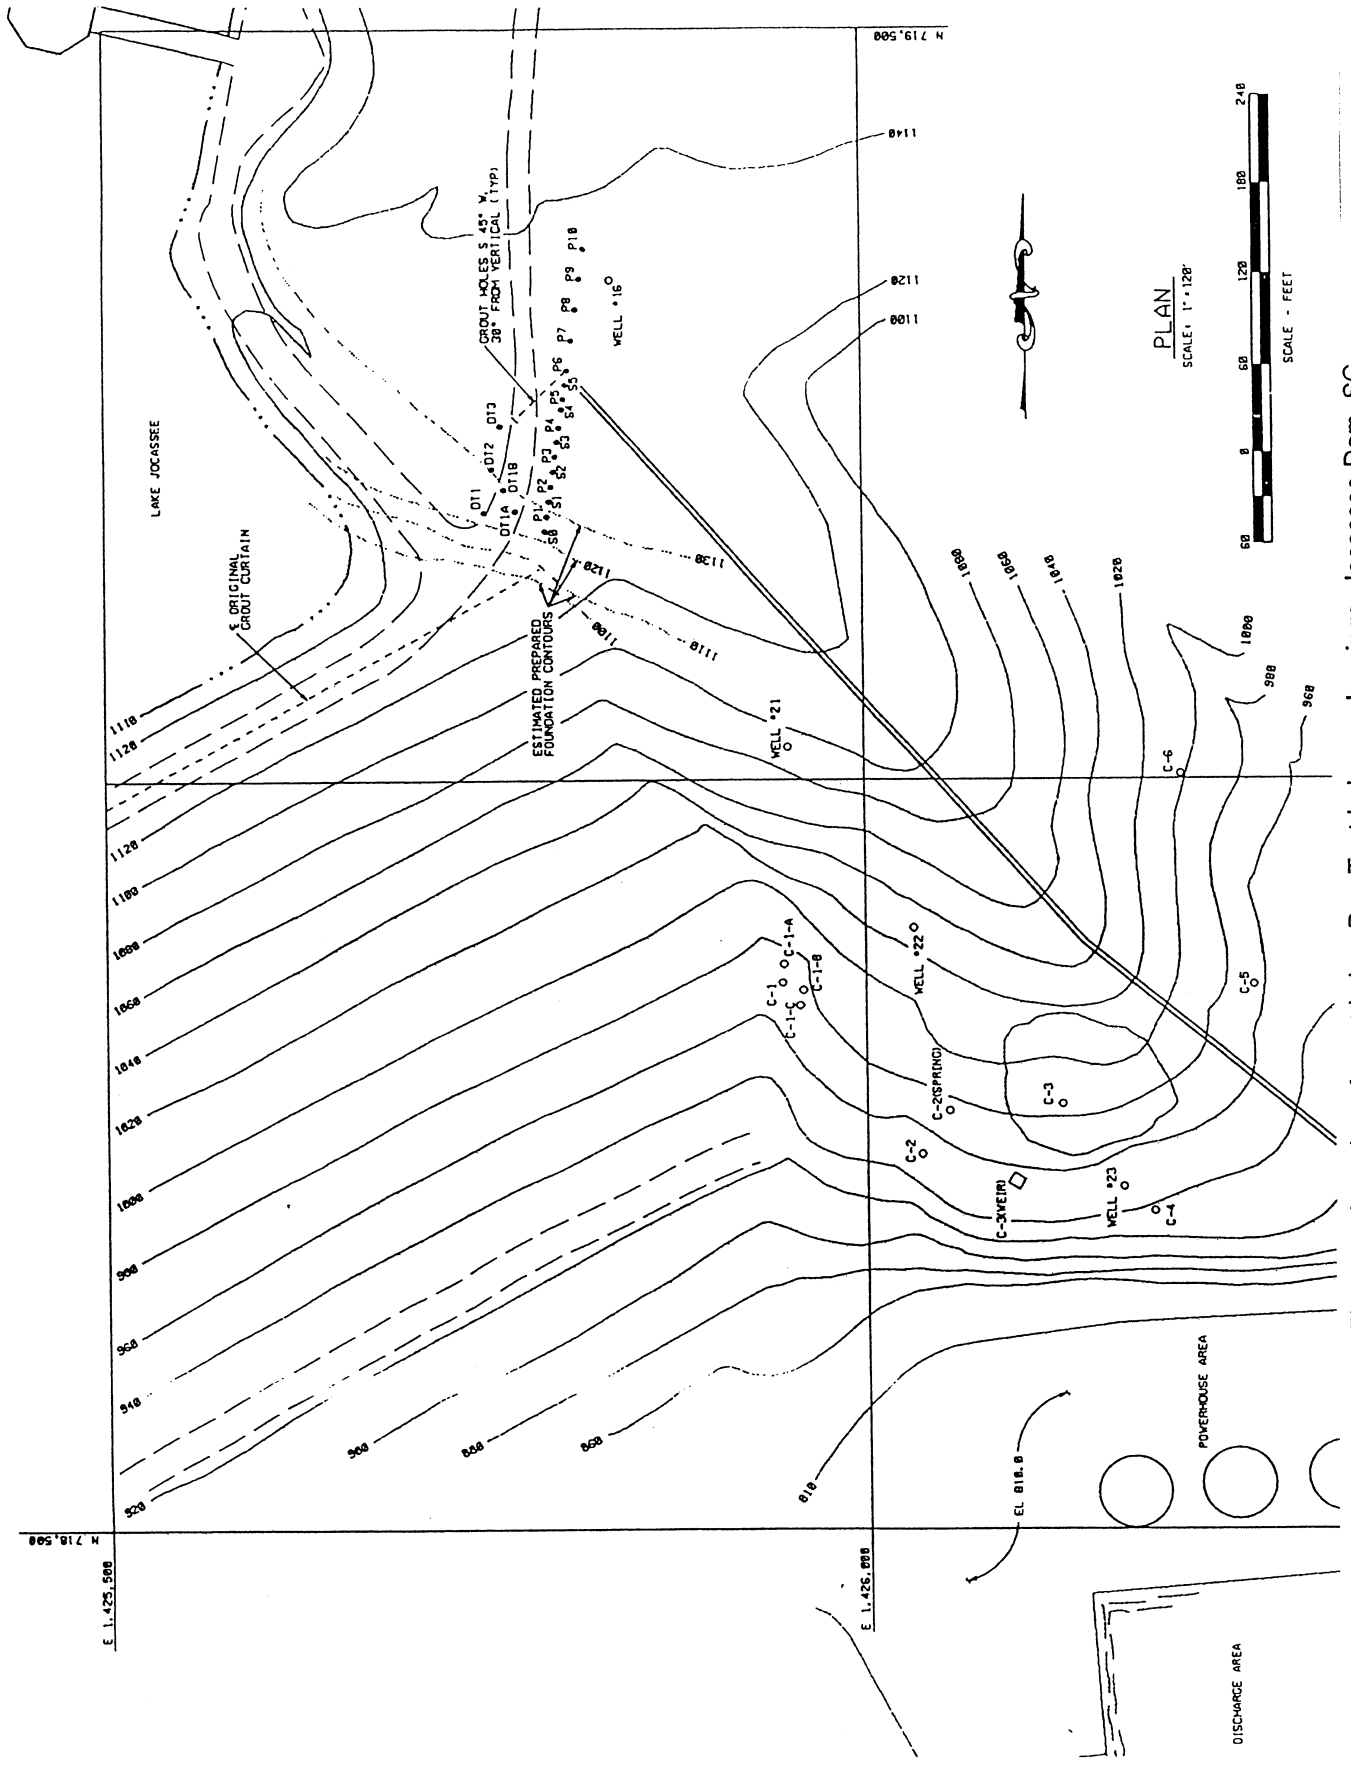
4.2 Introduction to Problem - Following first reservoir filling in late 1973, a number of springs and seeps were observed on both downstream abutments. By 1976, flows, carrying silt and sand were observed at the C3 weir (Figure 5) about one third of the way down the left abutment. The volume of flow from C3 (at El 986) was directly dependent on the reservoir level in the range between El 1080 and 1110 feet and varied from 0 to 50 gpm. After some interim measures, Duke undertook in October 1991 a full program of action to concentrate on spring C3 in particular. Additional data are provided in Bruce et al., (1993).

Figure 5. Location of grout holes, Dye Test holes, and springs, Jocassee Dam, SC.

4.3 Curtain Design - A straight line projection from C3 towards the dam crest helped locate the area to be grouted and this was confirmed by further coring and dye flow testing. Study of the major joint orientation yielded the most effective orientation for the grout holes (Bearing southwest; dip 30° below vertical). This single row of new holes was designed to intersect the original three-row curtain, but not to intrude into the core material. Their depth was determined as equivalent to El 1050, bearing in mind the relationship between reservoir level and seepage volume.

4.4 Construction - The work totaled 10 Primary holes, spaced at 10 foot centers, and 6 Secondary holes concentrated near the embankment. Since the seepage was felt to be restricted to well defined open channels in the weathered bedrock, (as opposed to a myriad of fine fissures) a 4 1/2 inch diameter down-the-hole hammer with air flush was used to drill each hole to dull depth. Permeability tests were carried out in stages of 27 to 33 feet length in each hole, using the multipressure Houlsby (1976) method to a maximum excess head of 38 psi.

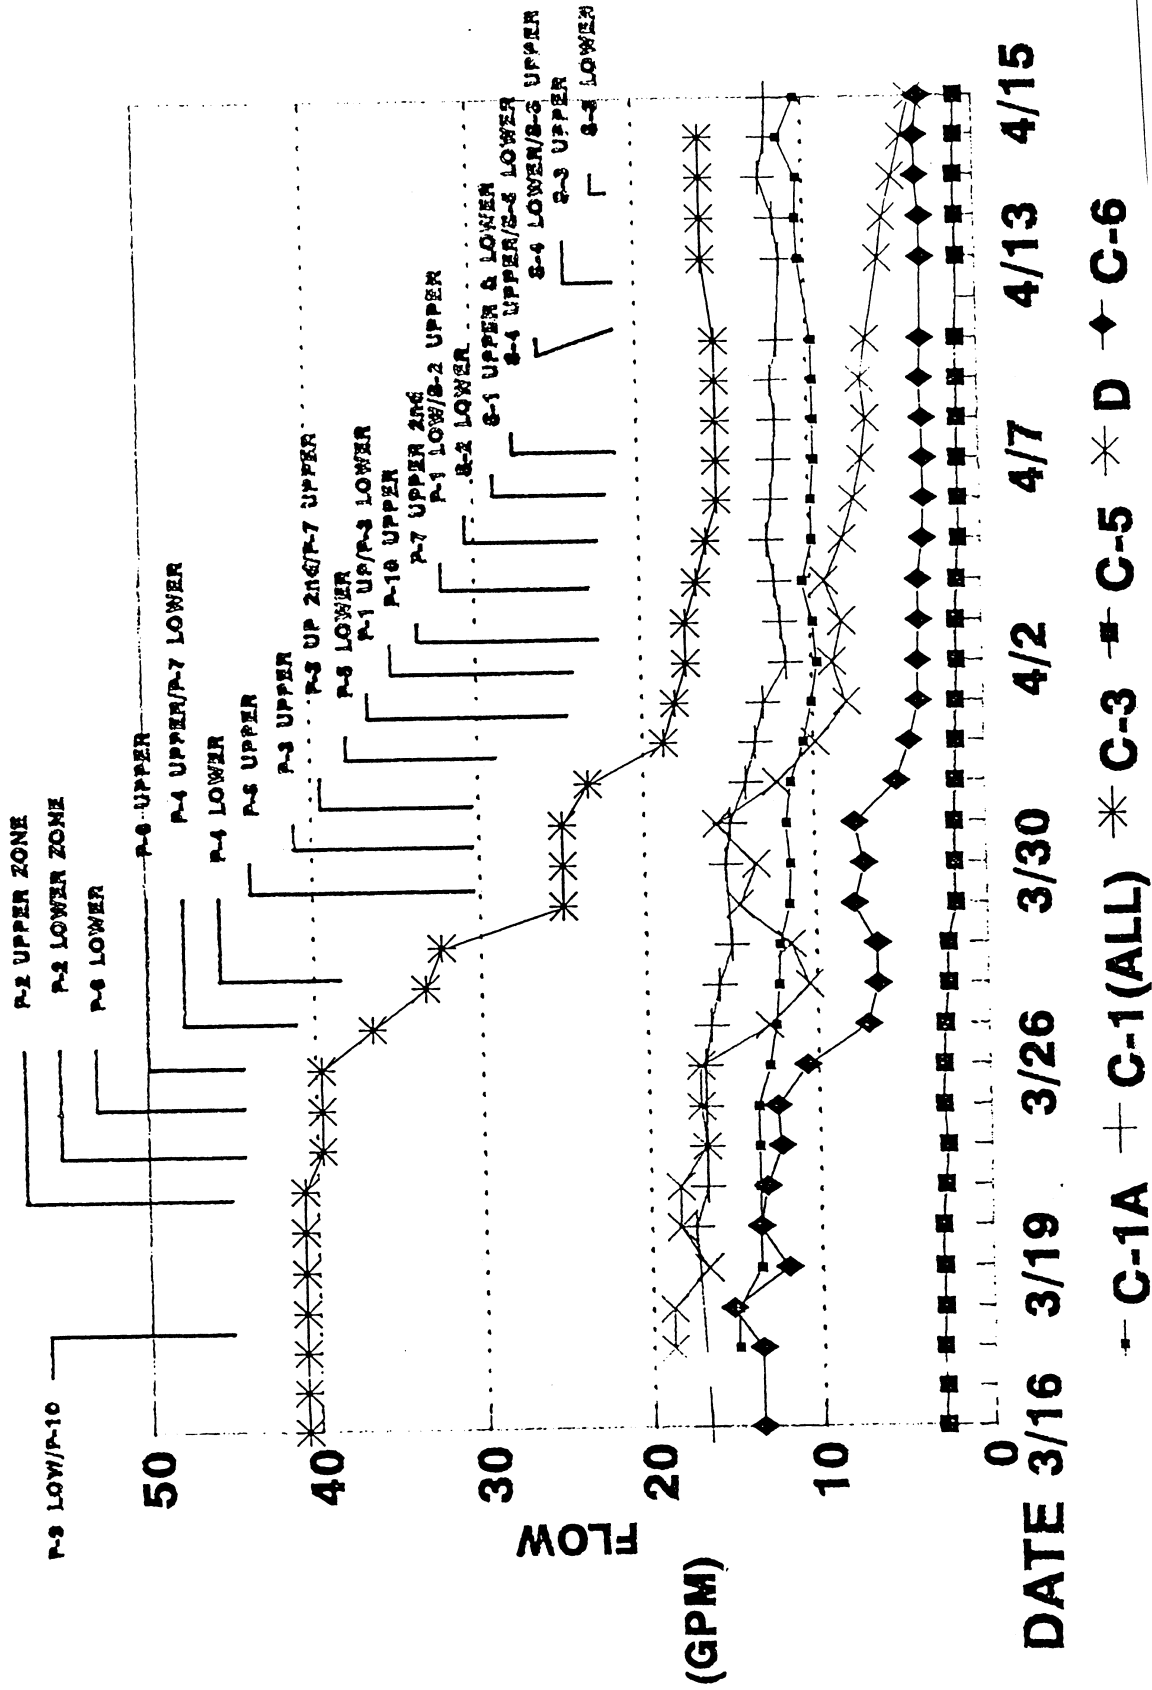
- the nearest piezometer showed a significant increase in head;
- spring flows from all sources in the vicinity were reduced from 107 gpm to just over 30 gpm. (Figure 6). No transported sediment has been noted;
- dye testing confirmed far less direct hydraulic connections across the curtain.

Figure 6. Spring flows measured during grouting (Reservoir level relatively constant between 1107.4 and 1109.0 feet. Elevations of flow points: C1 = 980'; C3 = 986'; C5 = 956'; C6 = 1000'; D = 1000'), Jocassee Dam, SC.

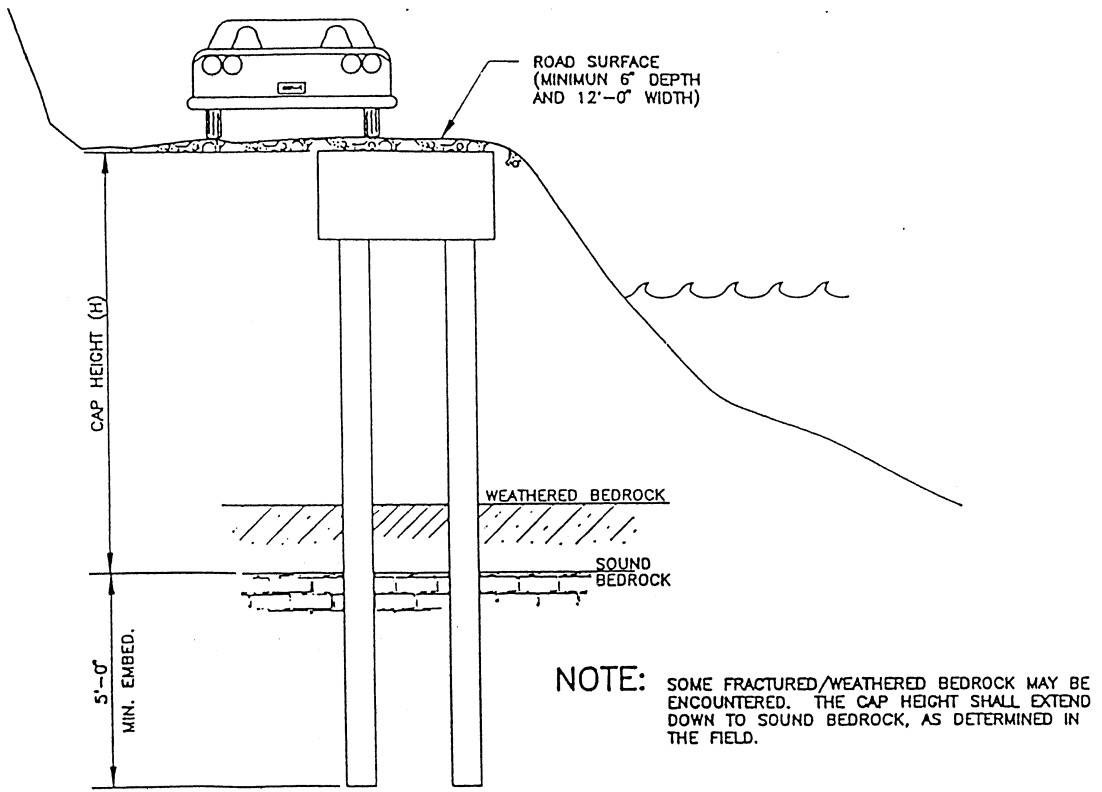
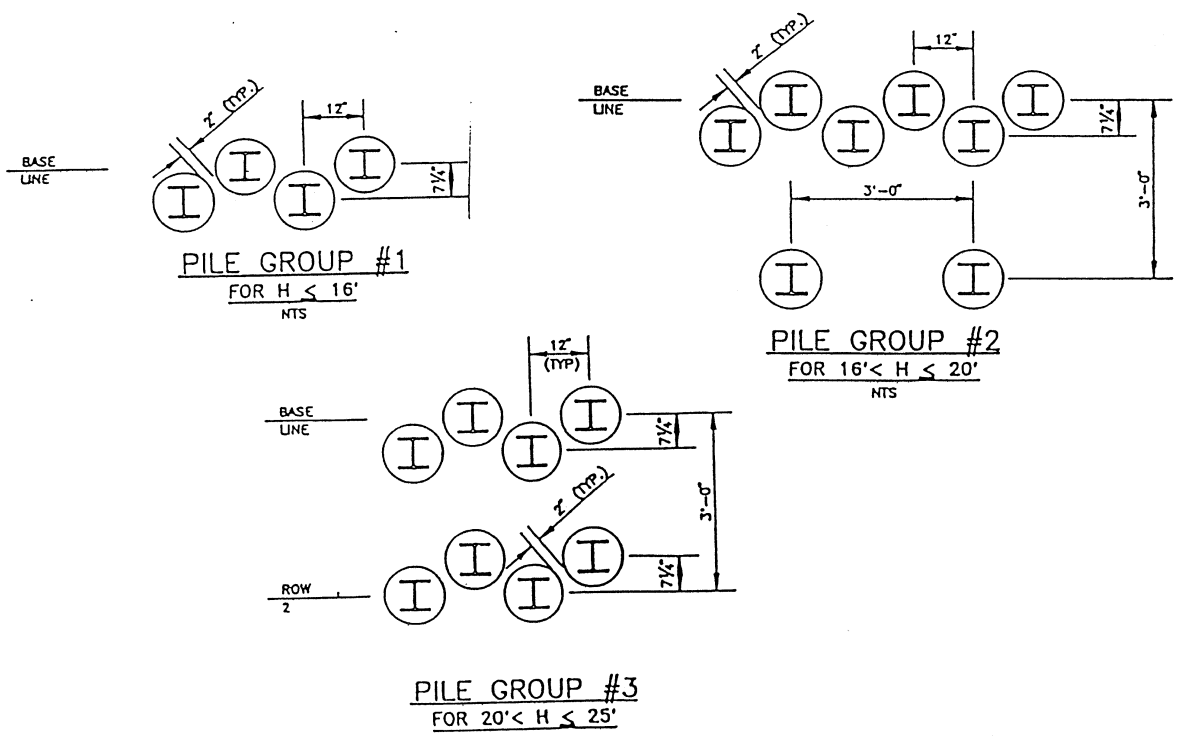
PILE GROUP
GENERAL INFORMATION
NTS

5.2 Introduction to the Problem - During the period from 1968 to 1983 the roadways were damaged to varying degrees six times from discharge volumes ranging from 3,000 to 70,000 cfs. Typical repair measures consisted of cleaning of the river channel, rebuilding the lower road with large rock material, and regrading the upper roadway. A large retaining wall consisting of a lower tieback anchored concrete wall with a Hilfiker welded wire reinforced wall on top was constructed in 1984 on the upslope side of the lower road, which allowed regrading and realignment of the upper road. The lower road was also rebuilt at this time. With construction of this large wall, the importance of the lower road stability was greatly increased.

Figure 7. Pile Group: General Information, Horse Mesa Dam, AZ.

The wall design concept and construction quality were tested during the very wet spring of 1993, during which extremely high dam discharge volumes were experienced. The heavy rains and high water discharge caused sloughing on the slopes above, washout of the lower access road upstream from the pile wall, and washout of the material in front of the pile wall. However, the pile wall and the adjacent anchored and reinforced earth wall remained intact.
