# DESIGN AND CONSTRUCTION OF SEEPAGE CUT-OFF WALLS UNDER A

# CONCRETE DAM WITH A FULL RESERVOIR

Peter D. Amos • Donald A. Bruce • Marco Lucchi • Neil Watkins • Nick Wharmby

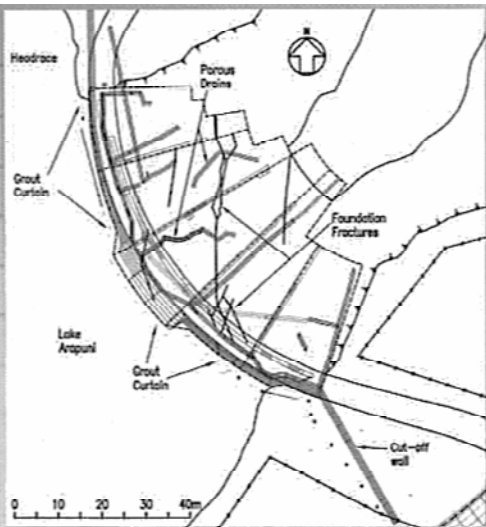
Figure 3. Plan view of Arapuni Dam (The positions of the foundation fractures noted during dam construction are shown).

The dam site is in an area of multiple ignimbrite flows from volcanic eruptions over the last 2 million years. The main dam footprint is founded on a 40-50m (130-165ft) thick sheet of Ongatiti Ignimbrite (Figure 3), a point-welded tuff. The upper part of the unit is very weak at 2 to 6 MPa (300-800psi), while below the original dam cut-off wall the Ongatiti is considerably stronger (up to 28MPa (4,000psi) (Figure 4). Major sub-vertical defects in the form of cracks or fractures trending North-South are present in the Ongatiti. These fractures extend for the

full depth of Ongatiti and vary in aperture from closed up to 80mm (3in). Clay infill is generally present where the cooling fracture opened around the time of ignimbrite emplacement. The fracture infill is nontronite, an iron-rich smectite clay with a very high moisture content and very low shear strength. This very weak clay is potentially erodible in the presence of seepage flow. Where infill was not present in fractures, seepage pressures correlating to reservoir level were present in some areas of open joints under the dam.

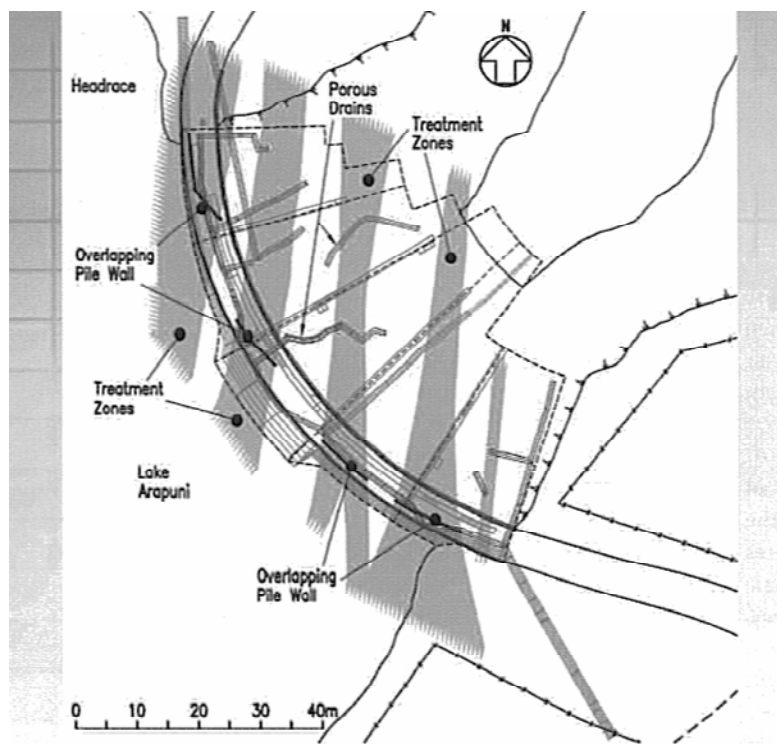
Figure 5. Plan of long-term seepage control remedial works, with cut-off walls, treatment zones and underdrain

The concrete cut-offs were to be located in the fracture zones as far upstream as possible to restore the normally accepted uplift profile under the dam (Figures 5 and 6). Because the reservoir was to remain full throughout, dam safety was an important consideration in selection of the final remediation technique.

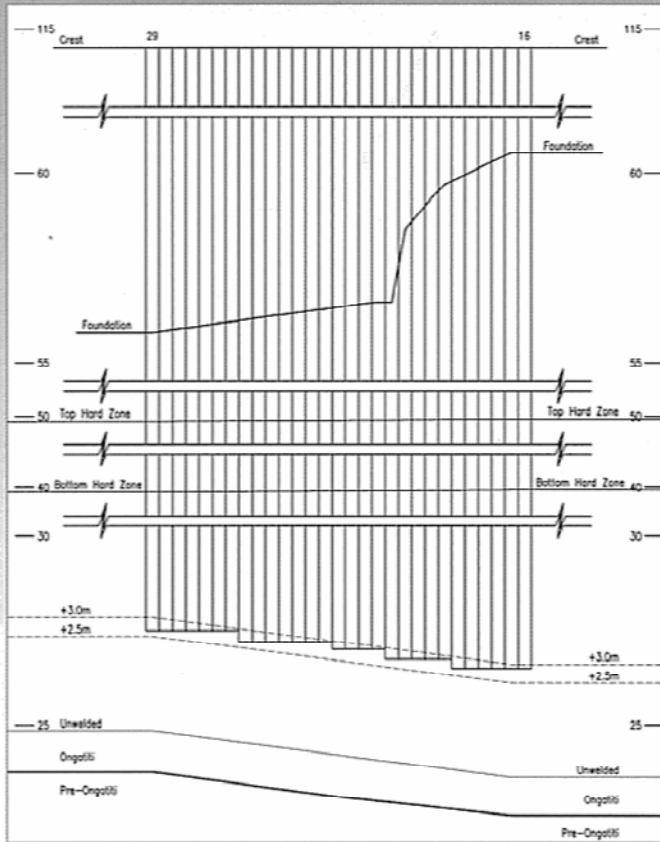
Figure 7. Typical Elevation of a Treatment Panel

The length of each panel was to cover only the zones of vertically jointed Ongatiti Ignimbrite identified in the geological investigation, supported by piezometer responses indicating hydraulic connections in the foundation. Some foundation joints were identified between the treatment zones, but these were confirmed to be sufficiently minor that they would not present a future risk of a concentrated leak. Target depth for cut-off panels was just above the interface with the underlying Pre-ongatiti Ignimbrite unit to avoid disturbance of the unwelded sediments between the ignimbrite units (Figure 7).

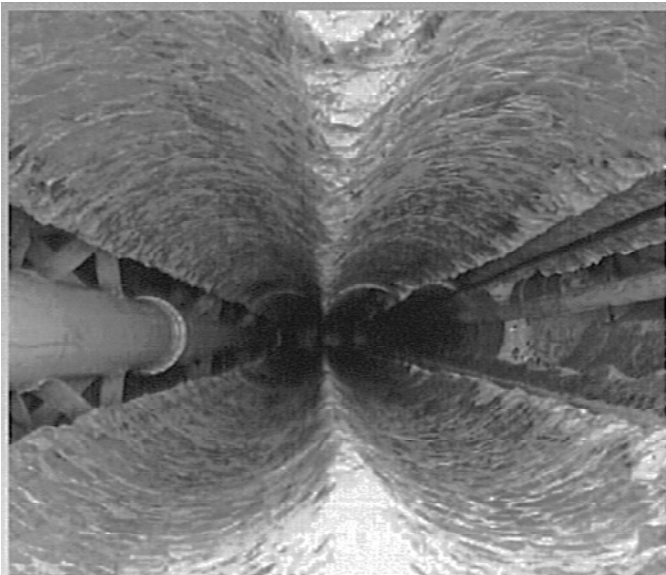
Hole accuracy was frequently measured during drilling by inclinometer measurement of drill rods. On completion of the prescribed number of holes for a slot, the continuity of overlap across the open slot was checked and if rock remained bridging across an open slot, this was removed by tools such as a steel chisel. The condition of the rock walls of the slot was usually viewed with an underwater camera and a velocity probe used to identify if any concentrated flow of groundwater was occurring through the open slot.

Figure 10. Downhole photograph of overlapping drill holes

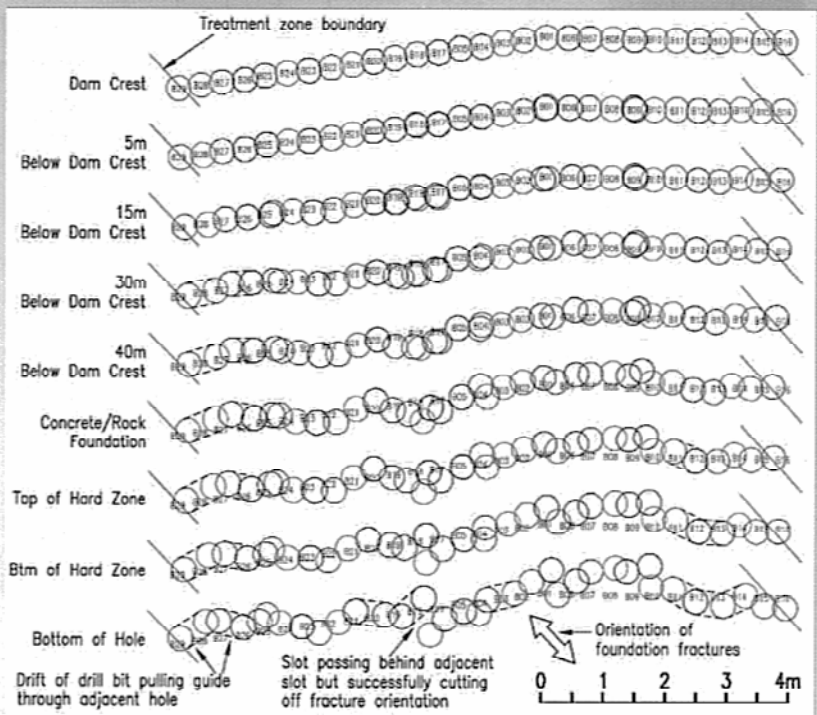
Foundation drilling and panel construction was completed in September 2007. Inclinometer surveys and continuity checks demonstrated that the completed panel geometry covers the defined treatment area, with hole drift typically less than 500mm (20in) over the height of the cutoff walls, as evident for the panel in Figure 11.

Maintaining drill hole accuracy over 90m was generally successful, although at times a new directionally drilled starter hole was required to improve slot alignment. At two locations shown on Figure 11 this resulted in holes passing behind the adjacent slot without direct overlap. However the orientation of the slots is such that it is not possible for a concentrated leak in a foundation fracture to pass through this section of wall. In particularly soft ignimbrite the drill bit would at times drag the guide sideways, resulting in an elongated slot as seen on Figure 11 where adjacent holes appear not to overlap. However verification tests confirmed successful creation of the slot over the full geometry.

Figure 11. Sections at key depths of Treatment Panel B, showing the relationship between inclinometer readings for each drill hole
