Use of Innovative Numerical Modelling and Rock Mass Characterization Approaches for Design of Foundations within Weak Coralline Limestones

Carter, T.G¹., Carvalho, J.L¹., Dittrich, J.P¹., Cottrell, B.J¹., Leew, B². and Cirulis, K¹.

Golder Associates Ltd., Mississauga, Ontario¹ and Calgary, Alberta², Canada

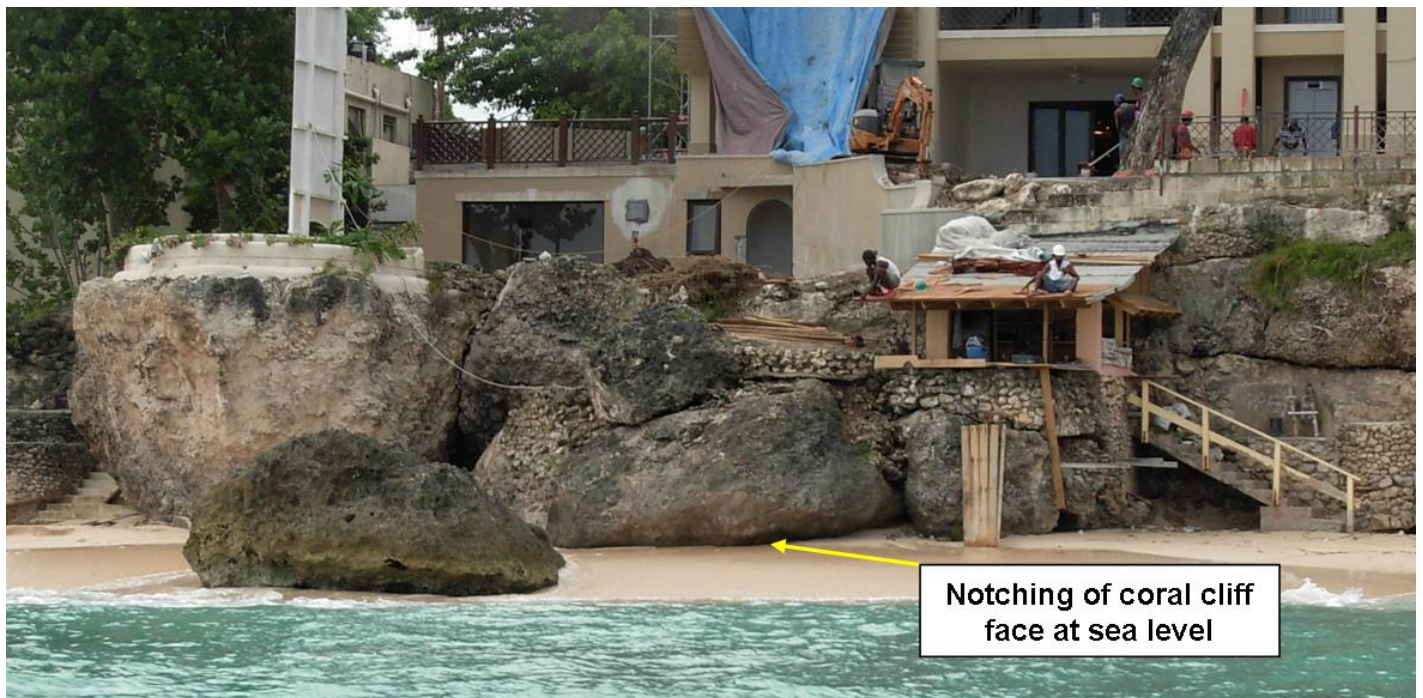
While some areas of real rock-like cap material were recovered in the borehole cores and are observed at exposures around the site, the excavation for construction of Level 0 (Basement) of the Phase 1 building likely removed most of this cap zone in the north part of the building footprint. Evidence from the remnant coral sea stacks immediately in front of the west side of the building (i.e. on the shore side), and from verbal and photographic information provided by the structural engineer and the building contractor on site, suggests that notching along the coral cliff face locally occurs at sea level and along prominent sub-horizontal weaknesses and that a set of sub-vertical major fissures exists extending landward from the sea (Photo 1).

Photo 1 – Notching of coralline cliff face along sub-horizontal weaknesses at sea level.

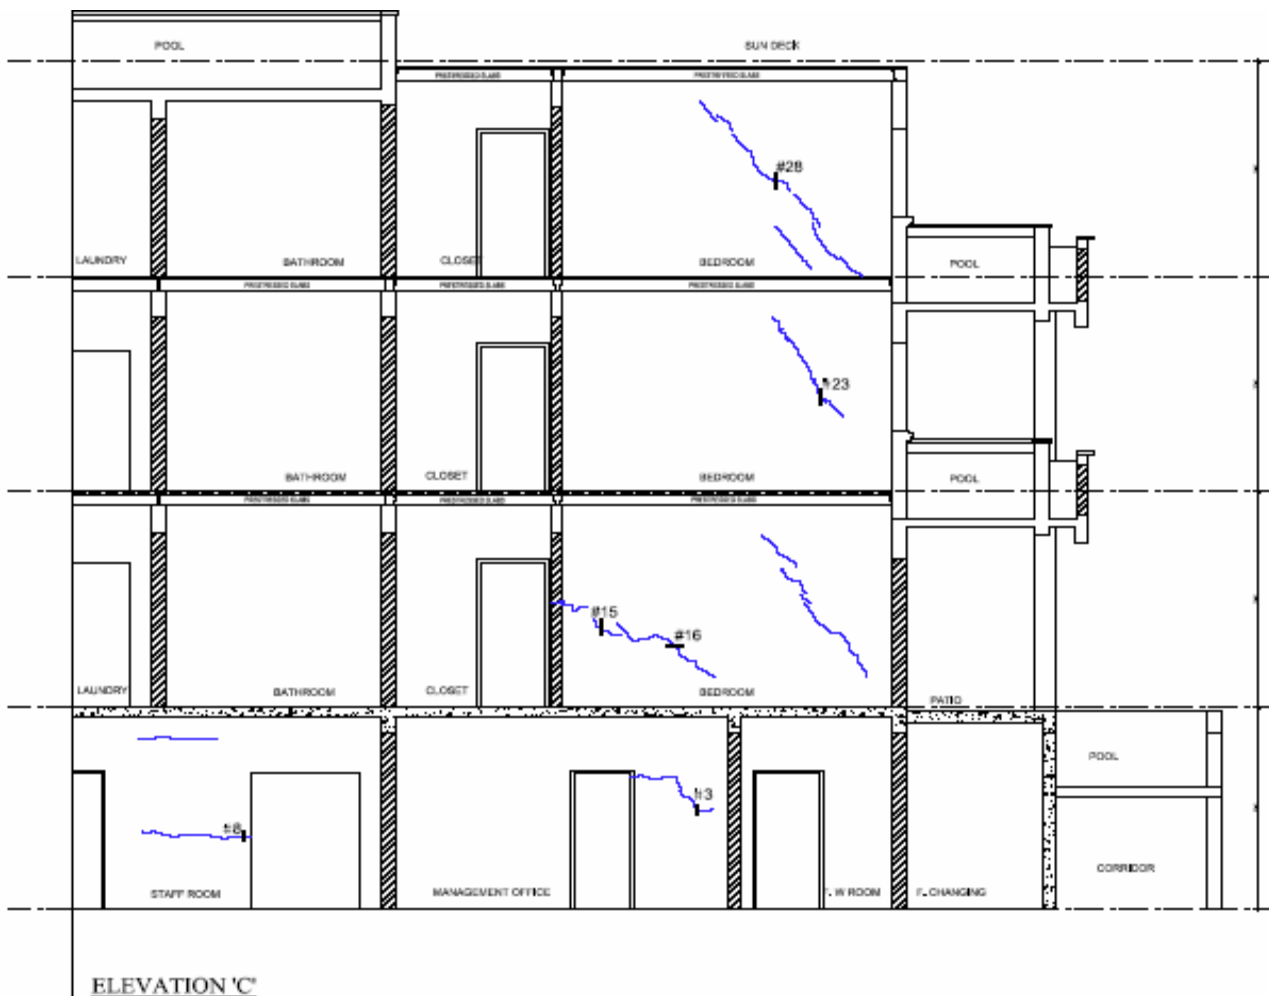
In general the cracking typically comprised $\sim 45^\circ$ oriented flexural shear cracking, however some subvertical ($\sim 90^\circ$) cracking was also observed. Based on the data plotted for the cracking, two different frameworks of cracking were identified. One of the sets of 45° flexural shear cracks dipped towards the sea (to the west) within the east-west building walls, (Figure 1) and the second set dipped towards the gully (to the north), within the north-south structural walls. In addition, some areas existed where cracking could be observed extending through cross-connecting main columns.

Figure 1 – Shear cracking ($\sim 45^\circ$) in east-west building walls.

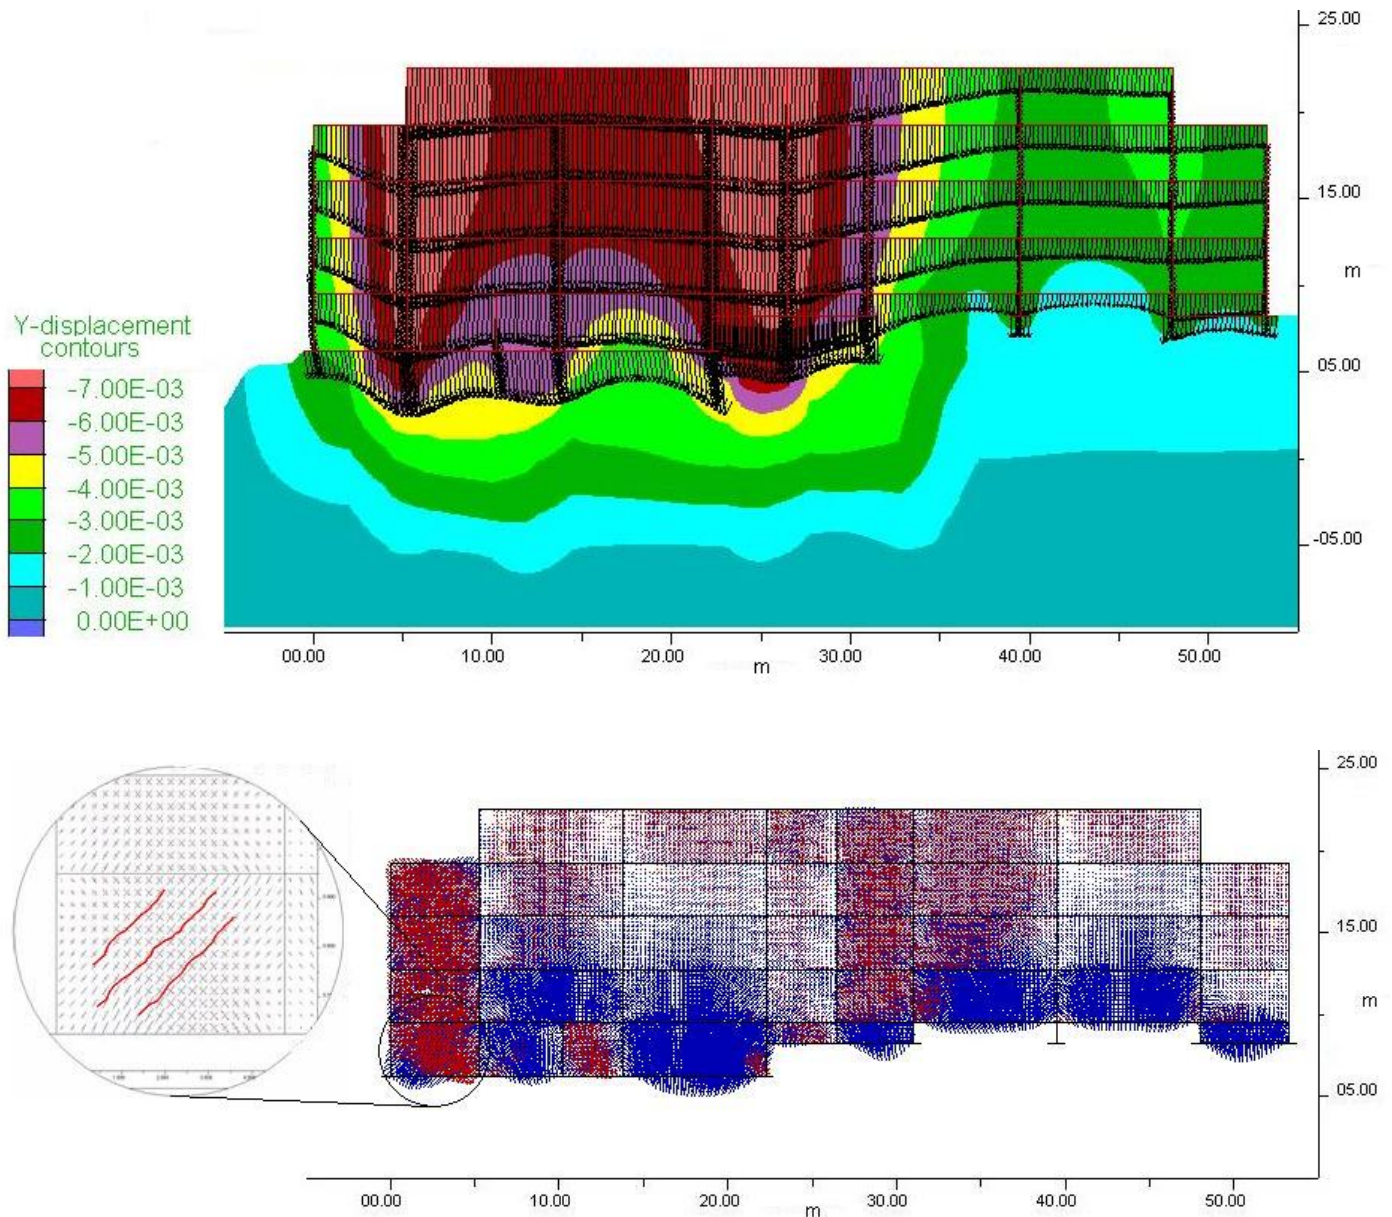
By contrast, as shown on Figure 2, the results of the analyses of the north-south section show more severe differential settlements and shear loading on the walls than east-west section. Based on close examination of the results and comparison with the observed crack patterns it is inferred that the higher differential settlements, which appear to preferentially occur towards the north end of the building, occur as a result of higher loads in the inner bearing walls in association with the poorer ground in this area. This differential settlement results in shear loads in the walls of the three northernmost bays. The principal stresses in the walls are oriented diagonally with the tensile direction dipping to the south in the highest loaded walls. This result in potential crack patterns which have the cracks dipping to the north (towards the gully) and similar to those patterns observed on the structure.

Figure 2 – Vertical displacements and principal stress directions – walls of first bay from the North end experience highest shear stress, consistent with the differential displacements.

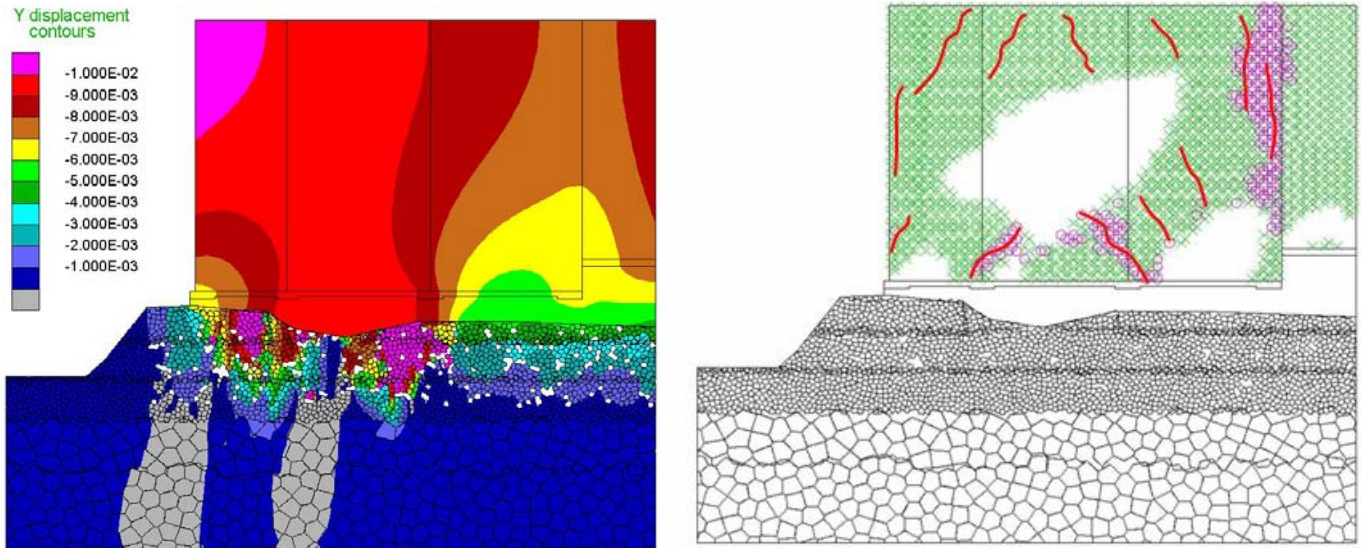
As can be observed on Figure 3, the results from the modelling show that significantly aggravated differential settlements develop towards the northwest corner of the building as a result of washout/marine flushing (replicated in the model by block deletion). With increasing void creation coincident increased differential settlements and plastic failure develop within the structure, until a critical state is reached at approximately 12% rock mass voids (ie., 40-45% total voids) wherein caving failure of the rock mass occurs associated with considerable settlement and structural damage. At this stage the highest differential settlement develops at the vertical jointed zones.

Figure 3 – Vertical displacement contours and interpreted cracking patterns based on stress trajectories after 12% void creation.

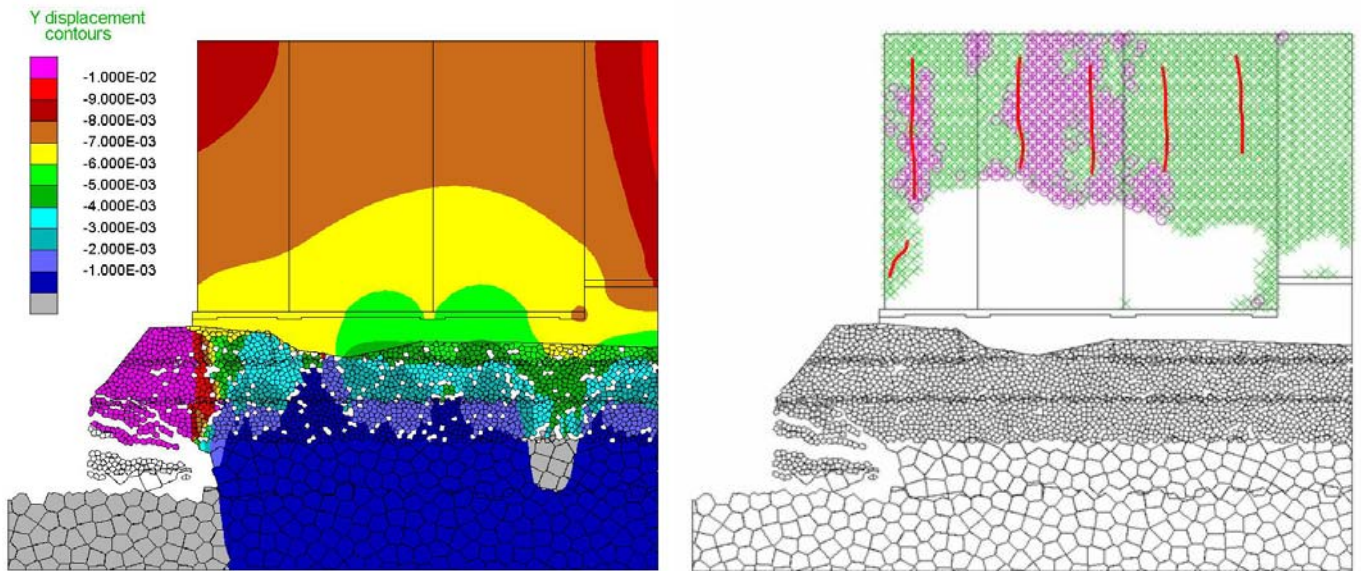
When a significant undercut is allowed to progressively develop in the model, as shown on Figure 4, failure becomes more of a toppling type mechanism, with the more competent rock above the undercut seam tipping and slumping towards the sea. This model response behaviour of toppling and overturning is absolutely characteristic of the pattern of sea cliff and cliff notch recession processes that are clearly evident around the island.

Figure 4 – Vertical displacement contours and interpreted cracking patterns based on stress trajectories after 12% void creation.

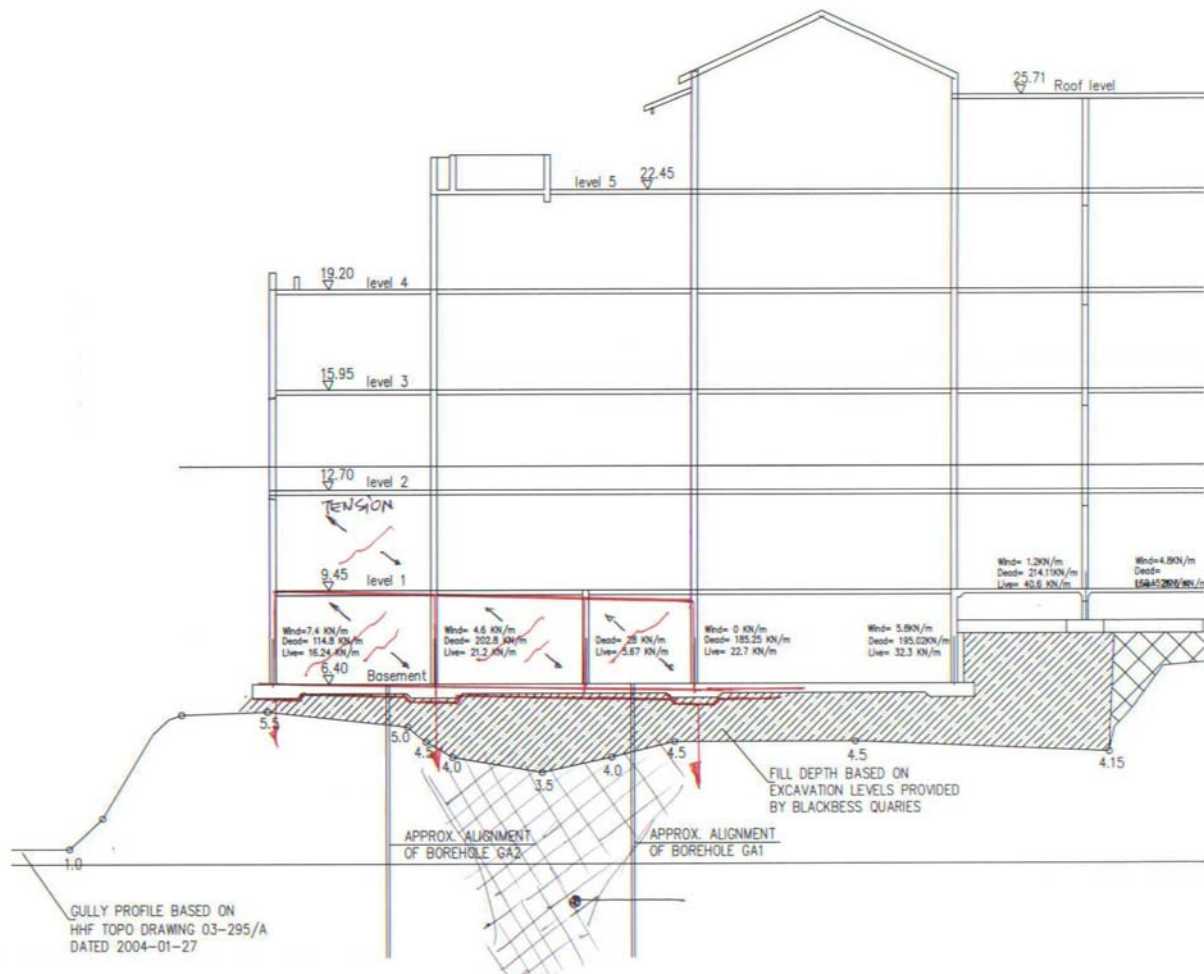
As shown on Figure 5, the fact that the northern half of the building was constructed with a lower foundation level than the southern half as a result of the basement may well have locally complicated the building response and been a key factor in the building behaviour. Because the excavations undertaken for the basement level construction likely removed any harder, indurated and more competent coralline cap-rock material that would have originally existed on the surface of the site in this area, this may have exacerbated the settlement response. Further, in this area, because of the basement, an additional floor level was created resulting in higher foundation loads in the northern half of building. This and the fact that because of the lower founding elevation, higher loads were transferred to the weaker, vuggy/voidy foundation conditions at depth further complicated building response. Finally, the reinforced concrete mat/floor slab foundation in the northern half of the building would have resulted in load spreading and distribution to a greater depth (into the weaker and more voided coralline strata at depth) than would have been experienced below the narrow strip footings (perched high in the relatively more competent coralline cap) below the southern half of the building.

Figure 5 – Northern half of the building with basement level.

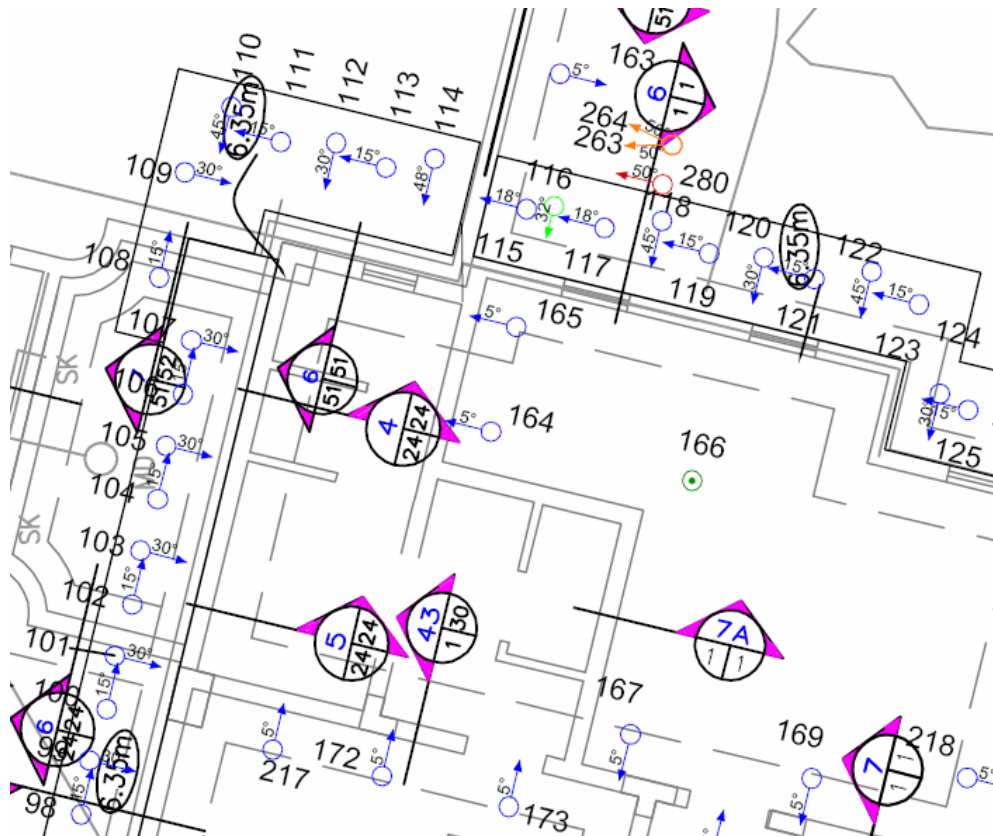
Figure 6 – Micropile layout in northwest corner of building.

As shown on Figure 6, the micropiles in each row were laid out on an approximately 1.2 m (4 foot) spacing in an alternating pattern. The outer row of near vertical micropiles were designed to be installed on a 15° inclination (from the vertical) parallel to the sides of the building in order to intersect as many near vertical joint features as possible in the subsurface. The inner row of battered micropiles was designed to be installed perpendicular to the sides of the building at inclinations varying from 30° from the vertical (along most of the southern and western sides – extending approximately 10 m horizontally below the building), to alternating between 30° and 45° (along the northern side – extending approximately 10 m to 14 m horizontally below the building). Additionally, on the western side of the building (away from the area that experienced the greatest distress) the inner row of battered micropiles was designed to be comprised of alternating installations of full length piles (approximately 20 m (65 feet) in length) and then half length piles (approximately 10 m (32 feet) in length). However, in the northwest corner and on the northern side of the building, all of the battered micropiles were designed to be full length (approximately 20 m (65 feet)) installations. At the northwest corner of the building, an extra row of five (5) grout only holes was included to be installed at a low angle (between about 50° to 55° from the vertical) to reach further below the building in this area.

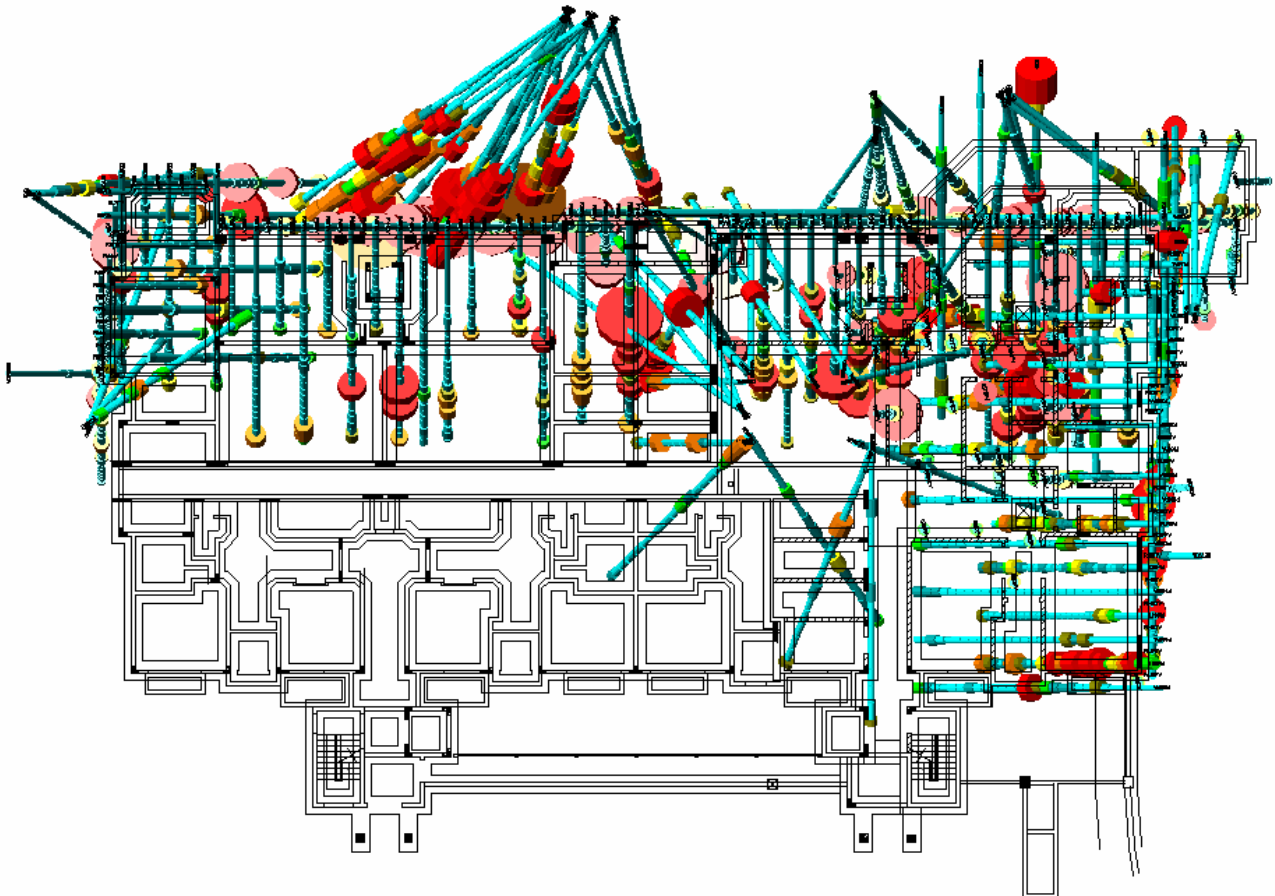
During the course of the remediation work, the conditions encountered during drilling and the volume of grout injected (or ‘take’) at discrete depth intervals in each hole was carefully recorded. In this manner, the geological model developed as part of the remediation design phase and formulated into the numerical simulations was adjusted and refined as construction proceeded. Refinements to design understanding and layouts were undertaken in near real-time as additional subsurface information was obtained during the remediation construction. Records were updated daily and the grout-take data was tracked using 2-D and 3-D graphical models so that the poorest conditions (i.e. most voided) in the subsurface could be readily identified. These areas were then targeted with additional grout-only holes during the course of the production work and then ultimately with a series of closure holes at key locations in the perimeter/cut-off wall. Figure 7 shows a typical key view from the 3-D grout-take model.

Figure 7 – Plan view from 3-D grout take model.

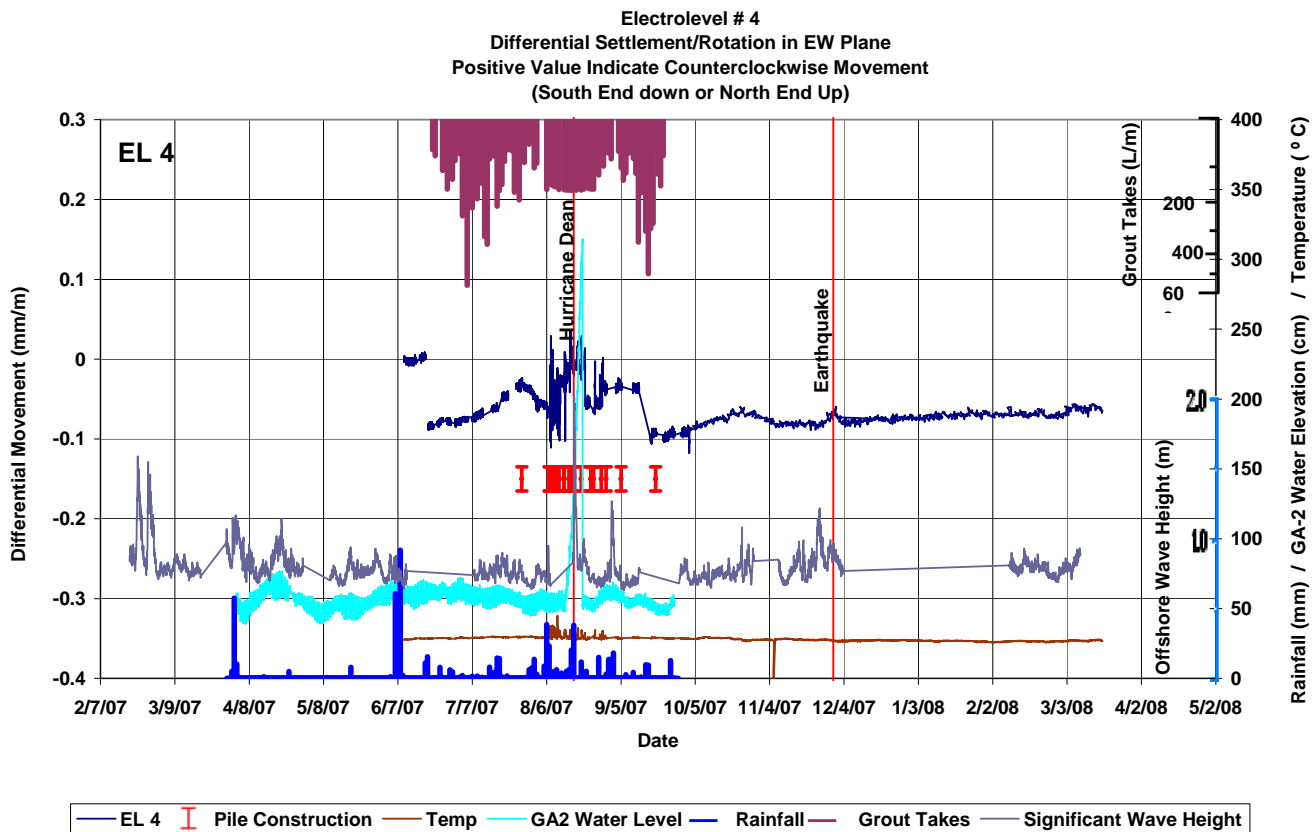
The instrumentation monitoring of the building behaviour during the course of construction confirmed the modelling assessments. The monitoring data (as seen in the typical electrolevel data plot on Figure 8) showed the building responding to the grouting by initial downward (i.e. settlement) movement as a result of the drilling/injection/flushing/disturbance to the poor subsoils by the micropiling operations, followed by upward (i.e. heave) movement as a result of the pressure grouting operations. In general, the geometry of the voided zones assumed in the modelling were matched by the zones of higher takes from the grouting and the expected behaviour of the building remediation well replicated, with increasing stabilization being achieved throughout the remediation program (see Figure 8), as each area of the building was underpinned and grouted, with completion of the improvement in the north zone of the building achieved in September 2007 right at the end of the remediation construction program.

Figure 8 – Monitoring data plot from electrolevel during and after completion of construction.
