# Micropile and Low-Mobility Grouting Foundation Remediation for a Coastal Development in Barbados

J. P. Dittrich, T.G. Carter, J.L. Carvalho  
*Golder Associates Ltd., Mississauga, Ontario, Canada*  
D.A. Bruce  
*Geosystems L.P., Venetia, Pennsylvania, USA*

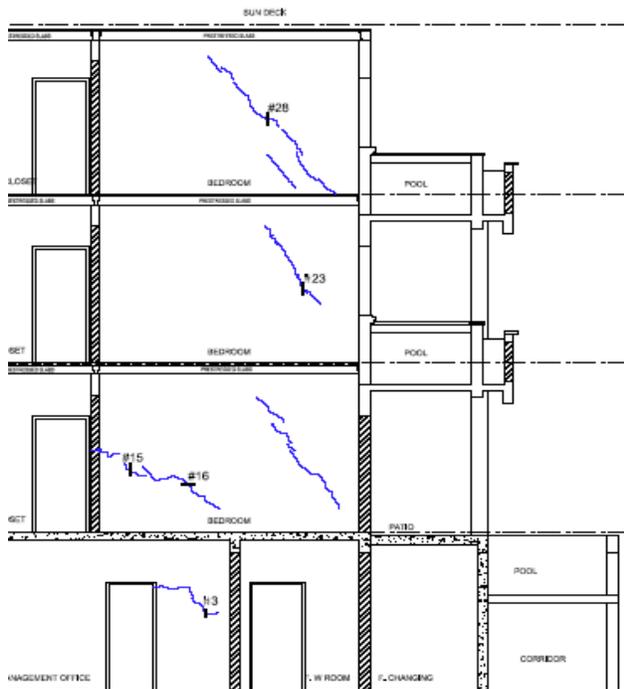
In general the cracking typically comprised ~45° oriented flexural shear cracking, however some sub-vertical (~90°) cracking was also observed. Based on the data plotted for the cracking, two different frameworks of cracking were identified. One of the sets of 45° flexural shear cracks dipped towards the sea (to the west) within the east-west building walls, (as shown on Figure 1) and the second set dipped towards the gully (to the north), within the north-south structural walls.

Figure 1. Shear cracking the east-west building walls.

The overall pattern of cracking indicated that the most distressed area occurred in the northwest quadrant of the building, with most noticeable cracking occurring close to the northern and western margins of the building footprint. However, several ~45° oriented flexural shear cracks were also observed on the first three floors in the southwest corner of the building and on the first two floors on the west central side of the building. In addition, ~90° oriented tensile cracking was observed in the basement and on the first three floors in the northeast corner of the building.

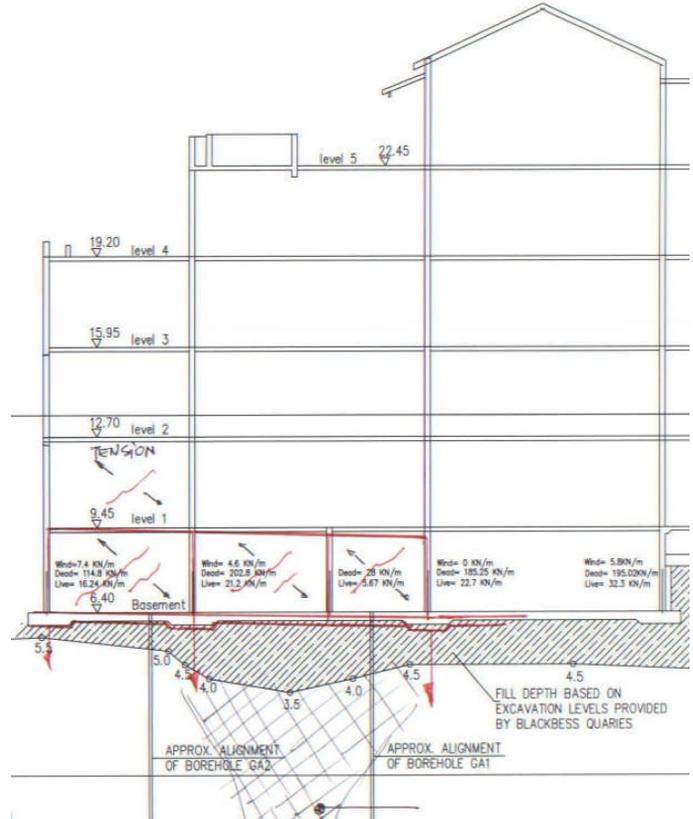
As shown on Figure 2, the fact that the northern half of the building was constructed with a lower foundation level than the southern half as a result of the basement may well have locally complicated the building response and been a key factor in the building behaviour. As described previously, the excavations undertaken for the basement level construction likely removed any of the harder and more competent coralline cap that would have originally existed on the surface of the site in this area, and this may have exacerbated the settlement response. Further, in this area, because of the basement, an additional floor level was created resulting in higher foundation loads in the northern half of building. This and the fact that because of the lower founding elevation, higher loads were transferred to the weaker, vuggy/voidy foundation conditions at depth further complicated building response. Finally, the reinforced concrete mat/floor slab foundation in the northern half of the building would have resulted in load spreading and distribution to a greater depth (into the weaker and more voided coralline strata at depth) than would have been experienced below the narrow strip

footings (perched high in the relatively more competent coralline cap) below the southern half of the building.

Figure 2. Northern half of building with basement.

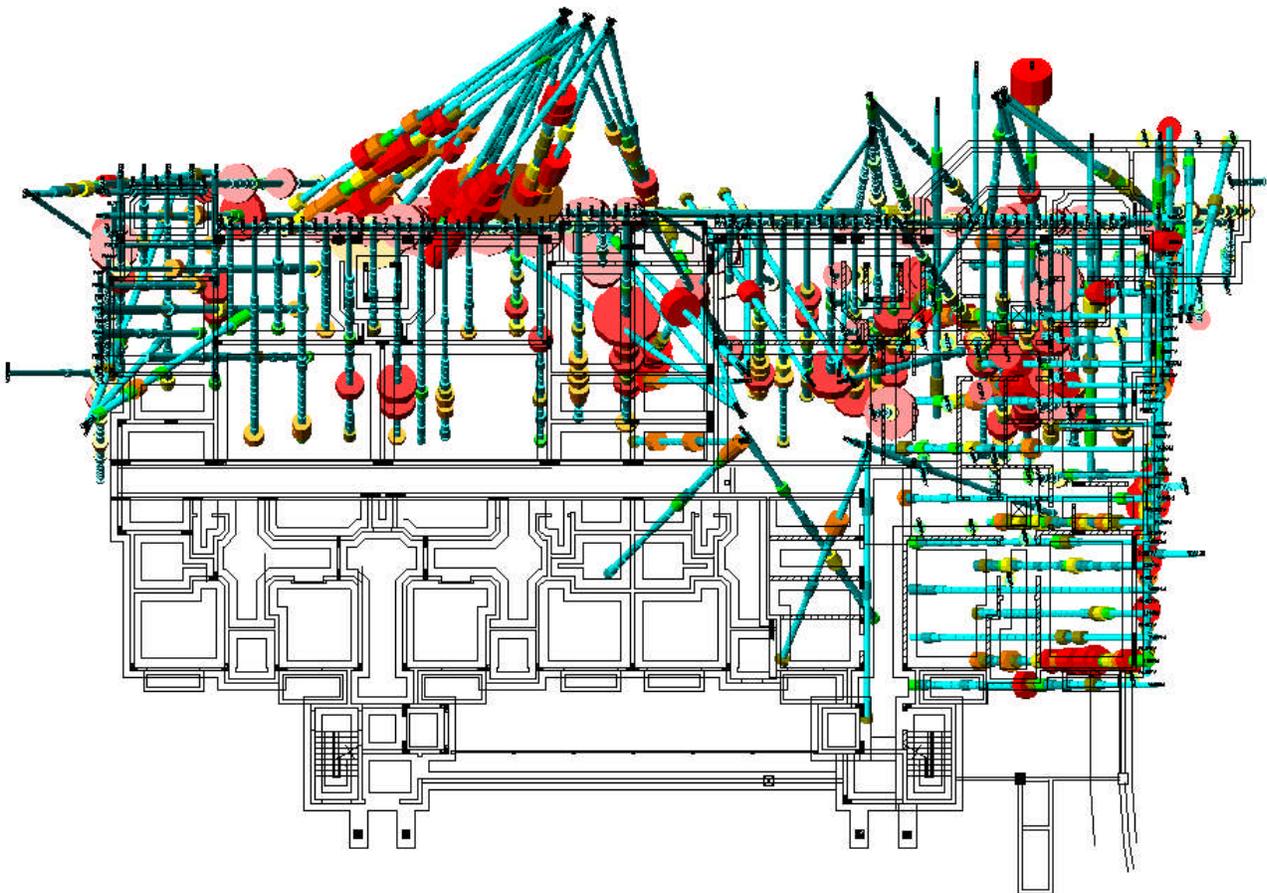
During the course of the remediation work, the conditions encountered during drilling and the volume of grout injected (or 'take') at discrete depth intervals in each hole was carefully recorded. In this manner, the geological model developed as part of the remediation design phase and formulated into the numerical modelling was adjusted and refined as construction proceeded. Refinements to design understanding and layouts were undertaken in near real-time as additional subsurface information was obtained during the remediation construction. Records were updated daily and the grout-take data was tracked using 2-D and 3-D graphical models so that the poorest conditions (i.e. most voided) in the subsurface could be readily identified. These areas were then targeted with additional grout-only holes during the course of the production work and then ultimately with a series of closure holes at key locations in the perimeter/cut-off wall. Figure 3 shows a typical key view from the 3-D grout-take model.

At the completion of the works, data had been acquired from the drilling and grouting of 174 micropiles, during which 750 m<sup>3</sup> (1000 yd<sup>3</sup>) of low-mobility grout was injected into the voided areas of the foundation around the perimeter and below the interior of the building.

Figure 3. Plan view from 3-D grout take model.

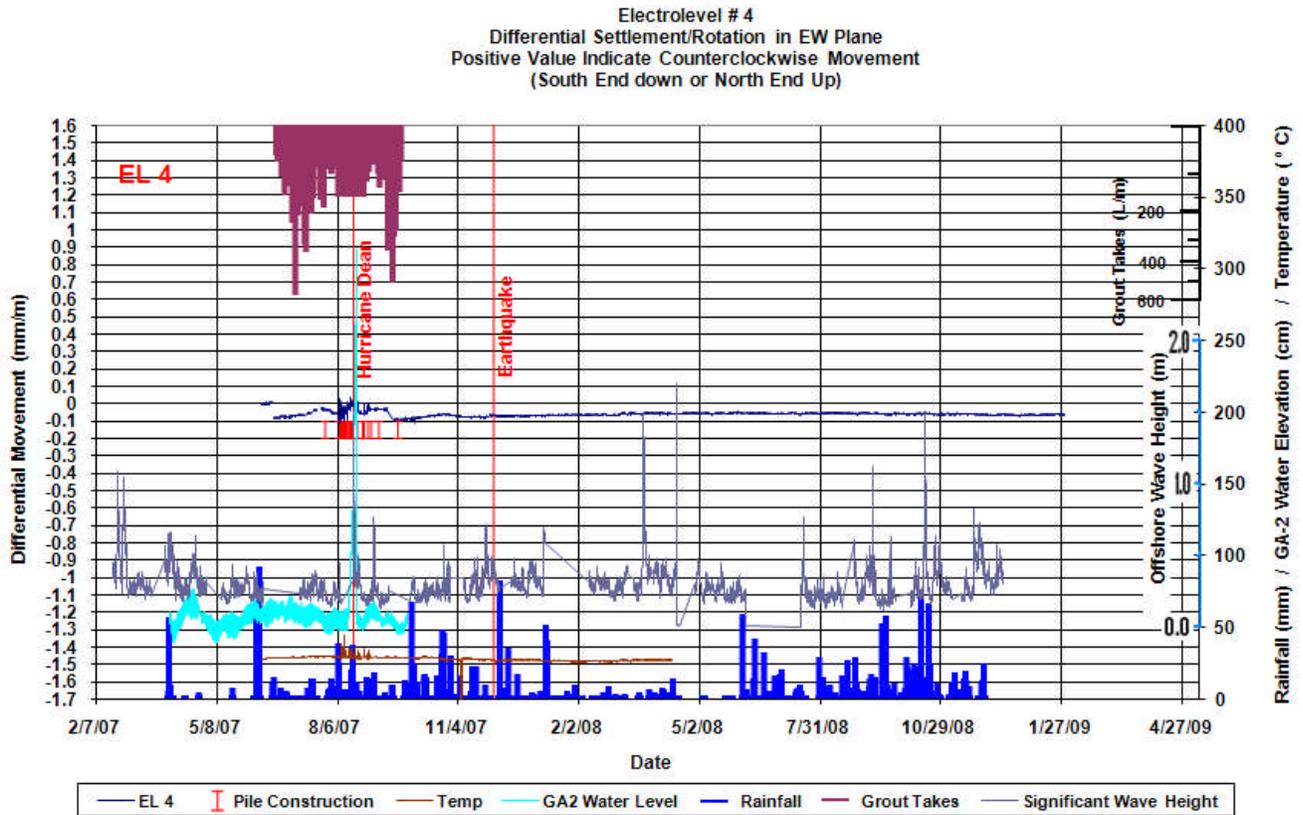
The monitoring instrumentation data (as seen in the typical electrolevel data plot on Figure 4) showed the building responding to the grouting by initial downward (i.e. settlement) movement as a result of the drilling/injection/flushing/disturbance to the poor subsoils by the micropiling operations, followed by upward (i.e. heave) movement as a result of the pressure grouting operations. In general a trend of increasing stabilization was observed in the instrumentation throughout the remediation program, as each area of the building was underpinned and grouted.

Upon completion of the foundation remediation, a selected number of the electrolevels (including Electrolevel EL#4 shown on Figure 4) and precise levelling points (including PLP-BB shown on Figure 5) were left within the structure to allow continued monitoring to assess the post-construction and long-term performance of the building.

Figure 4. Building monitoring data from electrolevel.

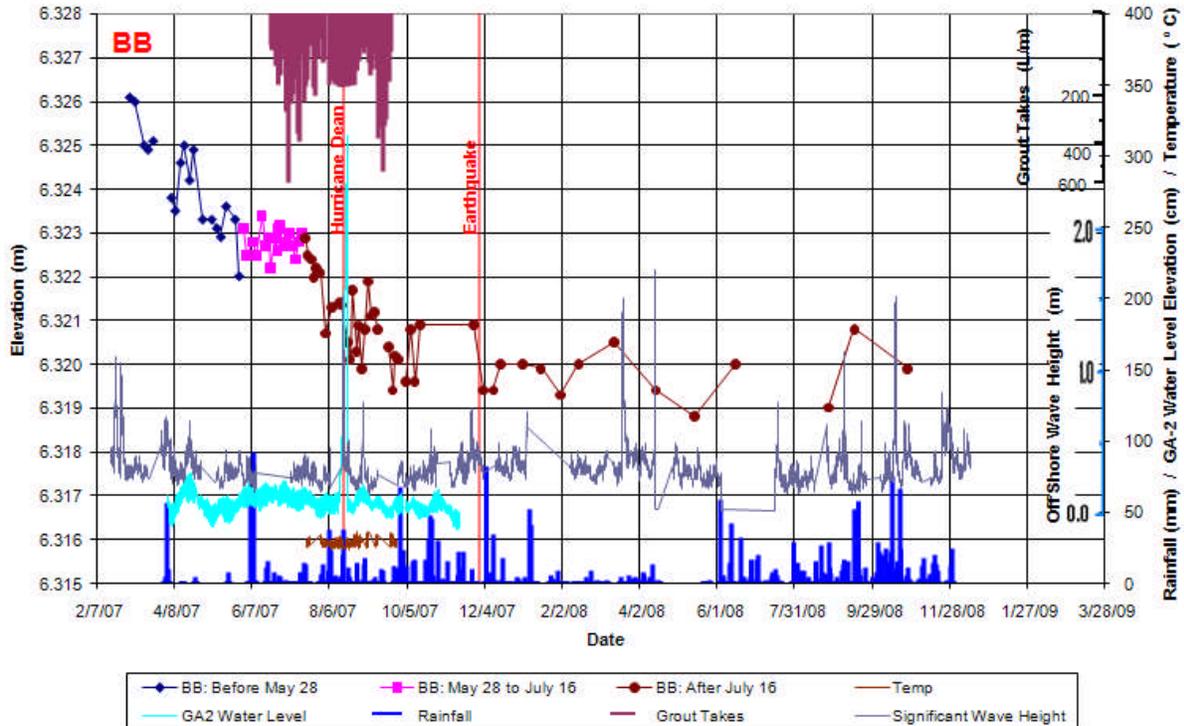
### Precise Levelling Point - BB

Figure 5. Building monitoring data from precise survey.
