## **THE BEAR CREEK DAM, ALABAMA**

Keith A. Ferguson, P.E.<sup>1</sup>  
Donald A. Bruce, PhD, C.Eng.<sup>2</sup>

### **ABSTRACT**

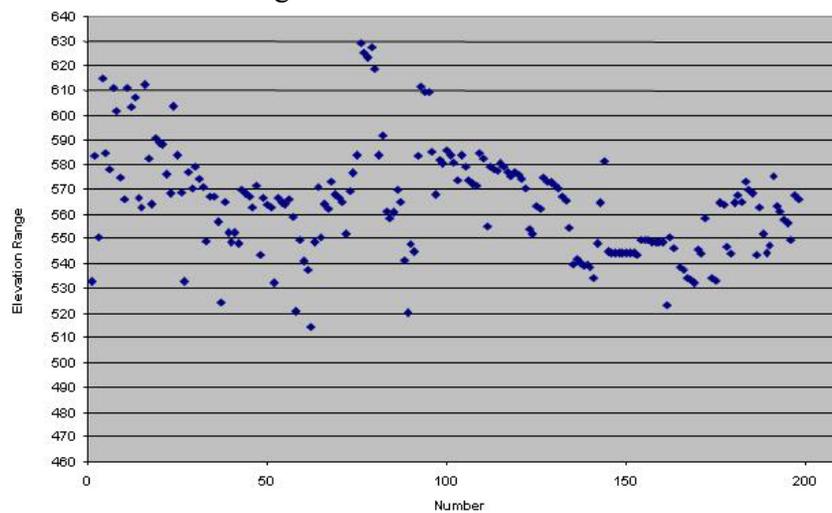
Figure 4. Elevation of Voids and Tool Drops  
(Number indicates sequence of encounter)

but the orientation of these features was not consistent with the orientation of any of the major joint sets shown on Figure 3. The seismic refraction along with the void and tool drop information on Figure 4 provided a hint of some potential stratigraphic controlled karst development. However, there were clear indications that karst development in the maximum section area had the potential to extend down to and through the Bangor Shale layer and possibly into the lower Bangor Formation. Hence there was uncertainty and risk in defining the amount of karst and corresponding treatment requirements and the time required to effectively treat the conditions.

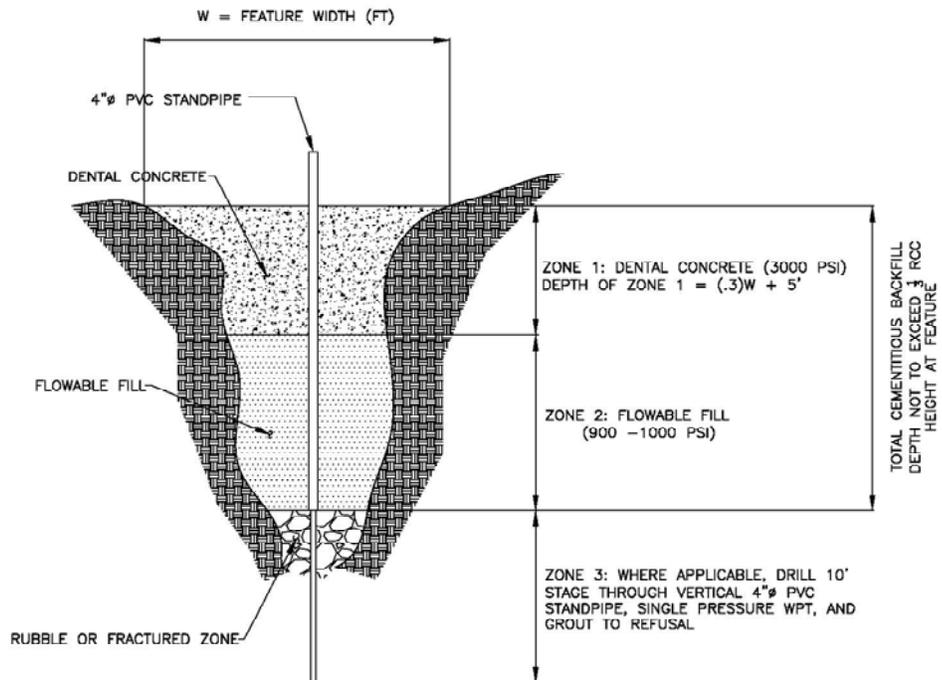
Figure 5. Karst Feature Treatment Detail

Competent rock head for the RCC structure was defined as partially weathered rock (USBR, 2001), a rock mass rating of "good" (60 or higher) and systematic treatment of major karstic features in accordance with industry "rule of thumb" (i.e., cleaning and backfilling to depths of three times the feature width; or 30% width plus 5 feet for features greater than 2 feet in width). In practice, excavation, washing and cleaning, and dental concrete backfill of features extended much further, to the maximum effective width of the equipment available: about 20 feet below ground surface (Figure 5). The rock surface was shaped to remove overhangs and surfaces.

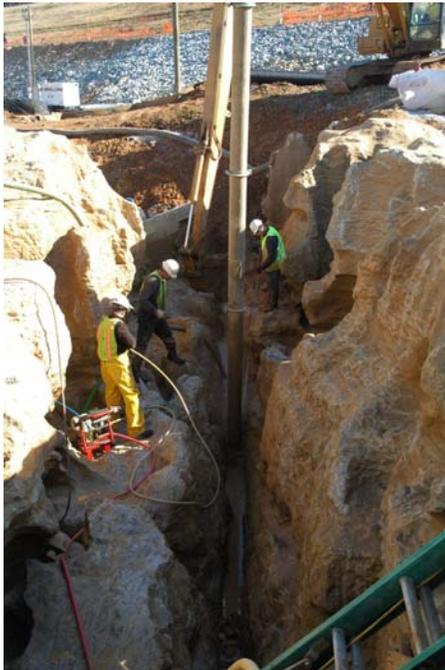
This process also allowed a very detailed surface geological map to be prepared by the Engineer of all features and discontinuities present across the new dam's foundation. In particular, two steeply dipping regional fracture sets, striking roughly N 30° E and N 55° W, were observed to have acted as zones of especially developed karstification (Figure 6). Also a packstone layer bounded above and below by cherty limestone illustrated stratigraphically controlled karstification (Figure 7). In all, a total of 6 major karstic features were exposed and treated during the three-phase excavation program which progressed across the site from left to right. A dewatering system was required to deal with inflows into the excavation from the reservoir, particularly from the more open N 55° W joint set.

Figure 6. Excavation of Karst Feature along N30E Joint

The surface was meticulously cleaned by handwork, water and/or air jetting to remove all loose and weathered material before placement of 3000 psi dental concrete to regularize the interface. This dental concrete was placed in approximately 1-foot lifts using a pump truck, wet cured, and isolated from traffic for at least 48 hours after placement. During the subsequent rock drilling program, water pressure testing of core holes through the dental concrete and visual inspection of the cores confirmed the integrity and cleanliness of the concrete/rock contacts.

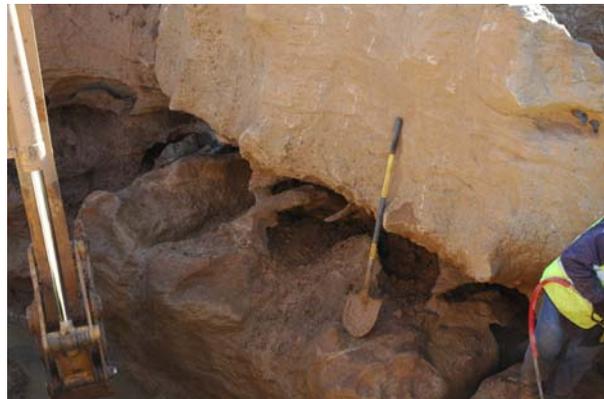
Figure 7. Example of Stratigraphic Karst Feature near Base of Packstone Subunit in Upper Bangor Formation
