Foundation Remediation at Sandy Cove, St. James, Barbados

Sandy Cove Condominium development on coralline rockmass

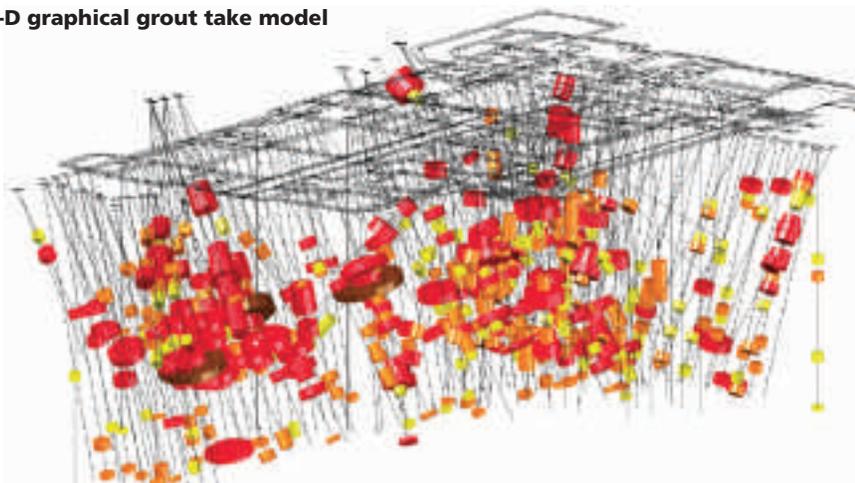
3-D graphical grout take model

The on-site team recorded the conditions during drilling and the volume of grout injected at discrete depth intervals in each hole. The geological model developed as part of the remediation design phase, and the numerical modelling was adjusted and refined as construction proceeded. Design layouts were refined in near real-time as additional subsurface information was obtained. Records were updated daily and the grout-take data was tracked using 2-D and 3-D graphical models so that the weakest/most voided conditions in the subsurface could be readily identified.

These areas were then targeted with additional grout-only holes during production. At completion, data had been acquired from the drilling and grouting of 174 micropiles, during which 750 m³ (1000 yd³) of low-mobility grout was injected into the voided areas of the foundation around the perimeter and below the interior of the building.

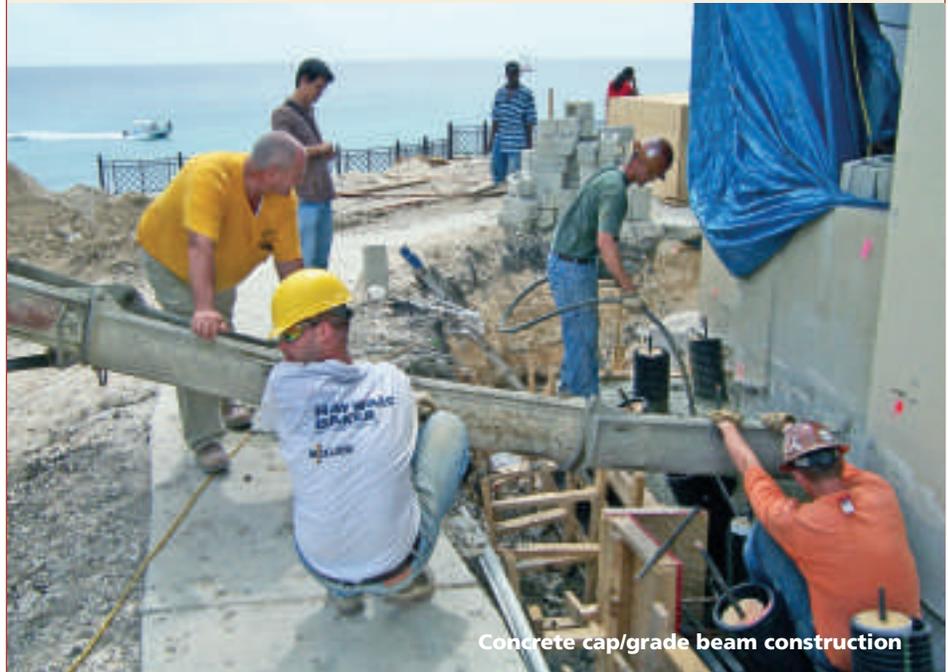
Concrete cap/grade beam construction

concrete cap/grade beam structurally connected to the existing building footings and/or to the foundation wall. Simultaneous grouting, carried out as part of the micropile installation and in separate targeted grout-only holes, was designed to back-fill the washed out zones and any open and interconnected fissures and fractures. The grout stiffened the in-situ rockmass, reduced void porosity and hence minimized potential future vertical settlement. In addition to the exterior micropile wall, the design included some near vertical micropiles installed within the interior of the building through the basement foundation slab where the wall loads were highest and where the largest measured vertical movement had occurred. These interior micropiles were supplemented by grout-only holes that provided additional void filling and foundation stiffening at key interior locations.

There were two micropiles options. One was to use the micropiles as a barrier; the other was to attach the micropiles with a cap beam directly to the condominium structure. By using the latter option for three exterior walls, we were assured that the direct support of the micropiles and pile cap would prevent any future settlement at those locations. If the micropiles had been installed only as a barrier to tie the rock together between the structure and the cliff, the direct benefits of the strength of the micropiles in compression would not have helped prevent settlement.

Below the capping beam, a bending moment transferred to the pile. By including a short section of steel casing at the top of the micropiles, any bending moments transferred to the piles by the structure are carried by the casing. A pile with only a steel bar would not have been able to carry the requisite bending moments and could have deflected or bent. The casing/pipe reinforcement assured the stiff response of the micropile system with the cap beam.

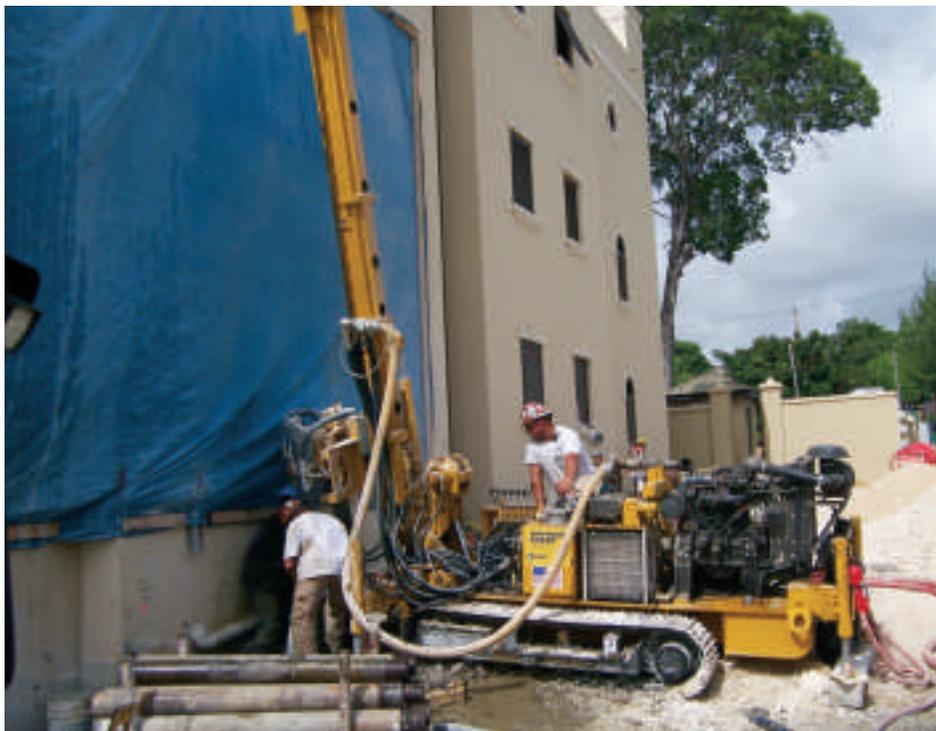
Drilling for micropile installation on the south side of the building

The subsurface barrier/seawall design included two rows of 5.5 in (140 mm) diameter micropiles. The outer row of near vertical micropiles was installed on a 15° inclination from the vertical parallel to the sides of the building and extended down into the more competent coralline rock below 50 ft (16 m) depth. The inner row of battered micropiles was installed perpendicular to the sides of the building at inclinations alternating between 30° and 45° from the vertical and depths varying from 30 ft to 60 ft (10 m to 20 m) to extend below the existing building. The top of the micropiles were encased into a reinforced

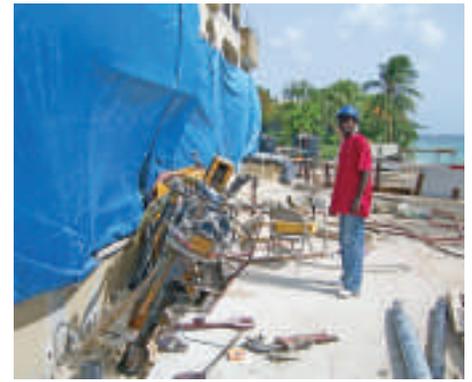
Drilling for micropile installation with restricted access on building's west side

- Underpinning three sides of the building with 137 – approximately 70 ft (21 m) long, 5.5 in (140 mm) diameter micropiles
- Indirectly supporting the heavily loaded interior walls below the northern part of the building with 37 – approximately 65 ft (20 m) long, 5.5 in (140 mm) diameter micropiles
- Grouting voids and interconnected fissures/fractures in the subsurface below the building
