The History of Grouting at **Wolf Creek Dam,** Kentucky

DONALD A. BRUCE

ABSTRACT

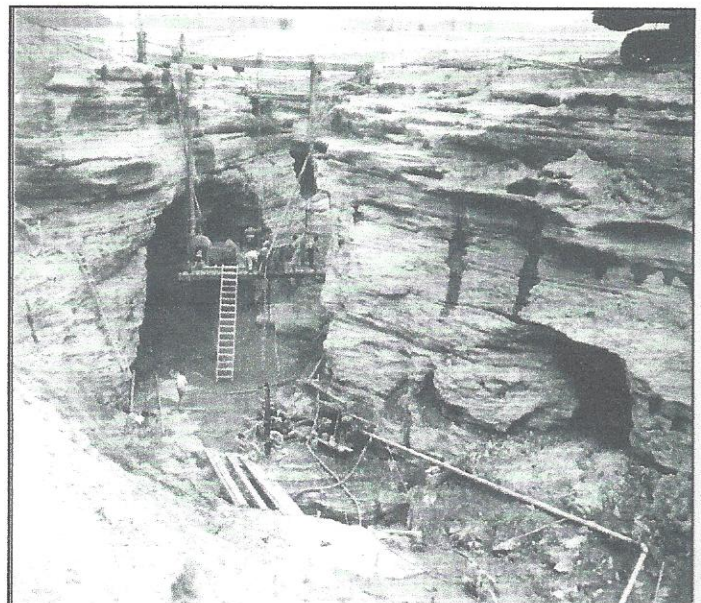
There is extremely well developed karstification restricted to the Liepers Formation. A deeply incised collapsed cavity sits along the upstream heel of the dam, which was utilized to create the core trench, and which ties into the concrete dam. A number of cavities intersect the core trench alignment, one of the largest being shown in Figure 4. During foundation preparation, the contemporary standard of care in the 1940's was to remove the cavity infill material, but to then replace it with core-like silty clay. The compaction of this backfill would have been of dubious quality under the overhangs created in the karstic features, and it was subject to erosion and removal under service conditions. Figure 5 shows the location of cavities detected by grout holes prior to 2006.

FIGURE 4. Karstic cavities intersecting the core trench alignment at Wolf Creek Dam as revealed during original construction (Courtesy of USACE).

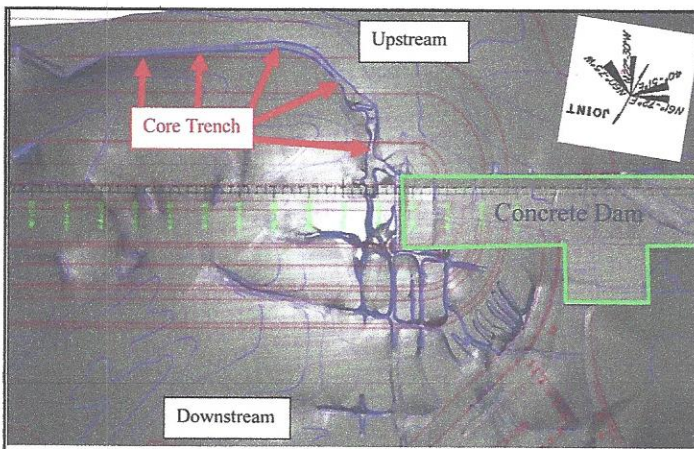
FIGURE 5. Karstic development trends. This shaded relief map is based upon data from pre-2006 grout holes. A joint rosette shows the orientation of joint systems. (Source: USACE)

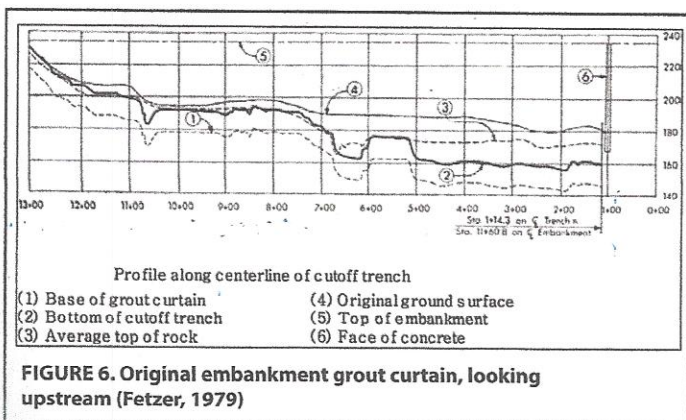
FIGURE 6. Original embankment grout curtain, looking upstream (Fetzer, 1979)

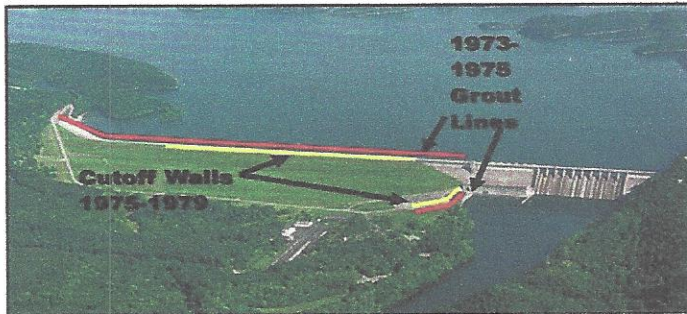
FIGURE 9. Generalized alignment of the 1973-1975 grout lines (red) and cutoff walls (yellow), installed 1975-1979 (Source: USACE)

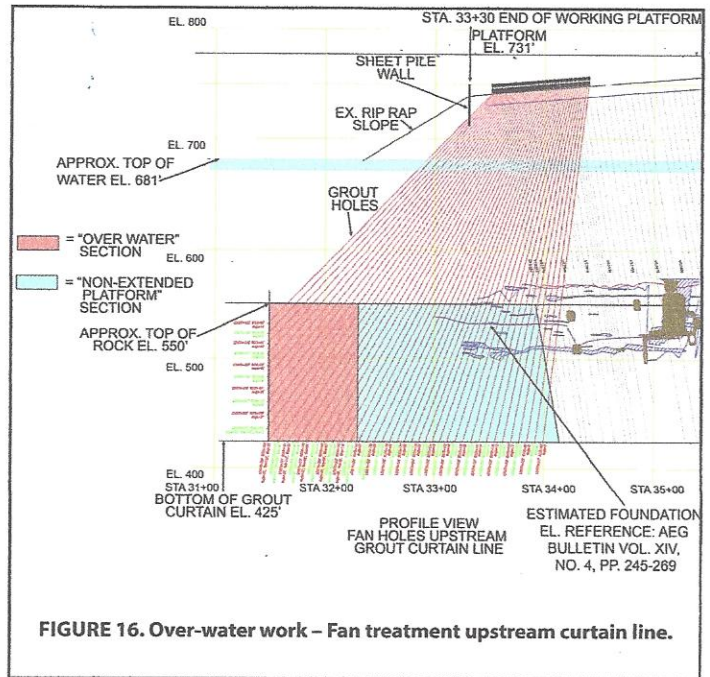
The planned over-water work in this area was located in a critical trout hatchery water intake area. The use of the fan hole alignment as detailed in Figure 16 effectively mitigated environmental and safety risks.

FIGURE 16. Over-water work – Fan treatment upstream curtain line.

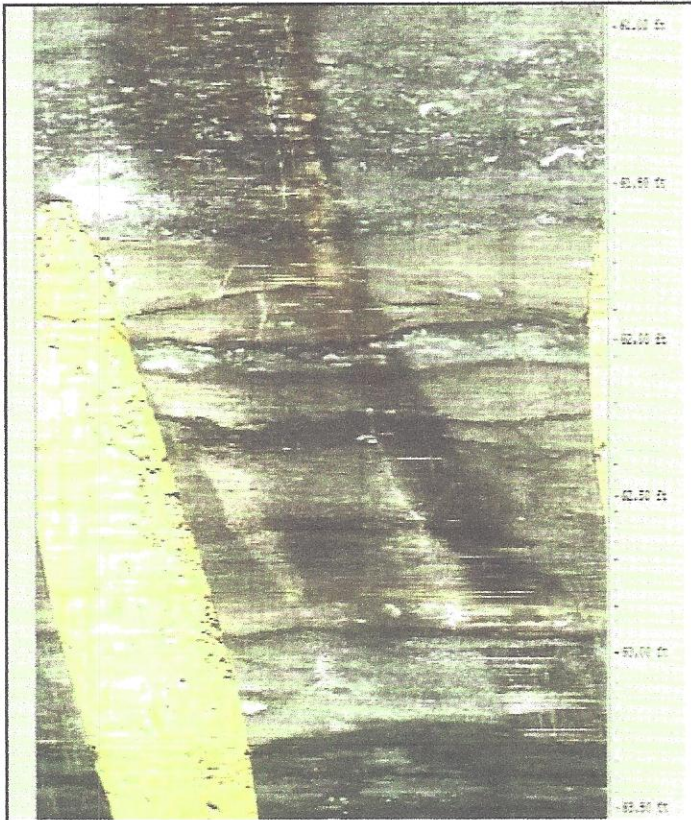
FIGURE 17. Down-hole televiewer image (360-degree view) showing dyed grout in an intersected grout hole (Courtesy of The Judy Company)
