Structural Repair by Grouting

by D.A. Bruce

1. INTRODUCTION

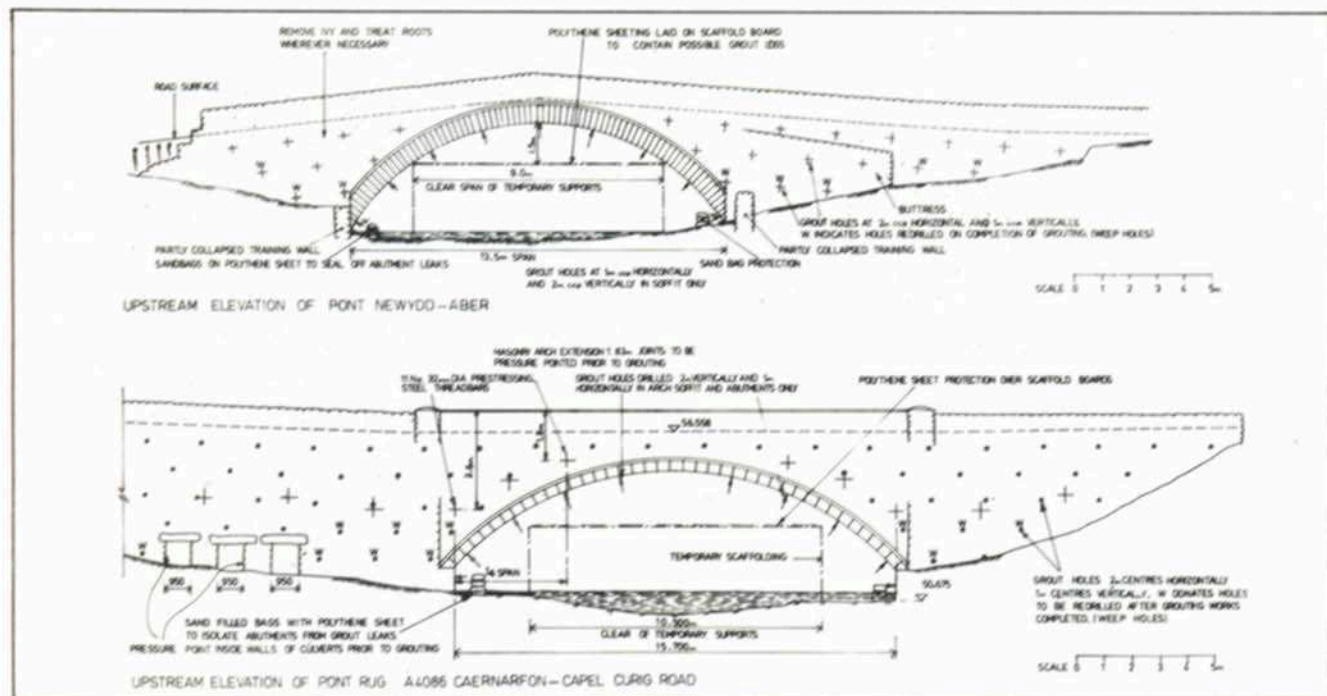
Fig 1. Details of Repairs Conducted on Two of the Bridges referred to in Table 1, above.

<i>Bridge:</i> Pont Rhyd-y-Fuwch	<ul style="list-style-type: none"> Deep penetration pointing for abutments, piers, training walls, arch rings and soffits. Weep holes. 	<ul style="list-style-type: none"> 172m² pointing plus 17 weep holes. 	
<i>Bridge:</i> Pont Newydd-Aber	<ul style="list-style-type: none"> Limited amount of surface hand pointing to spandrels, retaining wall, arch rings, soffits, abutment and training walls. Consolidation grouting of heaving. Weep holes. 	<ul style="list-style-type: none"> 14.6m³ excavation and back filling. 69.4m² pointing plus 22 weep holes. 102 grout holes involving 6.2 tonnes OPC and 3.4 tonnes 2:1 sand cement grout. 	As for Retaining Wall above. National Monument.
<i>Bridge:</i> Pont Dylif	<ul style="list-style-type: none"> Hand pointing. Consolidation grouting. Weep holes. Tie bars. 	<ul style="list-style-type: none"> 44m² of hand surface pointing +10 weep holes. 34 grout holes involving 2.6 tonnes OPC and 3.4 tonnes sand cement grout. 7 Nr 16mm tie bars 1m long to arch soffit. 	Inspection of arch soffits had shown flattening of arch in both directions. Subsidence noted at 2 d/s abutment corners.

soffits) the mix reverted to a 1:1 grout of W = 0.32 (plus pfa). The mortar was prepared in a roller mixer and pumped to the 18mm pointing nozzles by a small Colmono pump. Afterwards prior to final set, the pointing was wire brushed, and the surface washed to improve final appearance. Alternatively the pointing may be left with a "wet", trowel or recessed finish.

The consolidation grouting was executed through 50mm pvc ducts mortared or drilled in and used the range of colloidal neat cement, and sand cement grouts noted in Table 1. Grouting sequences, volumes and pressures were carefully designed and controlled so as not to damage delicate structures by, for example, exerting significant bursting pressures through large volumes of fluid grout. The effectiveness of the consolidation grouting was verified by grout take analysis, and by grout and/or water absorption tests in random holes, whilst its thoroughness was further demonstrated by interconnections between adjacent holes.

Weep holes consisting of 50mm pvc tubes were set through the blockwork in selected locations. These are a wise precaution in that the composition of the hearting is very varied and may contain ungroutable zones of silt or clay. These allow seepage of water, which if unrelieved, can initiate further damage by pressure build up, or frost heave in winter.

Tie bars were placed in 89mm dia. cored holes, drilled by diesel hydraulic frame mounted rigs. These tie bars reinforce the structures and/or foundations and inhibit any future tendency for movement. They were doubly protected against corrosion by grease impregnated tape and corrugated plastic tubing, and were fully grouted in place. The headplates were likewise protected and bedded on a sand cement mortar base. A nominal bar stress was applied. They were thereafter trimmed and dressed to blend into the surrounding masonry. Occasionally, where it is desirable to conceal even the headplates, these are placed in the cavity created by removing the appropriate facing stone, later replaced. The bars may be introduced before consolidation grouting (they would help to resist any grouting induced stresses), but it is more common to place them after consolidation when the hearting is more stable and easier to drill.

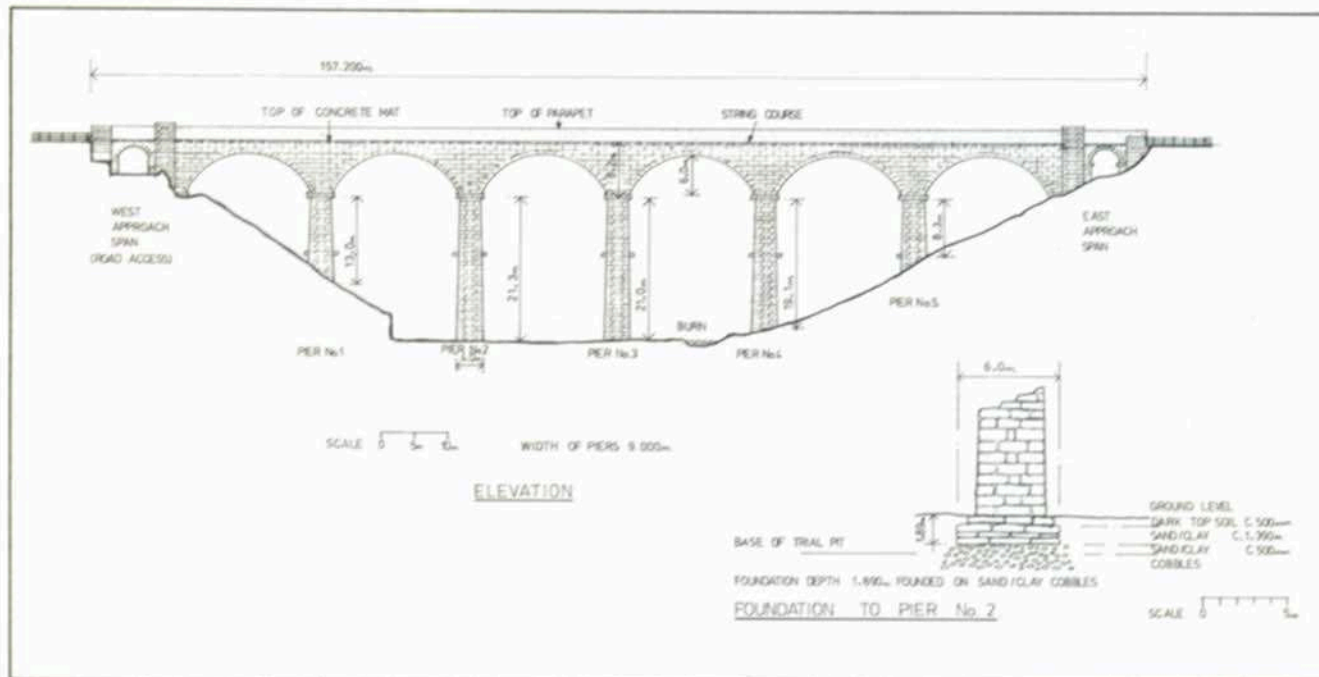
Fig 2. West Coast Main Line Underbridge No. 56A Kincardine Viaduct, Auchterarder

Investigation of the bridge confirmed that water from track level had penetrated through the whole structure. The action of this flowing water (and the ice effect in winter) had over the years led to a significant deterioration of the sandstone blockwork and a removal of fine granular material from the spandrel walls and piers, through the joints of the masonry. To maintain this major structure at an acceptable standard, a comprehensive scheme for both waterproofing and strengthening was therefore evolved.

Since details of pier construction were not available, a preliminary site investigation was undertaken to determine the thickness of the walls, the nature of the hearting, the footing dimensions and the allowable bearing pressure. Advice was obtained from the Geology Department of Dundee University on the characteristics of the pier stone, badly fractured and spalled in places. A small grouting trial of a pier base was also undertaken. Although it is normal to point masonry before attempting pressure grouting and/or stitching (as this prevents easy escape of the grout), the joints were relatively tight in this structure and so this preliminary was not held to be necessary. Thus the solution proposed to repair the structure was as follows:

- Conduct cosmetic repairs such as limited pointing, removal and replacement of damaged masonry sections, cleaning and washing etc.

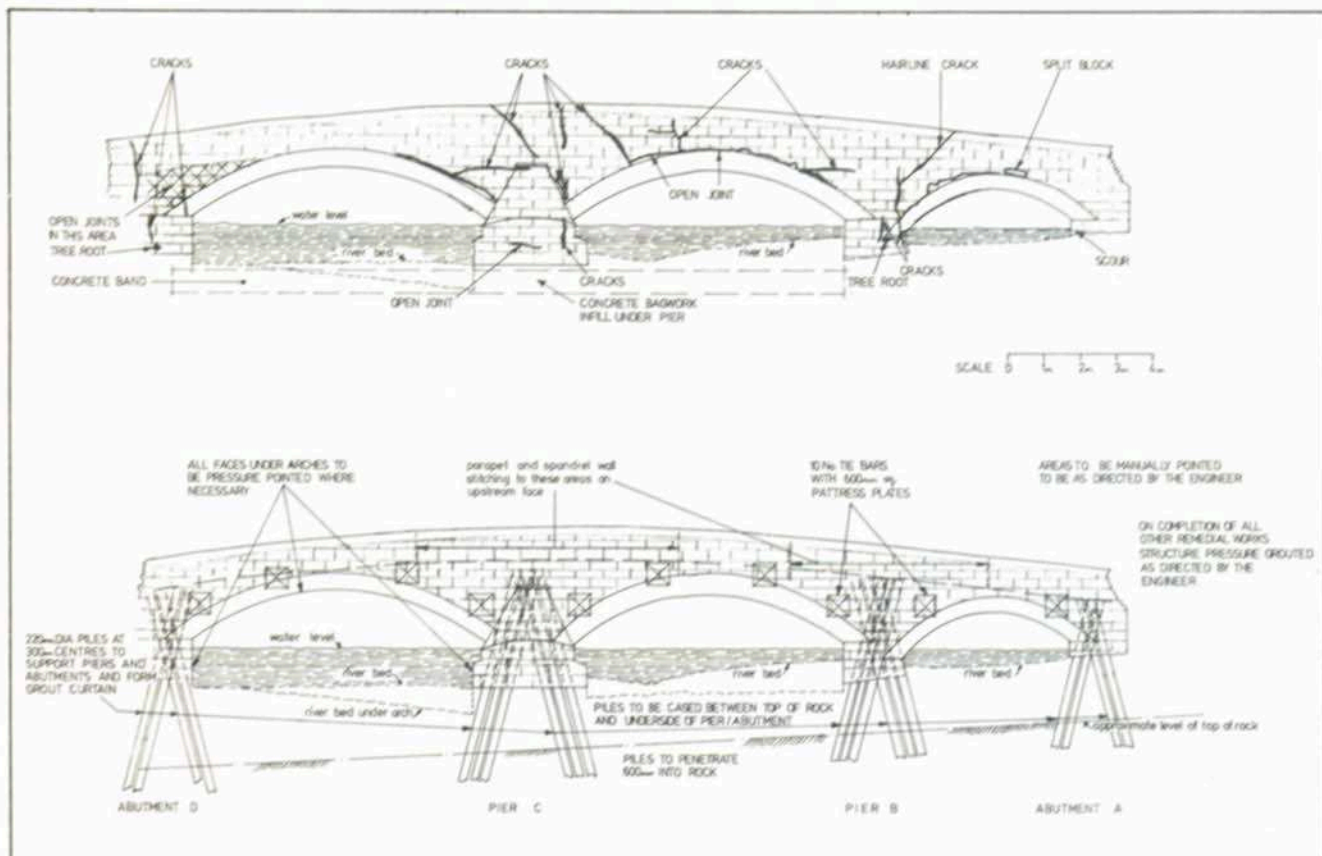
Fig 6. Upstream Elevation of Pont Glyn Gwynedd showing extent of deterioration and repairs

The subsequent structural problems appear to relate directly to the original method of construction, and the widening works. Separation of the extension from the old bridge was indicated by a crack running longitudinally along the bridge. Masonry pointing had also locally deteriorated, assisted by the subsequent growth of vegetation, and physical separation of some of the masonry blocks from each other was occurring. There was further evidence of scouring beneath the bridge piers.

In order to repair the structure the following measures were designed (Figure 6):

- Minipiling: to transfer the load of the bridge to sound bedrock (Table 2). These 220mm diameter cast in situ piles were to be installed at about 330mm centres to support the piers and abutments and to form a perimeter for the subsequent consolidation works.
- The piles were designed to penetrate about 600mm into rock. They were also to be permanently cased from bedrock to about 2m into the bridge, using 168mm OD steel casing

- Tie bars: ten tie bars to tie together the two sides of the bridge.
- Stitching: 24 Nr 16mm bars within the parapets and spandrels.
- Pointing: to repair the defective areas, particularly under the arches.
- Grouting: to consolidate the hearing over the two intermediate piers in particular.

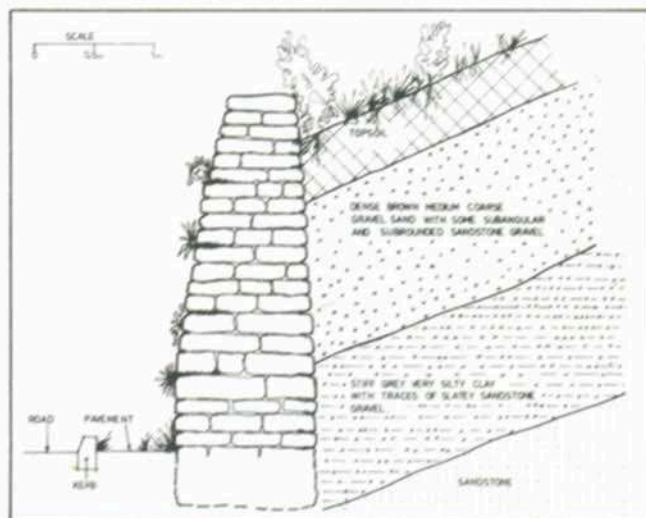
Fig 8. Typical cross section of retaining wall before repair, Denholme Clough, Yorkshire

In this particular example, the wall had actually collapsed in places whilst in other areas

there was significant bulging indicative of imminent failure.

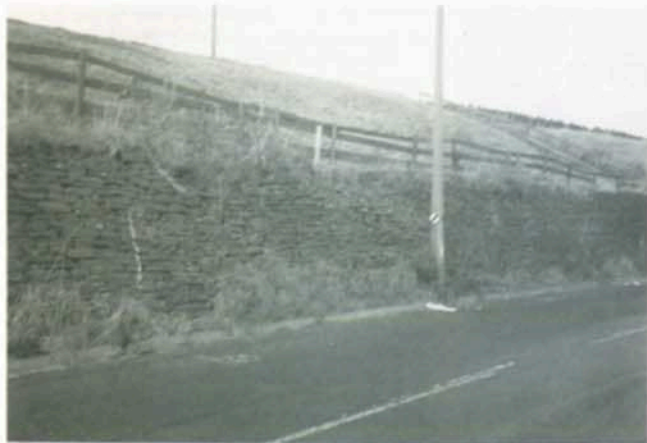
Photograph 3. View of part of the retaining wall, showing deformation and general delapidation. Denholme Clough, Yorkshire

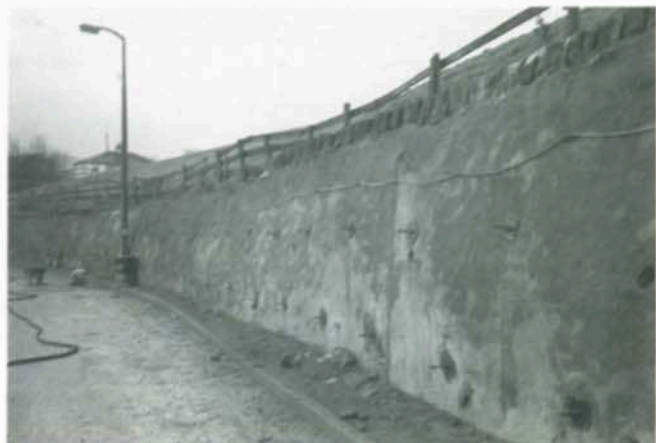
Photograph 4. View of wall after cleaning, partial rebuilding, guniting and nailing, and before construction of new masonry face. Denholme Clough

- **Repairing Wall Facing.** Those sections of wall in a state of collapse were rebuilt in a single skin brickwork with strengthening piers. The voids behind were backfilled with a sand cement grout plus Conbex 653 additive to restrict flow. A layer of light D49 steel mesh was fixed to the wall which was sprayed with a 50mm thickness of gunite to hold the component stones in place during the subsequent nailing. Vertical construction joints were located at 15m centres.

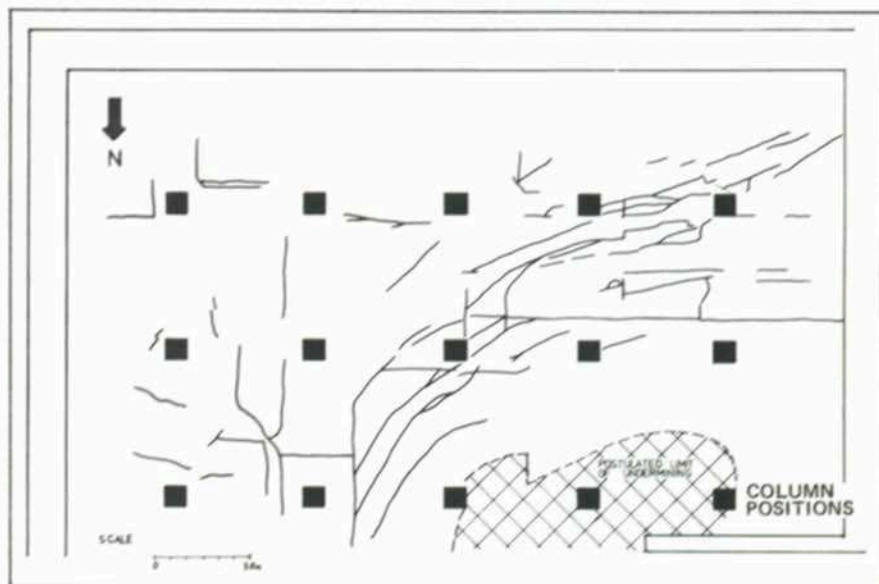
Fig 11. Plan of major fissures in reinforced concrete base slab, underground cistern, Rod El Farag Water Treatment Plant, Cairo

A portion of the filter foundation slab was found to have experienced undermining and associated cracking (Figure 11). Several weeks later, another smaller area of undermining was discovered west of the first area. It was believed that the damage to both areas occurred at about the same time and both were a direct result of a previously placed granular backfill being removed by an immediately adjacent dewatering system.

- firstly recreate reasonably uniform support to the foundation filter slab by pressure grouting the voids between slab and soil, with a penetrative cement based grout, and
- secondly restore the structural integrity and watertightness of the slab by pressure injection of structural epoxy into the fissures and construction joints.

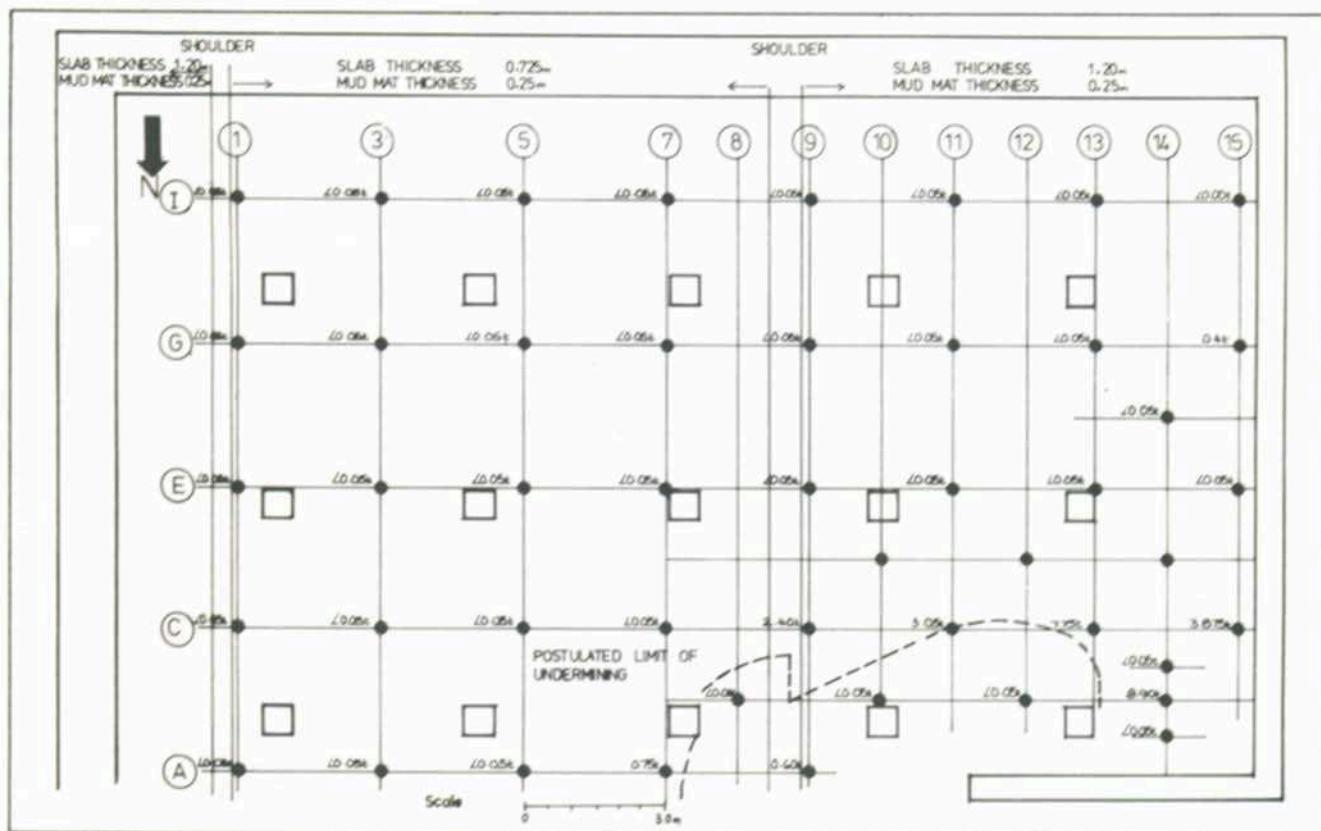
Fig 12. Underbase Drilling and Grouting Results, Rod El Farag Water Treatment Plant

thoroughly washed out and temporarily sealed with a wooden bung to keep out other construction debris. Hole depths varied from 1-1.8m and were occasionally continued for up to 0.9m into the fill material, for investigatory purposes. Drilling commenced in the NW corner of the main slab where undermining was anticipated as being most severe. Only 10 holes, all in this area, confirmed the anticipated voids under the slab. A "down the hole" Borescope was then used to inspect closely the slab/soil interface in key areas. These investigations all confirmed the existence of a significant void in the NW area.

- **Underbase Grouting.** A primary 3m grid of 41 holes was established (Figure 12). In order to minimise damage to the heavily reinforced base slab, a rebar detection meter was used to adjust the location of each hole to reduce the requirement to drill major reinforcing elements. In addition other holes were slightly repositioned to provide adequate edge distances. Drilling through the concrete was accomplished with electric powered wheel mounted drilling rigs (assembled in situ) using 82mm dia. roller bits on NWY rods with water flush. Upon encountering steel, (usually in the lower reinforcing mat) the system was changed to using thin walled 56mm o.d. diamond core barrels to ease penetration and minimise structural disruption. After completion, each hole was

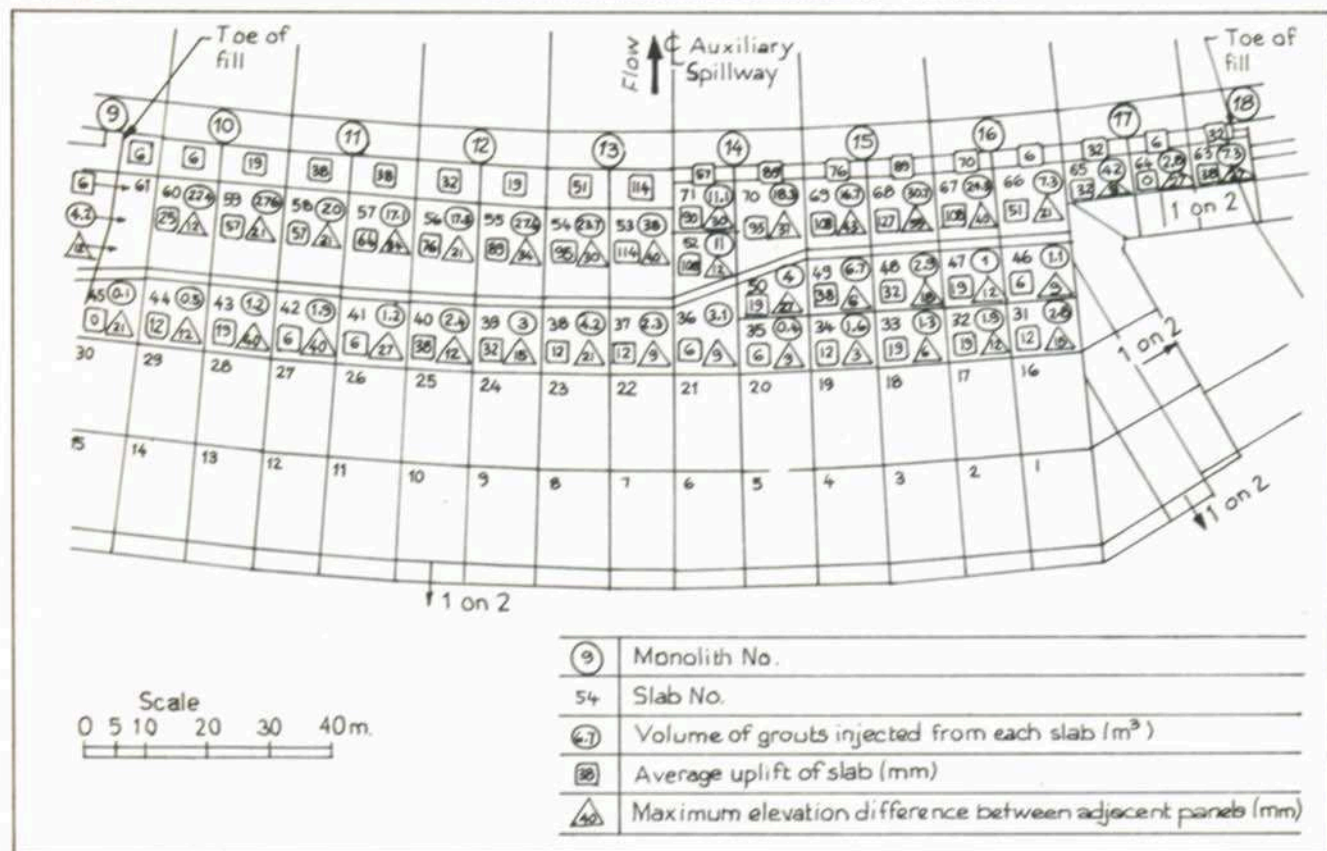
Fig 15. Grout consumptions, average uplift and relative attitudes of panels, after slabjacking, Tarbela Dam

Monitoring of the structure/rock system for the few years after first impounding indicated that the blanket was not acting in an acceptably efficient manner. Further investigations led to the conclusion that a major contributory factor was the concrete apron. It was reasoned that the blanket had settled under reservoir water pressure but that the overlying apron was "hanging up" at the spillway structure, leading to the formation of a void to which reservoir water had access from both sides. This water had washed out areas of fill leading to irregular settlements of certain panels by 30-180mm at

distances of 6-18m from the headworks. There was therefore also concern that the differential movements could have given rise to voids beneath "hanging" slabs and could be distressing the rubber waterstops to the point of failure, leading to the complete ineffectiveness of the crucial protective apron.

The pressure grouting commenced under Panel 55 (Figure 15), and progressed from left to right and in a general way towards the head-works. The lifting of the lower slabs was initiated from one of the peripheral holes on one edge only, and continued across the slab. As the grout migrated, wooden plugs were driven into the holes from which grout emerged. Practice was to permit travel of up to 6m before further packers were then installed nearer to the travelling face of the grout and injection transferred to them. When approximately two-thirds of the slab had been so treated, the grout line was returned to the first packer to attempt to lift that part of the slab.

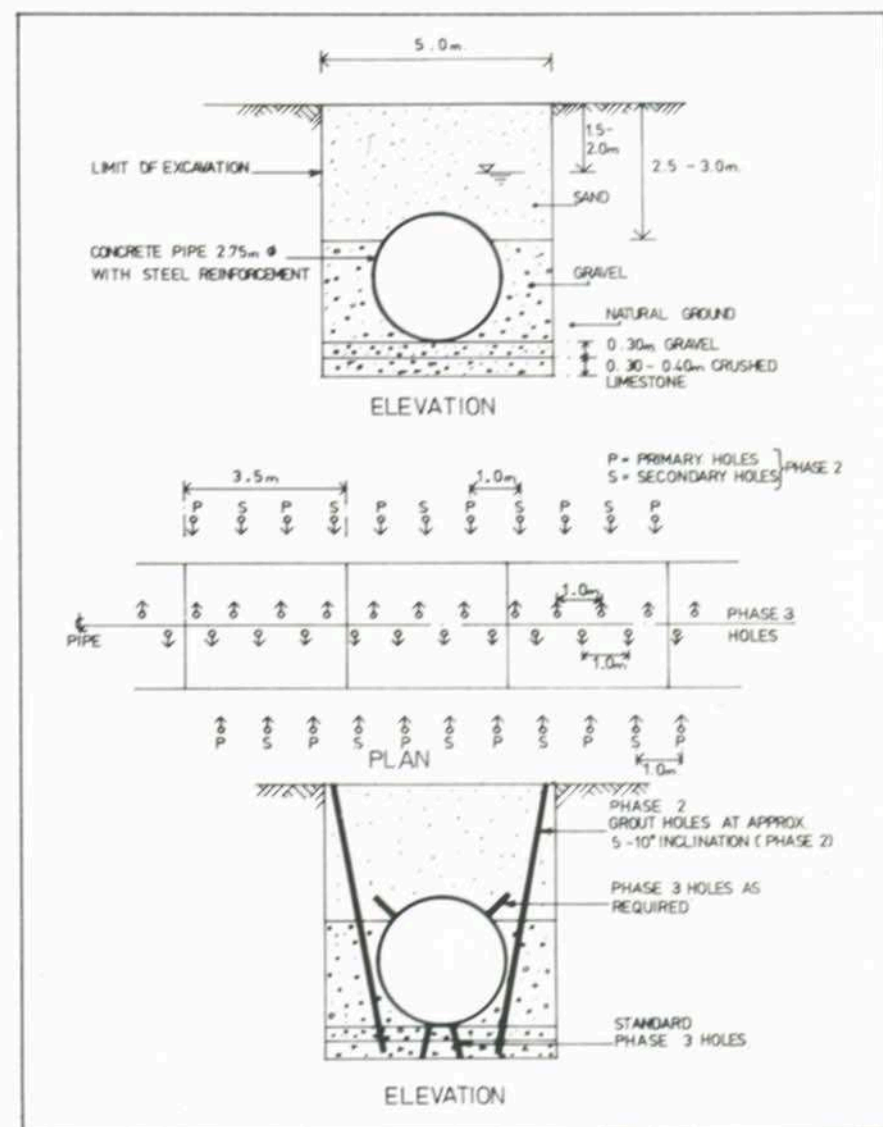
Fig 16. Details of pipelay and grout hole arrangement, sewer, Alexandria pipeline, A.R.E.

Due to certain operational problems during the construction of a particular 280m long stretch of pipeline, most of the connecting joints were damaged to the extent that major water ingress occurred due to flow of groundwater in through the surrounding highly permeable backfill. Access manholes were flooded to a level of 1m below ground surface.

Less severely damaged joints also gave inflows ranging from minor seepages to steady leakage. It was therefore clear that this situation was totally unacceptable in that it would prevent the structure acting efficiently by permitting escape of sewage. Various schemes were considered to remedy the situation, the most extreme being to exhume the defective section and replace it. However, a proposal based on grouting proved to be far more attractive commercially and was also preferable in terms of programme and logistics — the upheaval of conducting another period of excavation would not have been acceptable in the congested urban area. In addition, the relatively high strength microconcrete into which the backfill should be transformed by grouting would act to reinforce the "strength" of the pipeline structure and so
