The Repair of Large Concrete Structures by Epoxy Resin Bonding

by
*Dr. Donald A. Bruce, Technical Director,
Nicholson Construction Company*

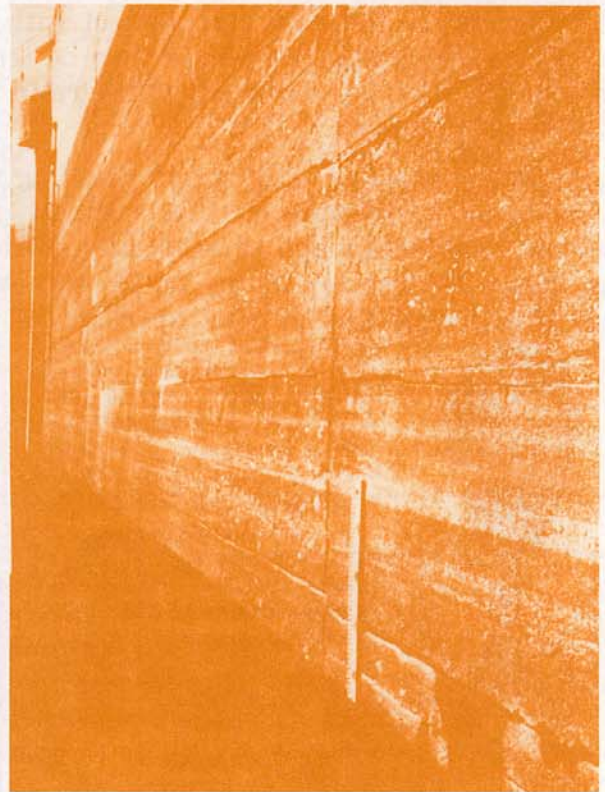
Figure 1. Upstream face of dam showing horizontal lift joints and vertical construction joints between blocks

This project involved a 60-year-old, 320-m-long, 65-m-high concrete arch, with gravity abutments and two spillways. Substantial leakage has been experienced from the first impoundment. Despite major structural modifications to the dam and repeated phases of cement grouting in the horizontal lift

joints, the situation continued to deteriorate. By mid-1987, leakage in the left side alone had reached over 4,000 L/min and was entering the lower drainage gallery at higher pressures and over larger areas than before. Seepages on the downstream side of the gallery were also noted. Following the structured analytical approach as outlined above, treatment was concentrated on a 23-m-long section in the most critical area and was conducted from within the 2.4- by 2.2-m lower gallery, running about 3 m above the foundation and 4.5 m back from the upstream face (Figure 2). Fans of primary holes, up to 6 m long, were cored at regular intervals upstream from the gallery to investigate the suspect joints. These holes confirmed that the water flows were travelling through the joints: the concrete itself was materially sound. Many holes intercepted flows of up to 400 L/min at full hydrostatic head.

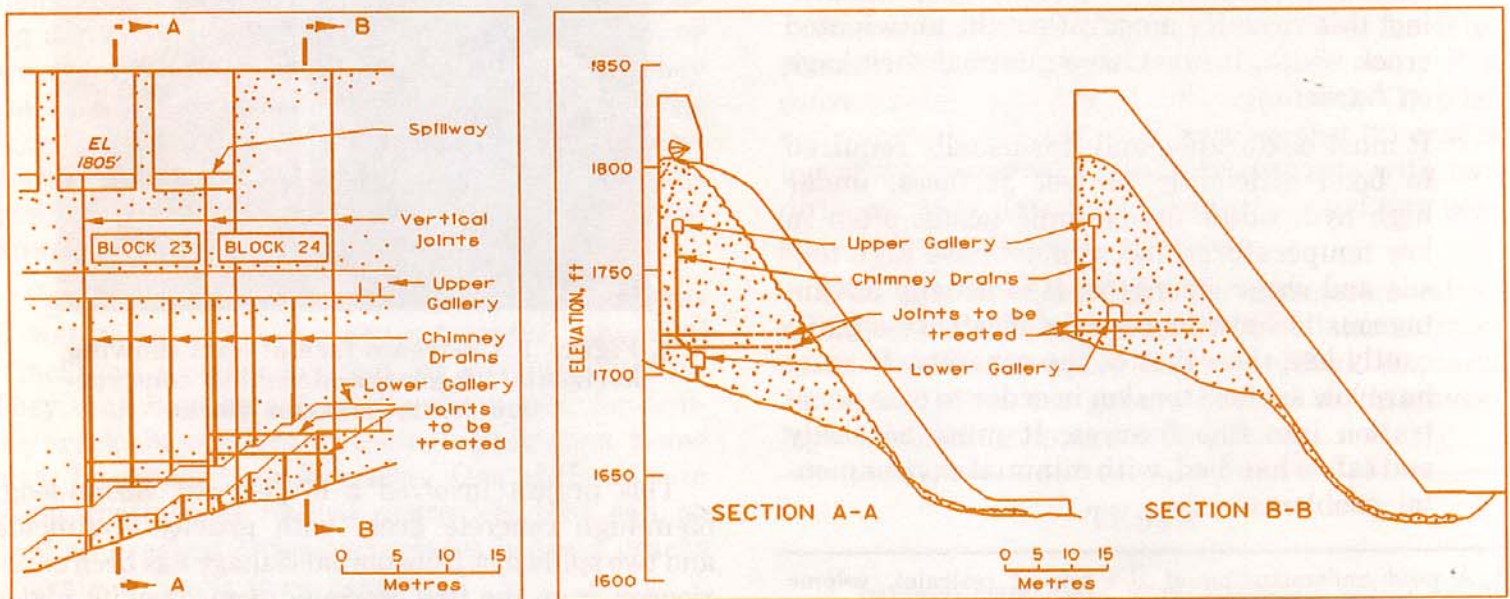
Figure 2. Horizontal joints investigated and treated in Blocks 23 and 24

After all the primary holes had been drilled (Figures 3 and 4) and the data carefully considered, the systematic epoxy resin grouting program was commenced through special packers fixed in each hole. Resin, injected through one packer, would be observed to travel and connect with the next hole, to which injection would then be transferred. In this way, the continuity of the resin filling could be promoted.

A secondary phase of drilling and grouting was then conducted to demonstrate this continuity and to permit "tightening up" of especially difficult areas. Resin thicknesses of up to 10 mm were found, illustrating the in situ aperture of the

joints, while later tertiary check holes — all totally dry — confirmed the penetration of the secondary grout into microfissures.

By the conclusion of the work in the fall of 1988, the total flow into the section grouted was about 120 L/min — virtually all of which was entering the gallery through vertical roof drains, intersecting fissures well above the levels grouted. The concrete of the upstream gallery wall had begun to dry, and flows from secondary, longitudinal roof fissures and from the downstream gallery wall were also stopped completely. This performance has persisted to date, even during the maximum reservoir levels recently experienced for the first time in several years. A fuller description of this work was given by Bruce and De Porcellinis (1989).

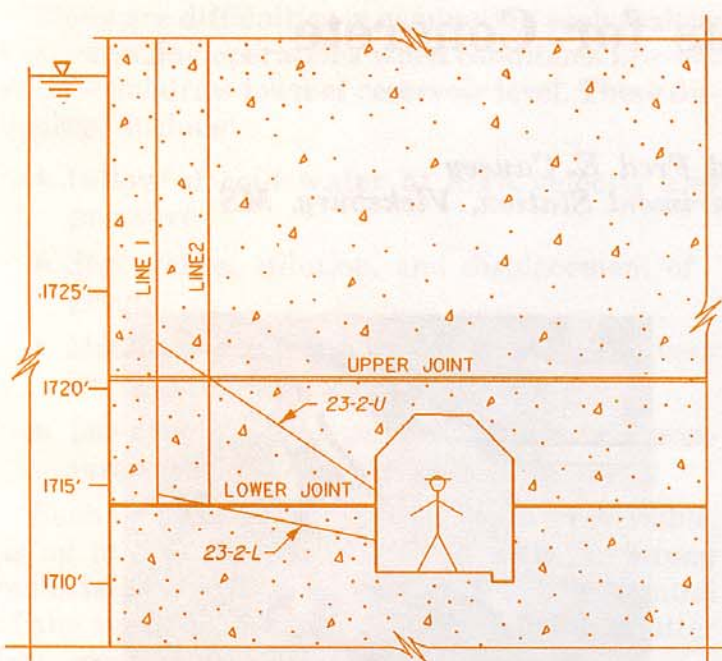
Figure 3. Typical section showing intended joint interception at one station

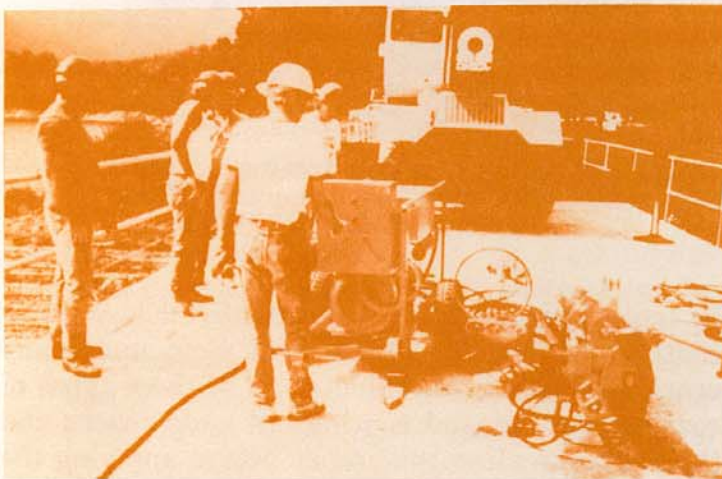
Figure 4. Components of the electrohydraulic coring rig (from right, mast w/head, controls, power pack)
