ENVIRONMENTAL SAFEGUARDS DURING ROCK ANCHORING: A CASE HISTORY

Dr. Donald A. Bruce
Nicholson Construction of America
Bridgeville, PA

This paper describes the remediation recently completed at Stewart Mountain Dam, Arizona, [3, 4] a thin, double-curvature, arch dam considered under Maximum Credible Earthquake calculations to need significant upgrading by prestressed rock anchors. It is the intention of the authors to illustrate what was specified and executed at this project: it is not their intention to stipulate what should be enforced on other sites, although clearly the standards observed at Stewart Mountain Dam set a very desirable standard.

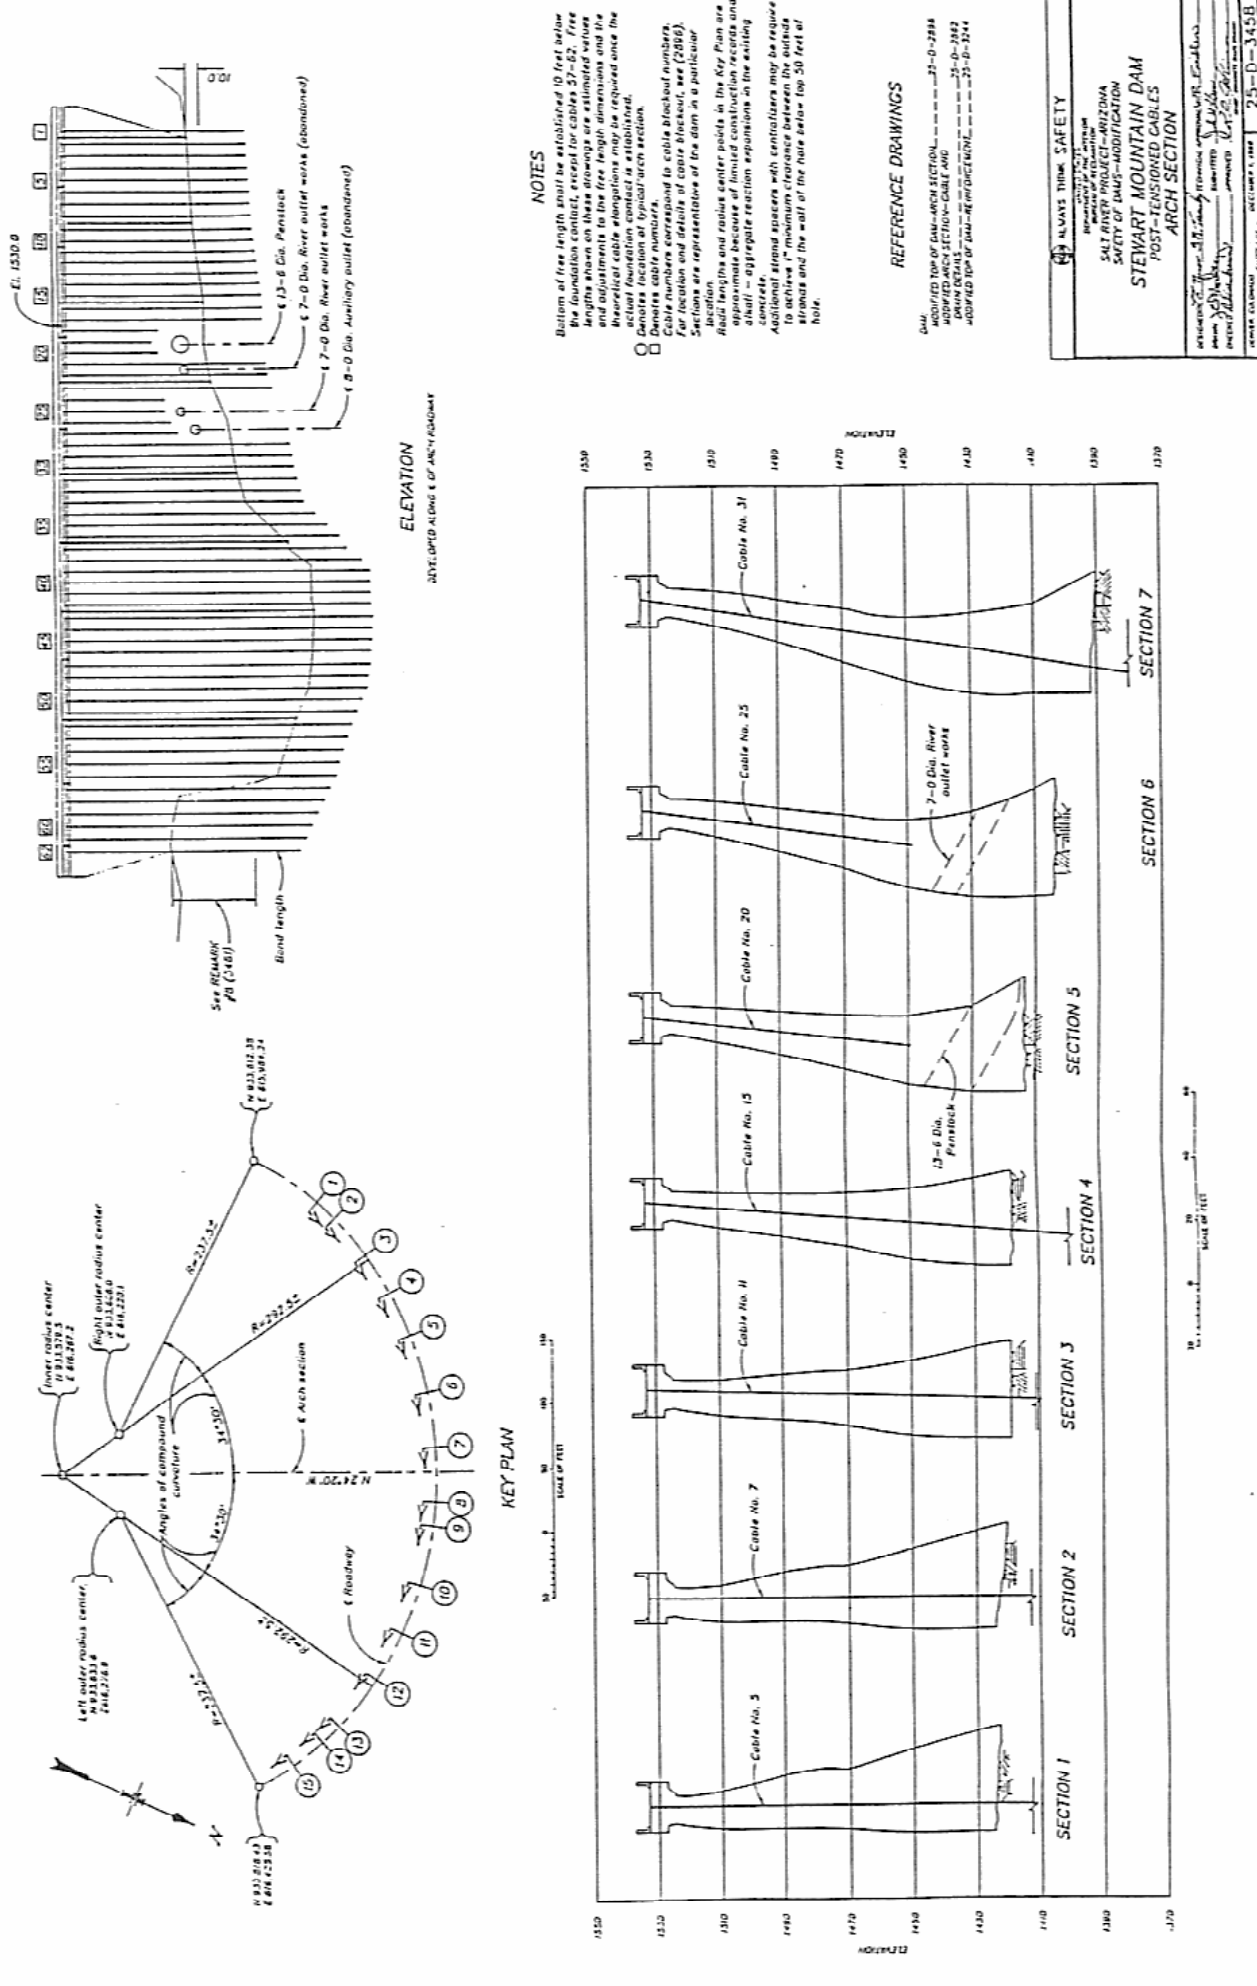
Figure 1. General arrangement of tendons, Arch Section.

The dam is a double-curvature, thin arch structure built over 60 years ago on the Salt River 30 miles east of Phoenix, Arizona. At its highest point, it stands 60 m above the riverbed, while the 180 m long crest is flanked by gravity buttresses and two spillways. As the importance of good cleanup on the horizontal construction joints was not recognized at the time of construction the joints were left untreated. This resulted in a layer of laitance on the horizontal joints, which later compromised bond across them. A three-dimensional finite element model of the dam was used to evaluate the dam's performance during various loading conditions, including seismic loads generated by the Maximum Credible Earthquake of Richter magnitude 6.75, occurring 15 km from the dam [5] and so generating an estimated site acceleration of 0.34 g. The analysis indicated that the dam would lose arch action during such an event, leaving vertical cantilever sections to support themselves. Because of the lack of bond at the horizontal lift lines, the blocks in the upper portion of the dam would be free to displace under these conditions. Sixty-two tendons were thus designed to stabilize the arch, each at about 2.7 m centers, with free lengths ranging up to 66 m, and bond lengths ranging from 9 to 14 m. Their inclination varied from vertical to $8^{\circ} 40'$. All but 7 of the tendons (all located immediately above the river outlet works openings through the dam) were anchored into the dam foundation bedrock (Figure 1). The arch tendons each comprised twenty-two 15.2 mm diameter epoxy coated strands. Design working loads averaged 285 tonnes (range 250-340) per tendon, equivalent to about 50% GUTS.
