The Use of Post-tensioned Tendons at Stewart Mountain Dam, Arizona: a Case Study Involving Precision Drilling

R.H. Bianchi
Bureau of Reclamation, Denver, Colorado

D.A. Bruce
Nicholson Construction of America, Bridgeville, Pennsylvania

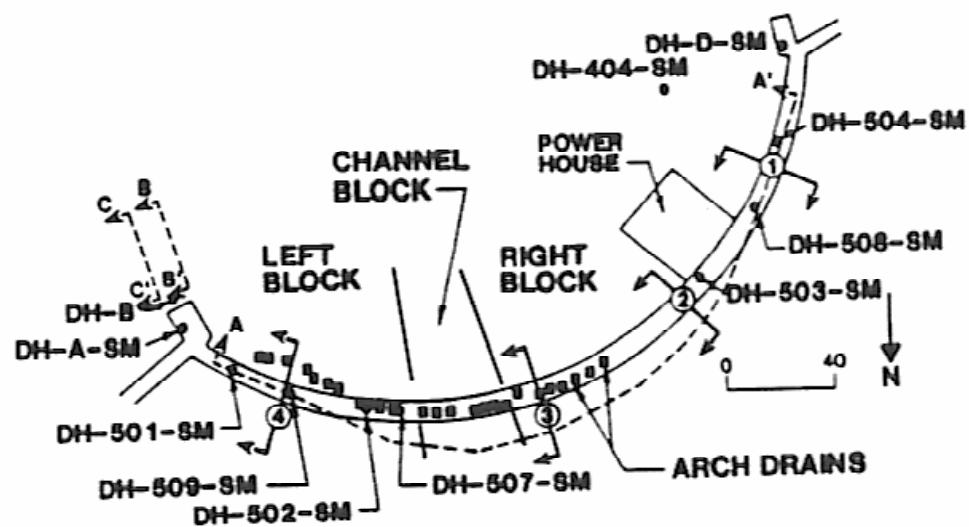
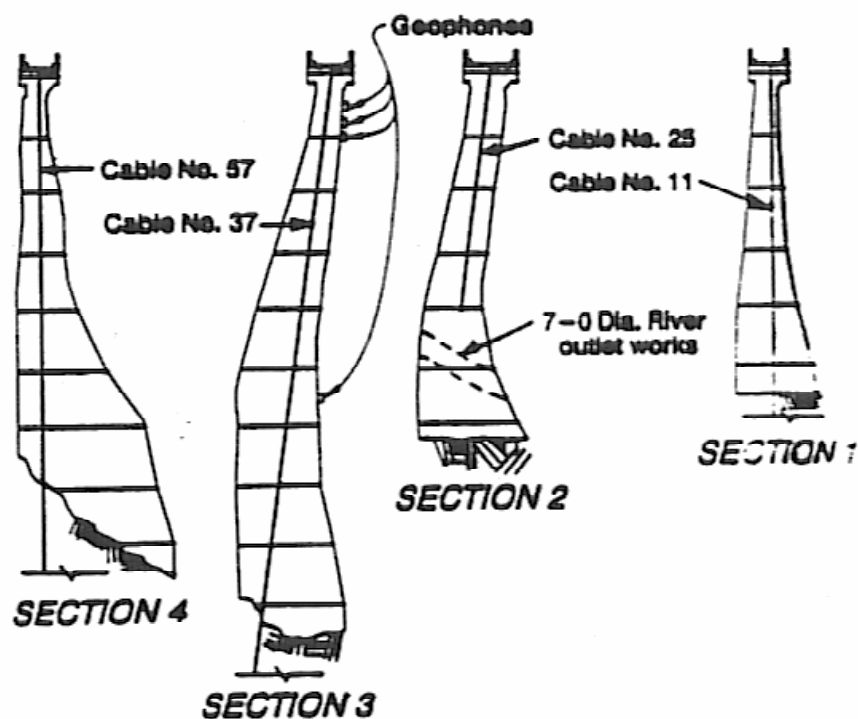
Figure 2 - Location of Exploration Holes, Arch Drains, & Typical Sections

Unbonded lift lines were evident in core recovery. Core breaks nearly always occurred along the lift lines. Seepage had been noted along the lift lines soon after the filling of the reservoir, and also during drilling, when new seepage was noted across the concrete faces along the lift lines. Within the arch section, core drilling with water often required grouting and redrilling. Loss of drill fluids along the lift lines was a common occurrence particularly within the upper 50 feet of the arch. During the drilling of hole DH-503-SM, the generator was shut down when drill fluid from the borehole travelled along a lift line and daylighted along the downstream face within the powerplant (Figure 2).

A major construction concern was the ability to drill the tendon borehole within a confined area (Figure 2). The drilling of large diameter boreholes has been performed on a variety of dams (Bruce, 1987). Drilling tolerances as small as 6 in/100 ft have been specified. However, surveys at most of the sites were performed with magnetic survey tools with uncertainties between 0.1' on vertical holes (2 in/100 ft), to 0.2' on 10' off vertical holes (4 in/100 ft), and to 0.8' on 30' off vertical (18 in/100 ft) [Wolf and deWardt, 1981]. The uncertainty of the magnetic tools was often equal to the tolerance specified. At Stewart Mountain, drilling tolerances required the drill holes to fall within a 12 inch radius at a 100 foot length for an ideal alignment. Electrical interference from the powerplant could impact the bearing reading and within the thrust block, steel reinforcement was pervasive throughout the concrete and

The only other item impacting the Stage II modification was the fact that the system of drainage holes' drill reports and core provided additional subsurface information. This assisted in determining the three rock mass categories used during the pullout tests. The only potential negative impact of the Stage I work was that by adding all the drains within the thrust block and arch, more potential obstructions were created if the tendon holes were not drilled within a tolerance of 9-inches/100 feet (Figure 2).

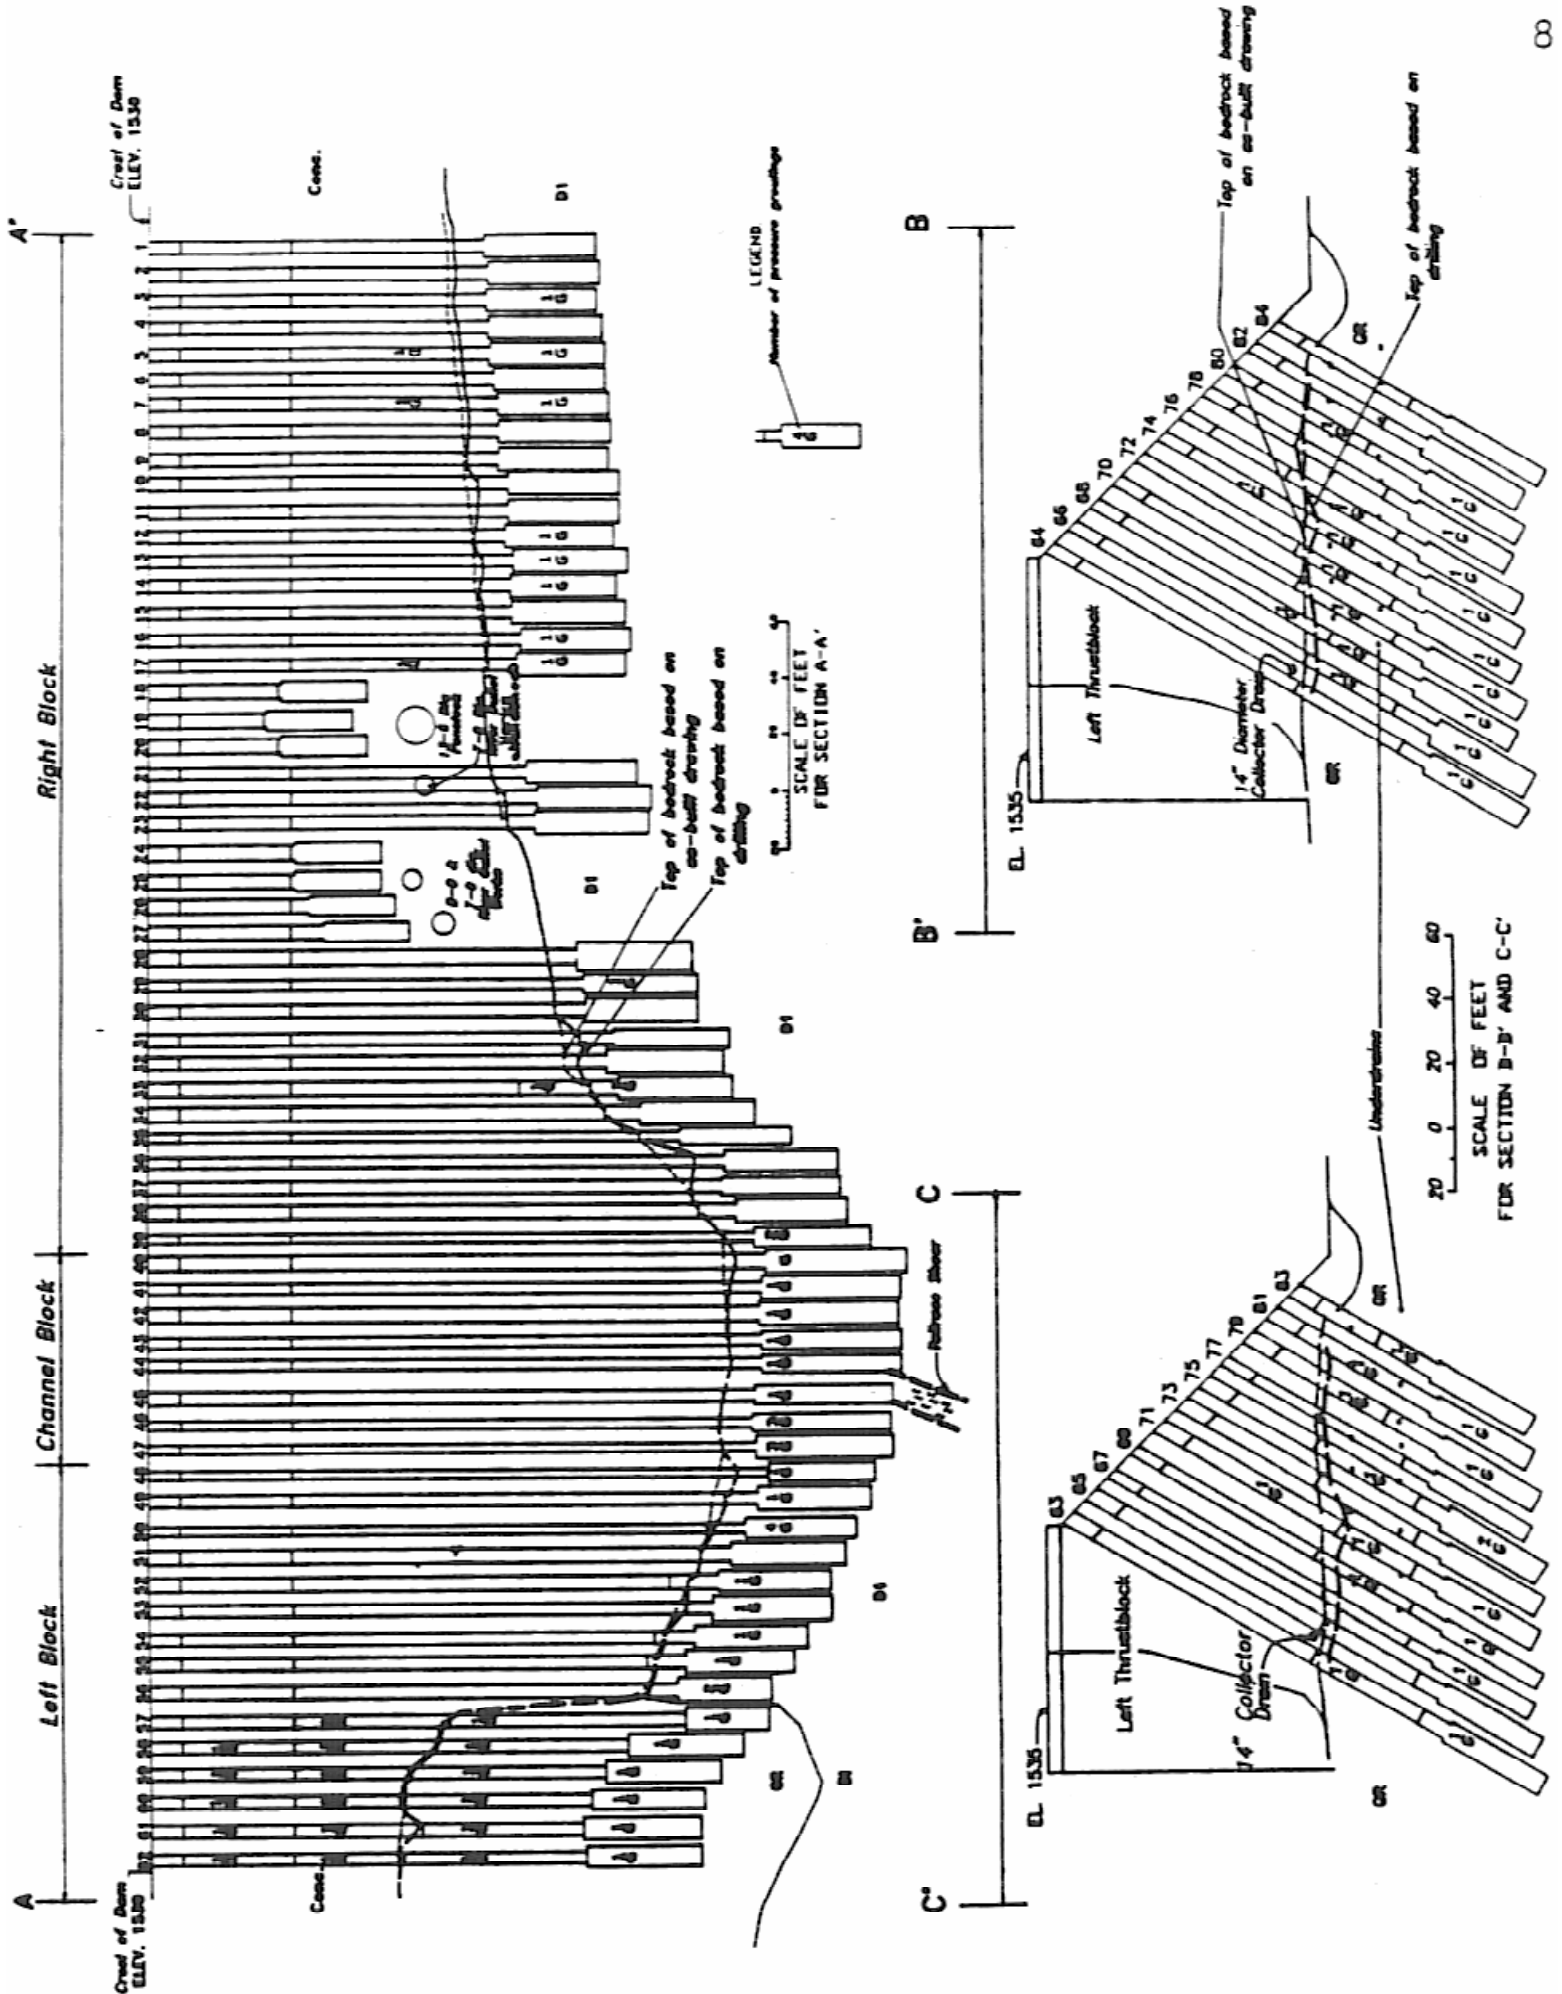
Figure 3 - Vertical Sections through Tendons showing Grout Intervals, and Number of Tests

Water testing. - Water testing of arch tendon holes for the bond lengths was in accordance with the Recommendations of the Post-tensioning Institute (PTI, 1986). The maximum allowed water loss within the bond length was specified for a 10 minute interval as being 0.001 gallons per minute, per inch diameter, per foot of hole with a 5 lb/in² pressure at the collar. The free length requirements were relaxed to 0.002 gallons per minute, per inch diameter, per foot of hole with a 5 lb/in² pressure at the collar. The specified water testing performed during the drilling investigation had indicated that most of the intervals would fail even the free length criterion of water testing. The specification required water testing be performed on a minimum of two stages for holes 18 through 27: the upper 50 feet, and the remainder of the hole. Arch holes 57 through 62 were to have at least 4 stages (2 stages within concrete and 2 stages within foundation). All the remaining holes were water tested at least in 3 stages (2 stages within concrete and the bond zone). Figure 3 shows the test intervals and shows the number of times water retesting was required.

Pressure Grouting. - Where stage water tests exceeded the criterion, pressure grouting was performed as specified. If the upper 50 foot interval was found to be permeable and the remainder of hole was found to be tight, the entire hole would require grouting and redrilling. If only an intervening interval was found permeable and the rest of hole was found tight, the permeable interval to the bottom of the hole required grouting. In nearly every case where there was an isolated interval showing a water take, the interval was retested after pressure grouting and was found tight. Figure 3 indicates the intervals requiring pressure grouting (G) and number of times pressure grouting was performed within an interval.

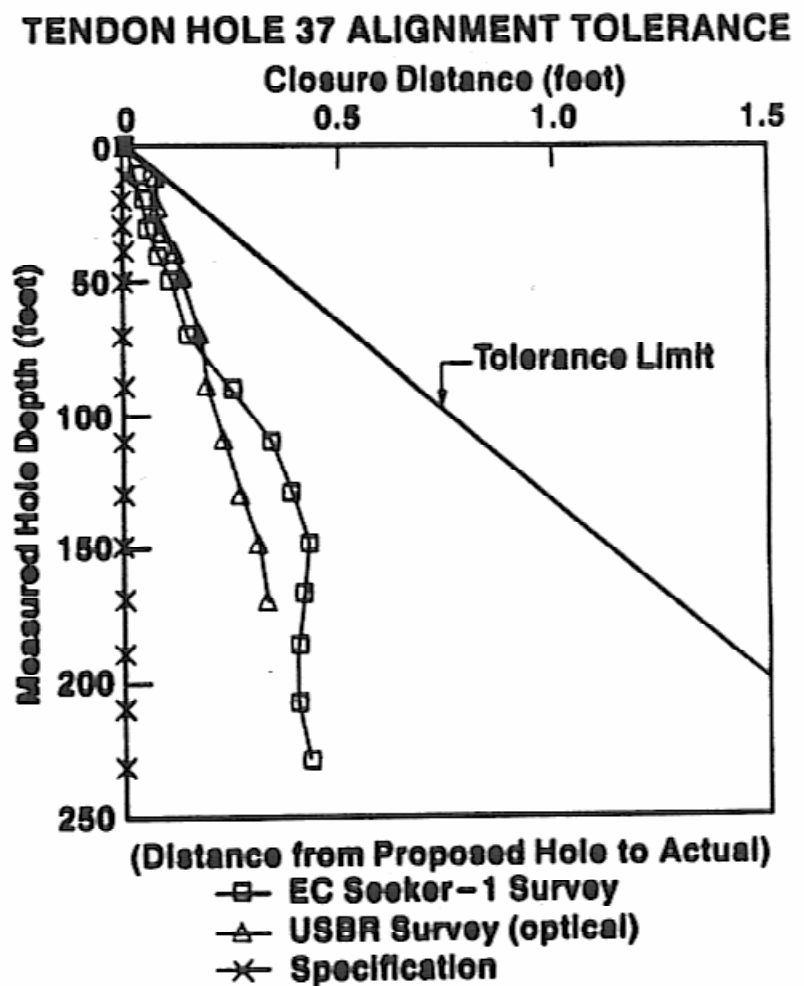
Figure 4

The specifications required the tendon hole be surveyed at 10 foot intervals for the first 50 feet and at 20 foot intervals along the remaining length. Data from the survey readings were processed within the time it took to withdraw the survey tool from the borehole and reconnect the drill rods to the down-the-hole hammer. Initially, although the readings from the Seeker were within the specified tolerances, the data required conversion into formats that an inspector could appraise quickly (e.g. see Figure 4).

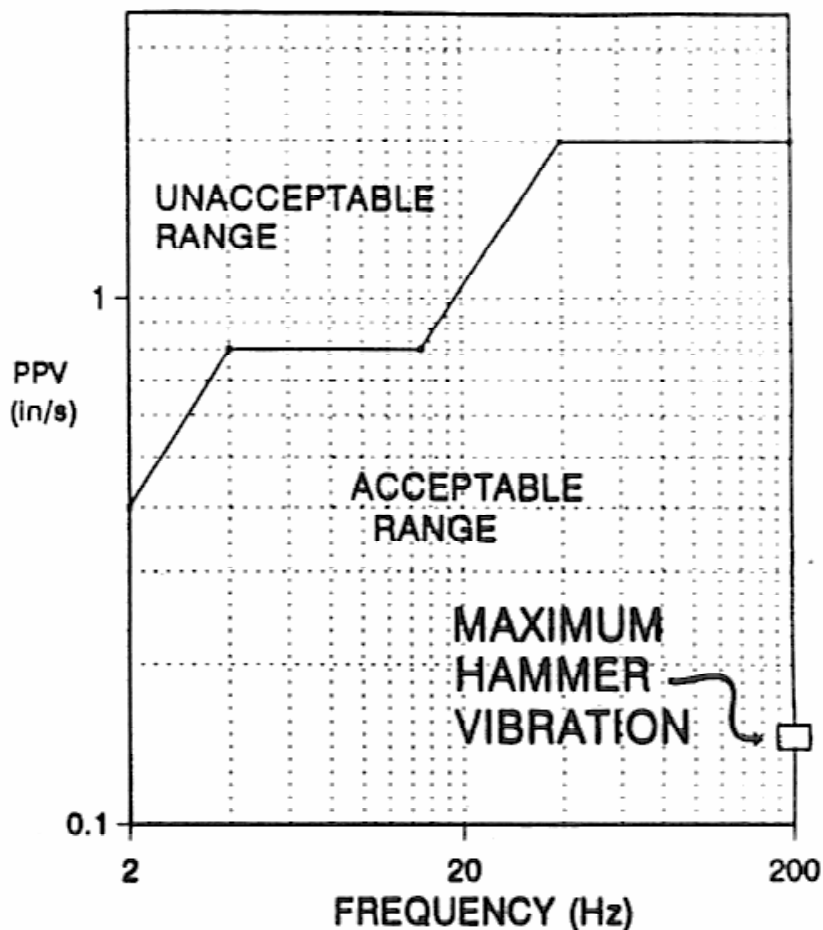
Figure 5

The four geophones measured peak particle velocity (ppv) on a continuous basis. In general, the maximum peak vector sum was greatest when the drill bit was closest to the measurement location (Table 2). The maximum peak vector sum of 0.147 inches/sec was well within the allowable criterion of 2 inches/sec for blasting vibration normally (Figure 5) accepted for structures by Reclamation (Reclamation, 1980) and Corp of Engineers (Department of Army, 1972).

Vibration Monitoring of Hole 37
