THE REHABILITATION OF BEAVER DAM: A MAJOR SEEPAGE CUT-OFF WALL

D.A. Bruce * and G. Dugnani†

Abstract

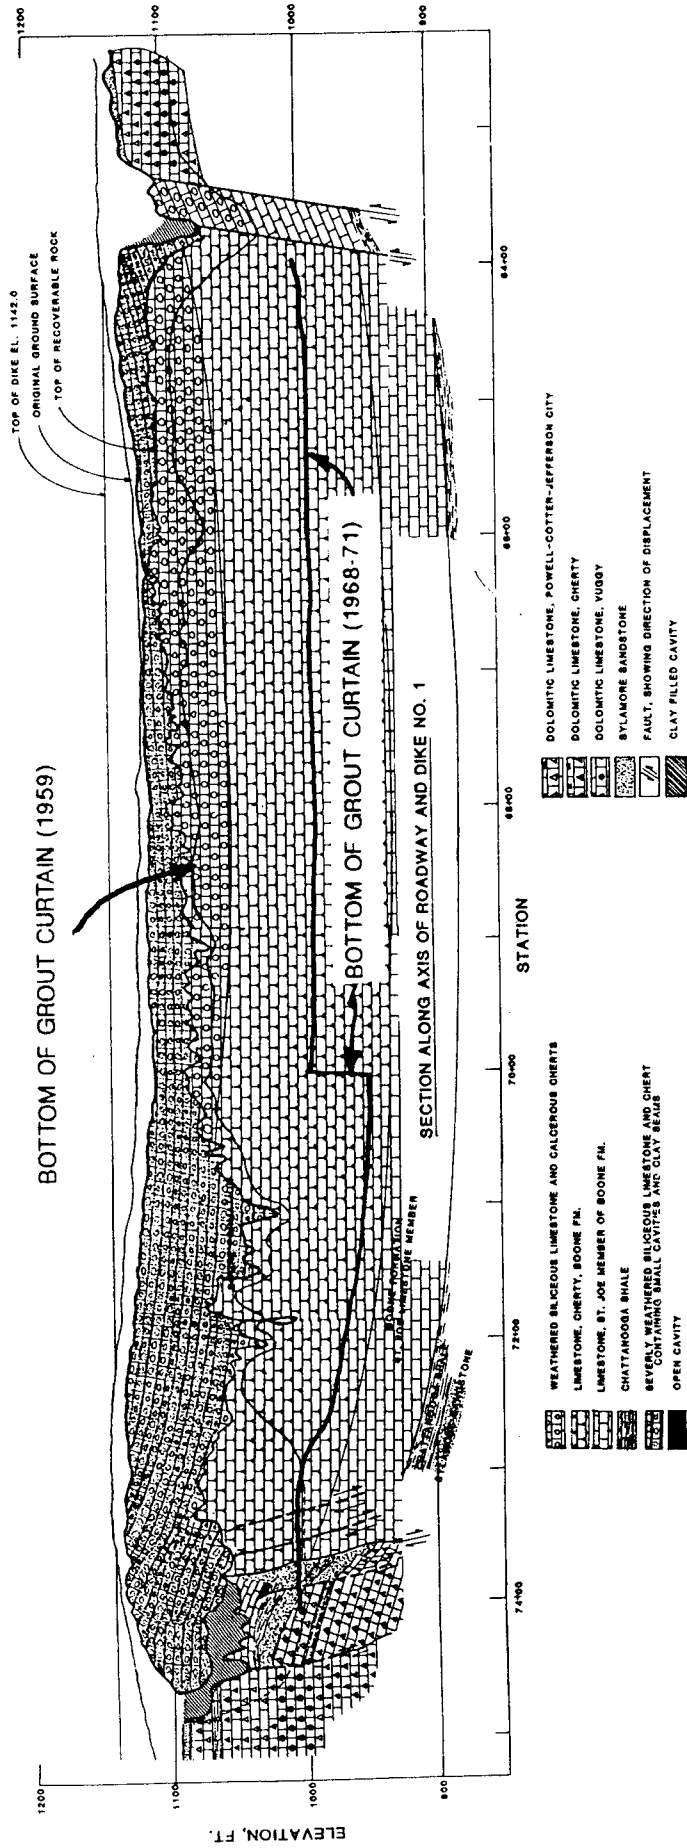
Figure 2. The inferred geology of the graben area underlying Dike 1 (Llopis et al., 1988).

The graben underlies Dike 1 and the contiguous 200 feet of the northern Main Embankment (Figure 2). It is downfaulted about 200 feet between NE/SW trending faults, which now are characterized by zones of disturbed material. Some planes are infilled by a competent breccias or solution deposits. Other fault planes are open and clean.

Under variable thickness of relatively impermeable overburden (typically 15-40 feet) the deeply weathered siliceous and cherty Boone overlies sound rock. The Boone is mainly spongy and chalklike, containing highly irregular tubular and sheet-like cavities, mostly infilled with soft clay containing rock fragments and chert concentrations. The sound rock contains a network of inter-connecting cavities that locally extend down to elevation 974 feet.

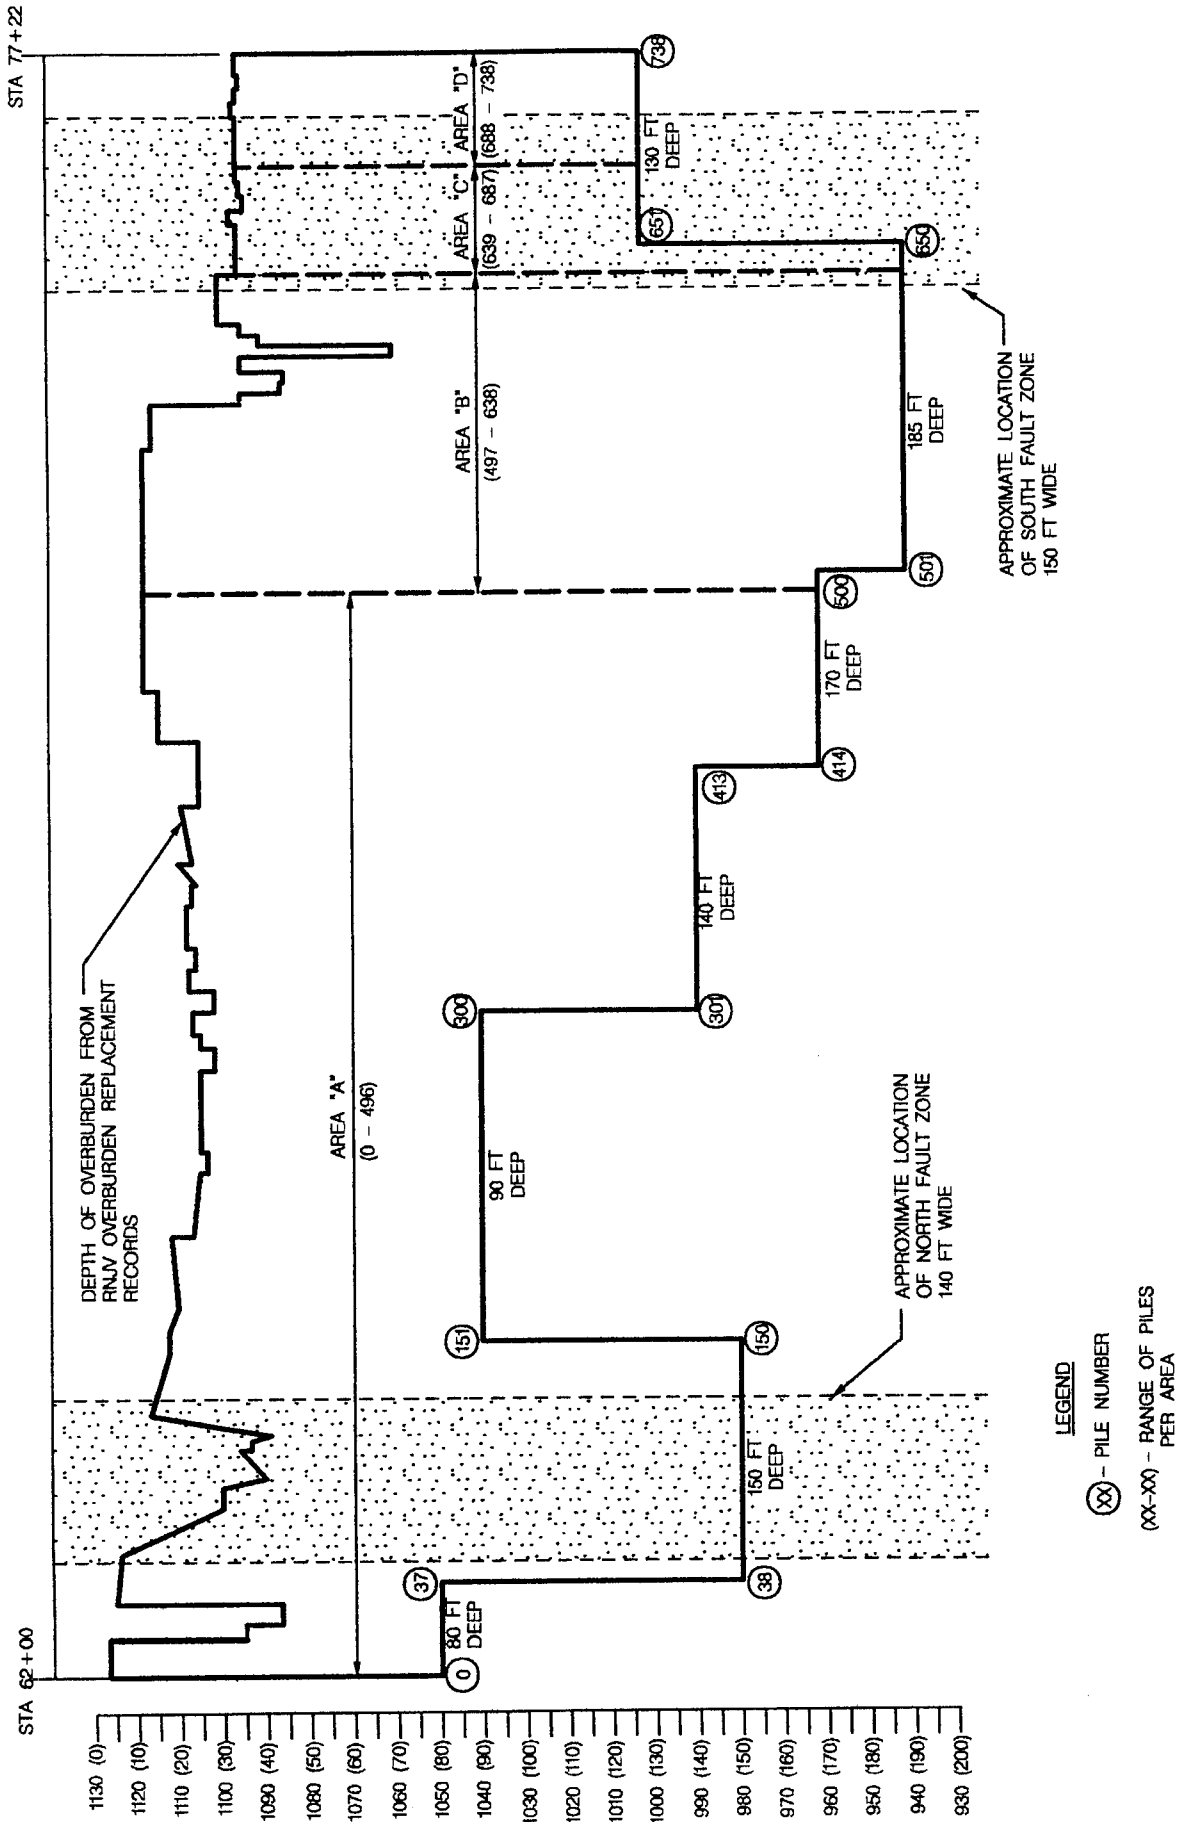
Figure 3. Elevation of the cut-off wall showing main construction parameters.

Figure 3 shows the recorded profile of overburden depth, and the lateral subdivision of the wall, into four "Areas", based on the different geological and construction conditions subsequently encountered.

As shown in Figure 3, the cut off-wall extends for a total length of 1475 feet from Dike Stn 62+00 to 77+22. It is offset 65 feet upstream of the embankment centerline, and needed a work platform, benched into the upstream face of Dike 1 at elevation 1130 feet. This platform was 65-75 feet wide.

The wall depth varied in response to the geological conditions from 80 to 185 feet although Pile 572 reached 215 feet for exploratory purposes. The total wall area was 207,700 square feet. A total of 24 additional ("conforming") piles were installed, mainly in Areas A and D to assure the required pile overlap at full depth, as identified in Table 1, which also summarizes where coring of piles, and their contacts, was executed for QA/QC purposes.

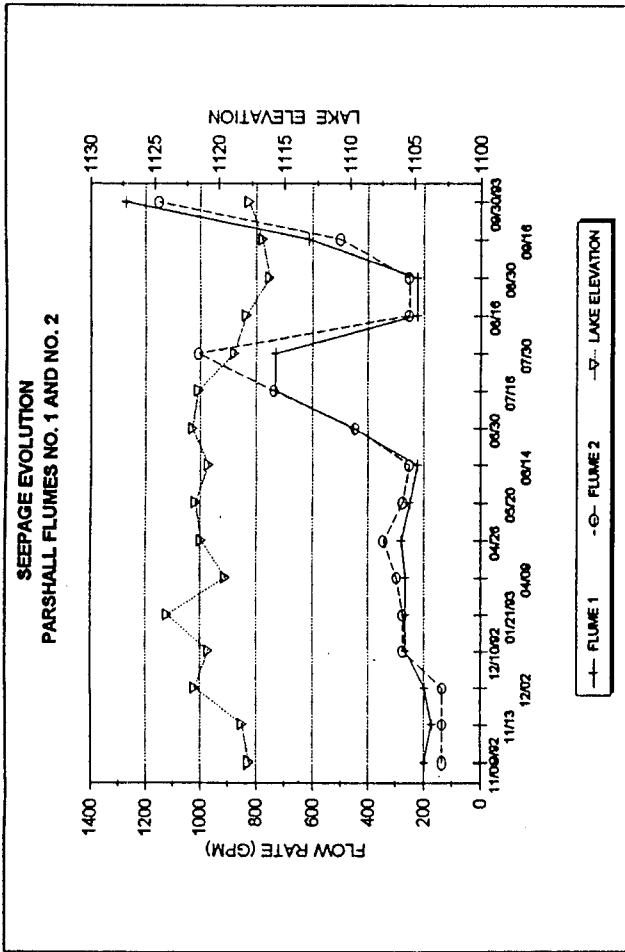
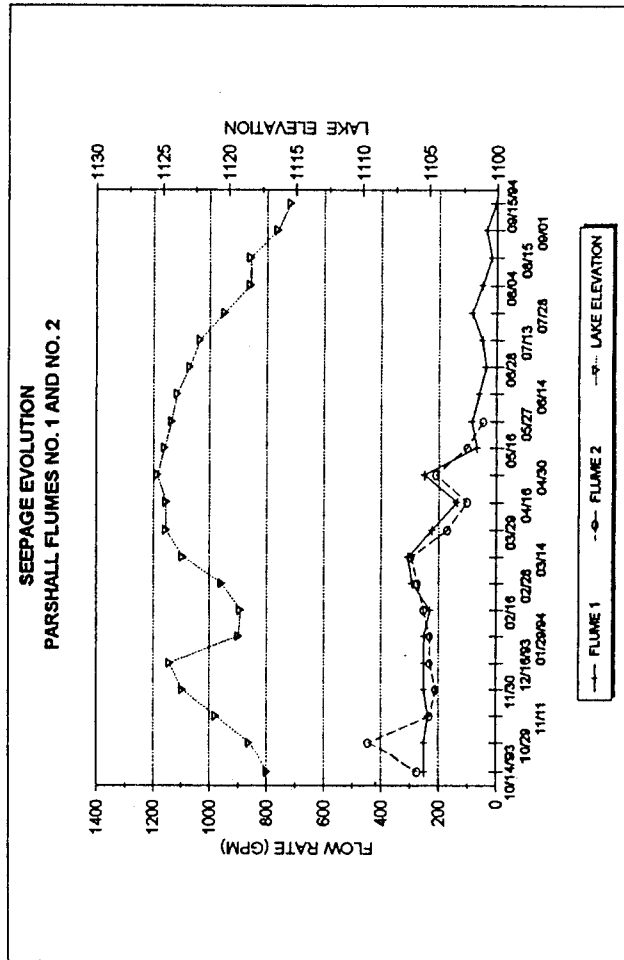
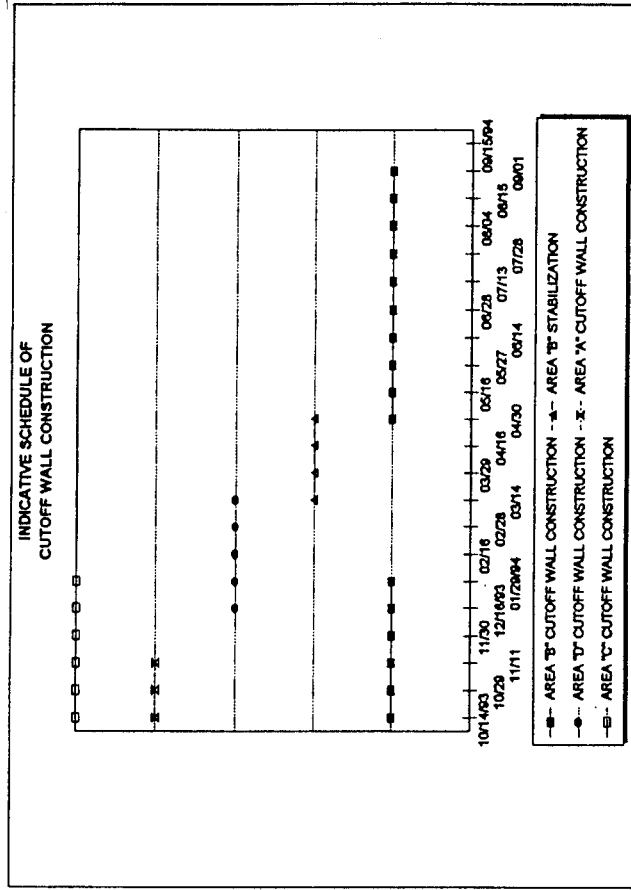
Figure 6. Evolution of seepage volumes: Parshall Flumes No. 1 and No. 2.

- Parshall Flumes No. 1 and No. 2 - the rise in flows in mid June 1993 was associated with pumping excess surface water from the work platform to the other side (downstream) of the Dike. By mid March 1994, Area D had been completed and the grout stabilization of Area B commenced: flows decreased. By mid September 1994, after surface pumping had ceased, the remnant seepage was barely 4 gpm, compared to a maximum of over 1270 gpm in September 1993.

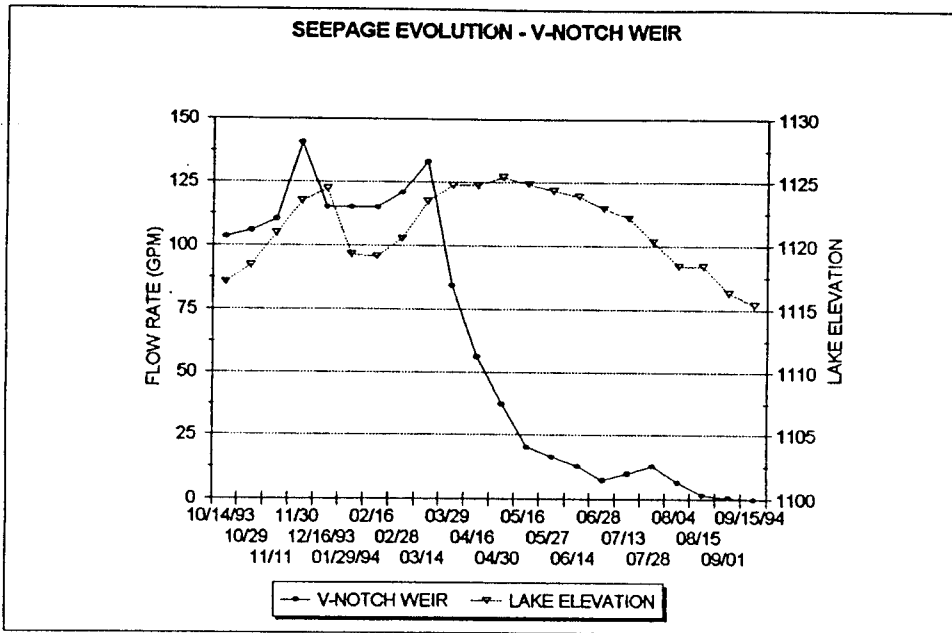
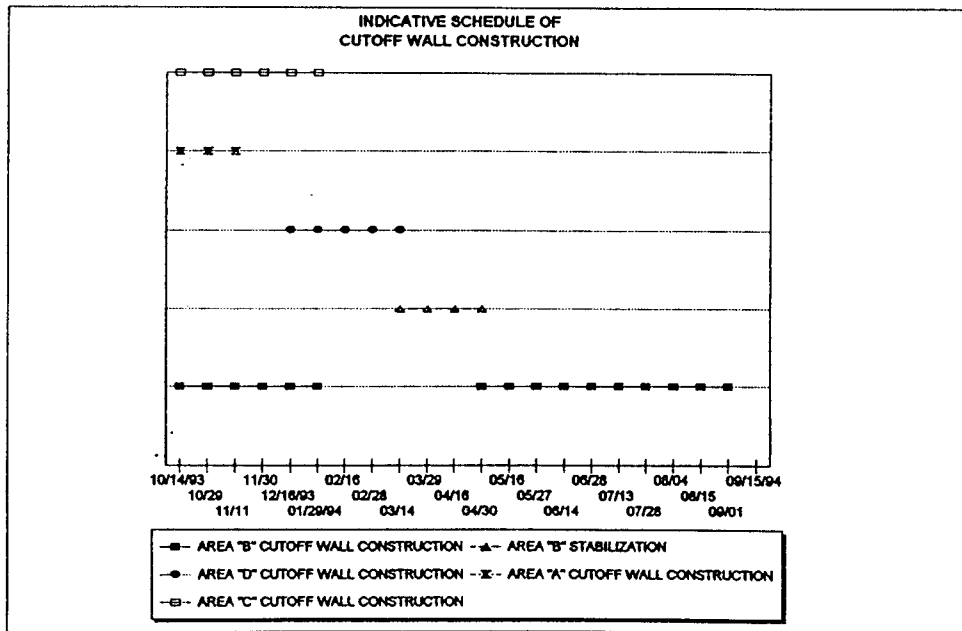
Figure 7. Evolution of seepage volumes: V-Notch Weir.

- V Notch Weir - a sharp decrease (in both seepage and pumped water) also occurred from mid March 1994 but by late August 1994, when the cut-off was completed, it had totally dried up.

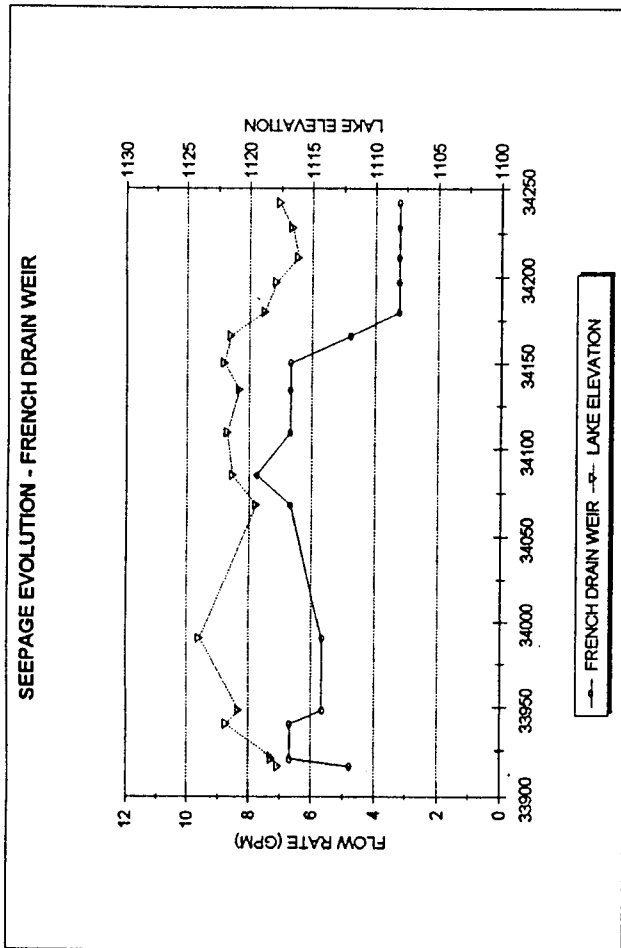
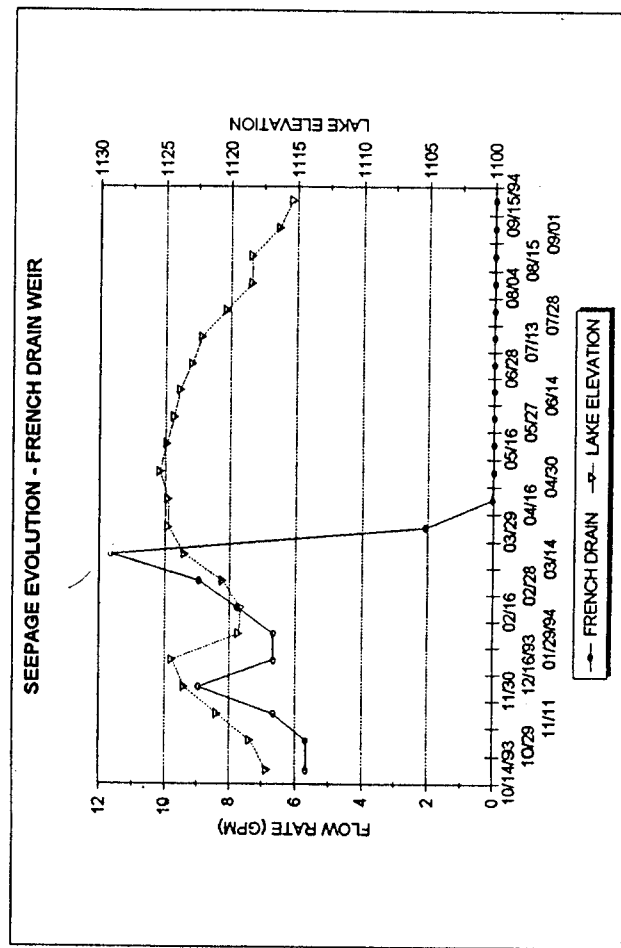
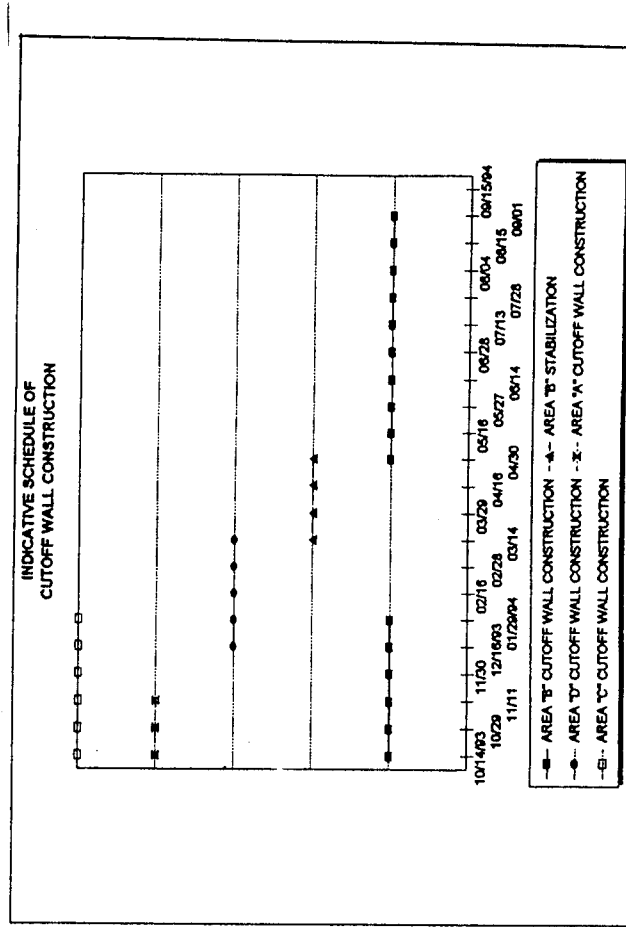
Figure 8. Evolution of seepage volumes: French Drain Weir.

- French Drain Weir - until September 1993 the flow was related to lake level, stabilizing at 3.25 gpm when the level fell below 1118 feet. At the beginning of grout stabilization in Area D in late January 1994, a sharp increase in flow occurred - greater than attributable to lake level fluctuation alone. This suggested a redistribution and concentration of flow paths by the treatment. The flow peaked at 11.64 gpm on March 14, 1994, three days after the completion of Area D. However, by the end of March 1994 the flow had dropped to 2.06 gpm, and eventually dried up totally two weeks later.

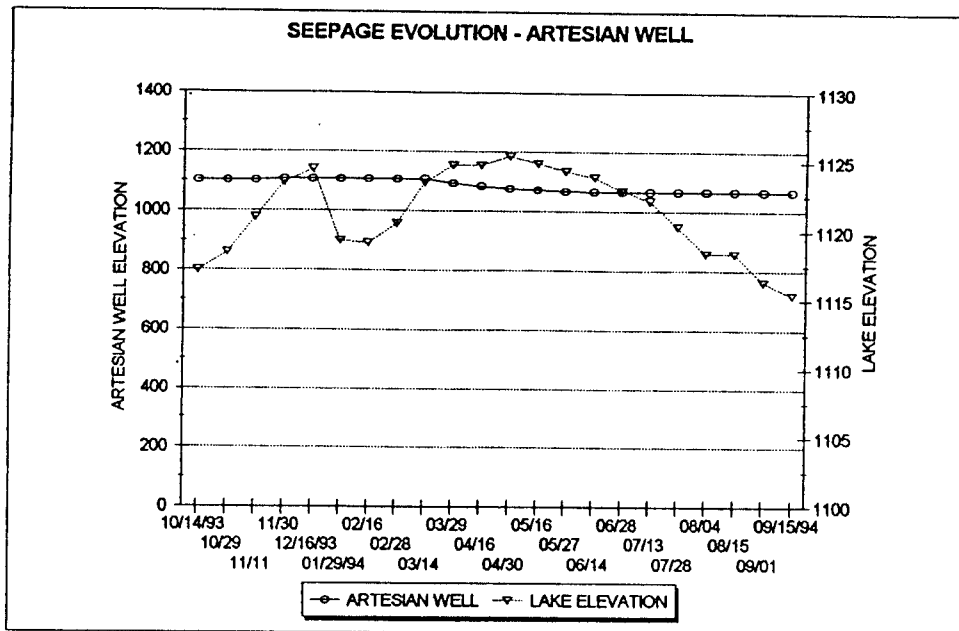
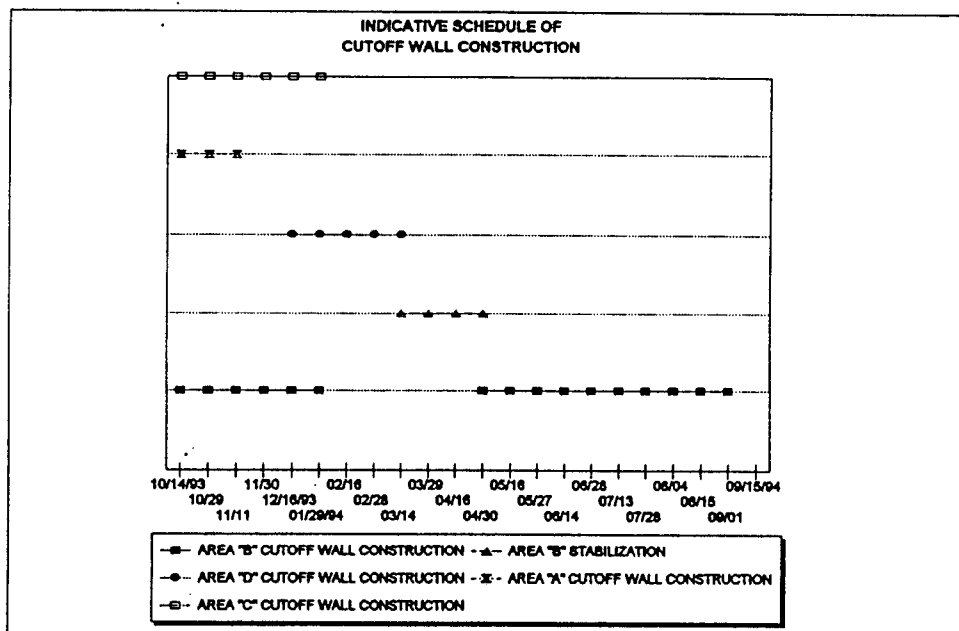
Figure 9. Evolution of seepage: Artesian Well.

- Artesian Well - reacted, with delay to lake level, but showed a 41.35 feet drop in March 1994, despite the rise in lake level. In mid-June 1994 it reached its "drying up" elevation of 1066.2 feet.
