A major seepage cut-off wall has been installed through karstic rock at Beaver Dam, Arkansas. Given the geological, hydrological and logistical restraints, this curtain was formed by overlapping 864mm diameter concrete piles. Special equipment was needed for every phase of the work. Following the construction of the 19,300m² cut-off, to depths of over 56m, the remnant seepage had been reduced by a factor of several hundred. This successful project was undertaken under a partnering agreement between the owner and the contractor.

Rehabilitation of Beaver Dam: a major seepage cut-off wall

by DA Bruce & S Stefani.

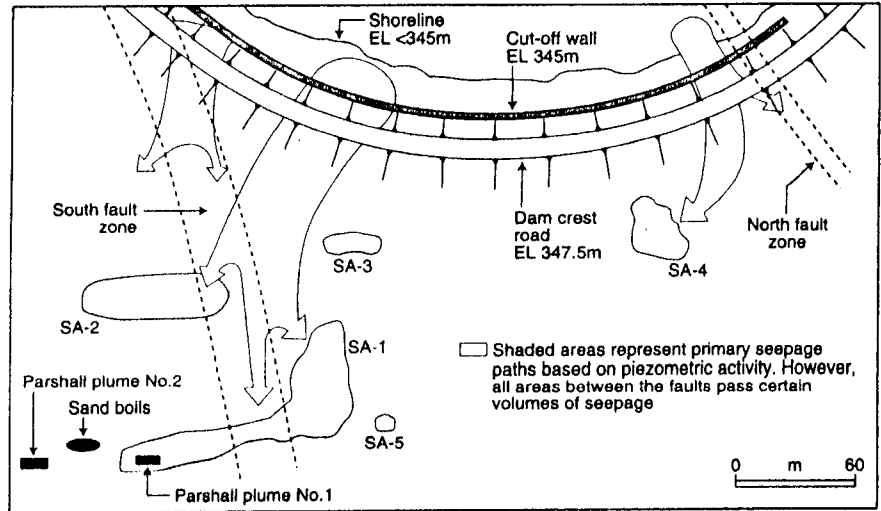
ABOVE RIGHT: Figure 1. Relative positions of dike one, the cut-off wall and the major seepage features. RIGHT: Figure 2. The inferred geology of the graben area underlying dike one (Llopis et al, 1988).

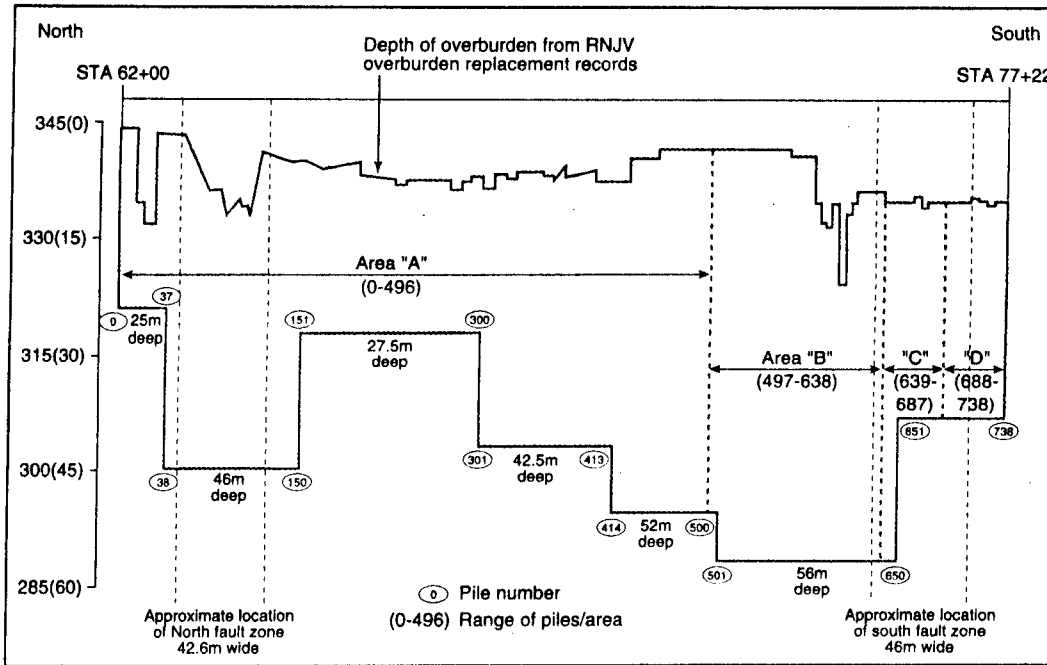
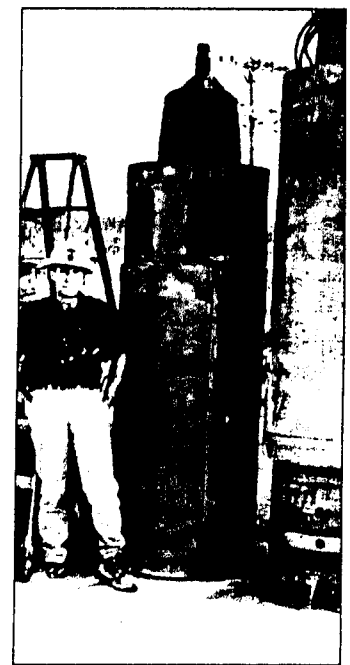
Figure 3. Elevation of the cut-off wall showing main construction parameters.

Figure 3 shows the recorded profile of overburden depth, and the lateral subdivision of the wall, into four contiguous 'areas', based on the different geological and construction conditions subsequently encountered.

As shown in Figure 3, the cut-off wall extends for a total length of from dike stn 62+00 to 77+22. It is offset 20m upstream of the embankment centreline, and needed a work platform, benched into the upstream face of dike one at elevation 344m. This platform was 20m-23m wide.

The wall depth varied in response to the geological conditions from 24m to 56m although pile 572 reached 66m for exploratory purposes. The total wall area was 19,300m². A total of 24 additional ('conforming') piles were installed, mainly in areas A and D to assure the required pile overlap at full depth, as identified in Table 1 which also summarises where coring of piles, and their contacts, was executed for purposes of quality assurance/quality control (QA/QC).

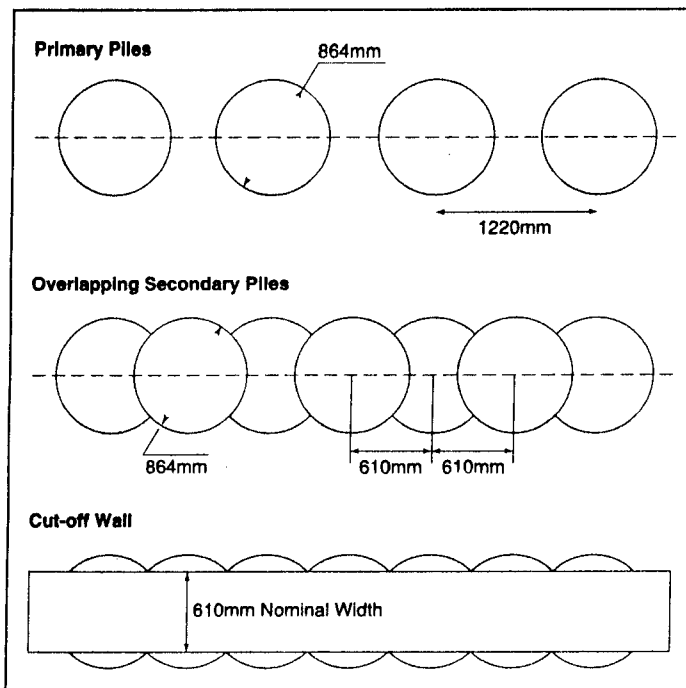
Figure 4. Construction sequence of the cut-off wall.

The individual piles were located at 610mm centres, yielding a nominal chordal joint width of 610mm (Figure 4). This overlapping pile method is executed in two stages:

- in stage 1, a series of 'primary' piles is drilled and concreted;
- in stage 2, the intermediate 'secondary' piles are installed to complete the cut-off.

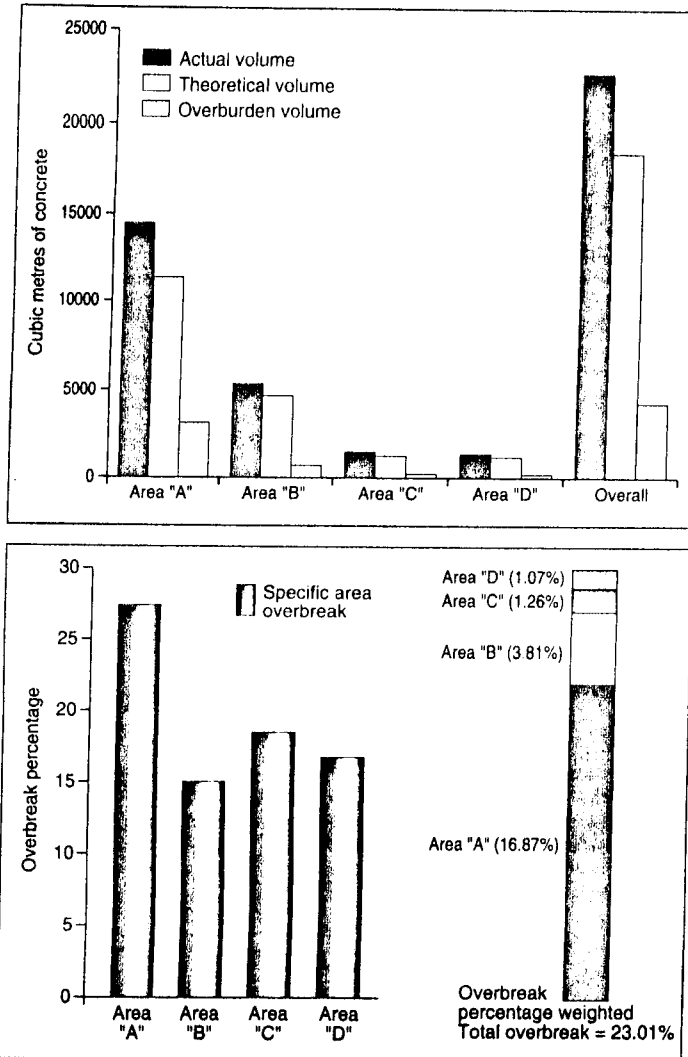
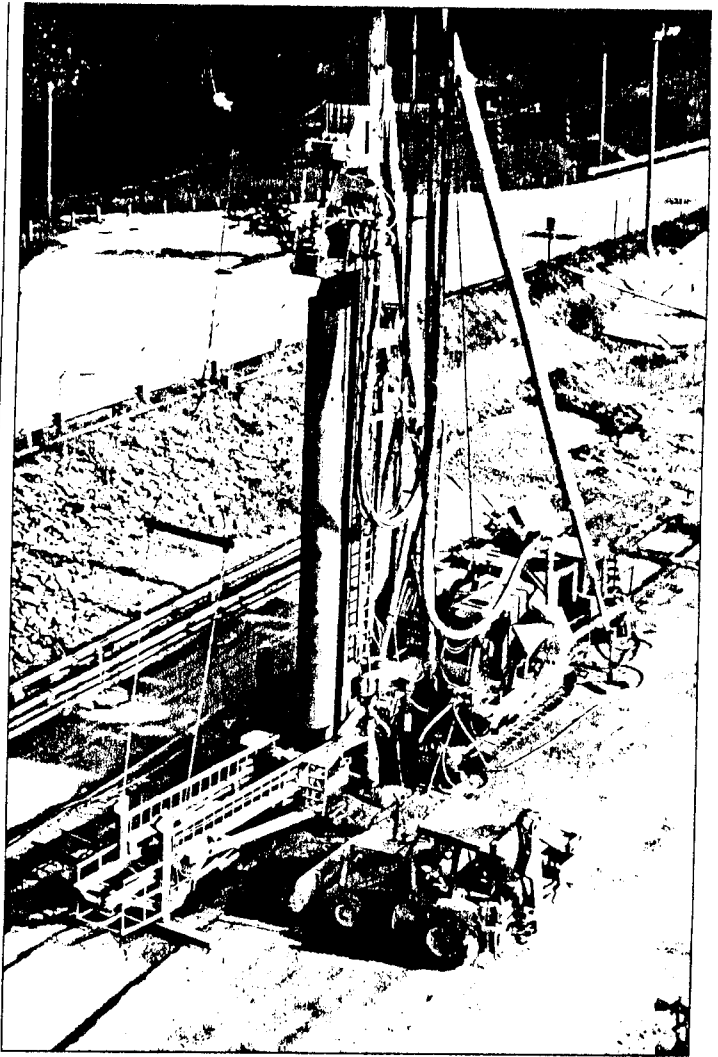
Figure 5. Quantities of final concrete used in the cut-off wall broken down by area, by volume (TOP) and overbreak percentage (ABOVE).

Water was heated or chilled, depending on the other material and ambient, temperatures. Final concrete placement data for cut-off wall construction are shown in Figure 5. Total quantities of work conducted are summarised in Table 2.

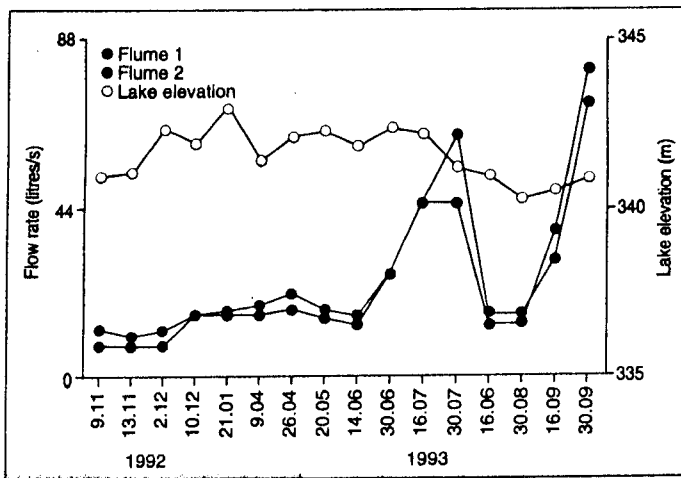
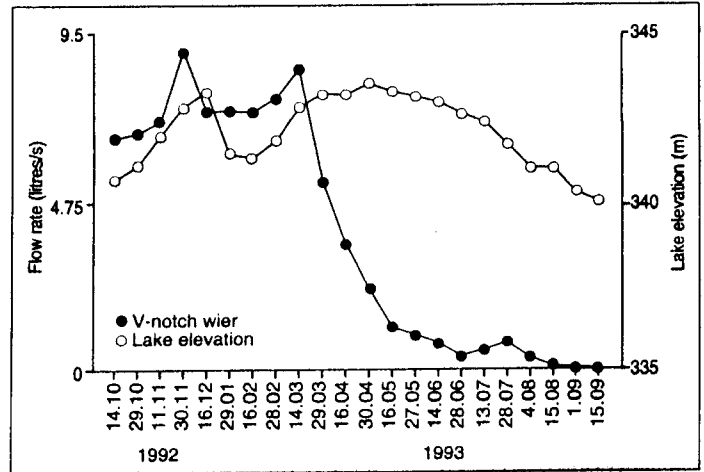
TOP LEFT and LEFT: Figure 6. Evolution of seepage volumes: Parshall Flumes No1 and No2. ABOVE: Figure 7. Evolution of seepage volumes: V-Notch Weir.

- Seepage area SA-1**
- Parshall Flume No1: measures flow from SA-1 (Figure 6).
- Parshall Flume No2: measures flow from all the seepages from dike one (Figure 6).
- V-notch Weir: measures surface water seepage from SA-1 (Figure 7).

Major observations are:
 ●Parshall Flumes No1 and No2 - the rise in flows in mid June 1993 was associated with pumping excess surface water from the work platform to the other side (downstream) of the dike. By mid-March 1994, area D had been completed and the grout stabilisation of area B commenced: flows decreased. By mid-September 1994, after surface pumping had ceased, the remnant seepage was barely 0.3 litres/s, compared to a maximum of over 81 litres/s in September 1993.
 ●V Notch Weir - a sharp decrease (in both seepage and pumped water) also occurred from mid-March 1994 but by late August 1994, when the cut-off was completed, it had totally dried up.
 ●French Drain Weir - until September 1993 the flow was related to lake level stabilising at 0.2 litres/s when the level fell below 341m. At the beginning of grout stabilisation in area D in late January 1994, a sharp increase in flow occurred - greater than attributable to lake level fluctuation alone. This suggested a redistribution and concentration of flow paths by the treatment. The flow peaked at 0.7 litres/s on March 14, 1994, three days after the completion of area D. However, by the end of

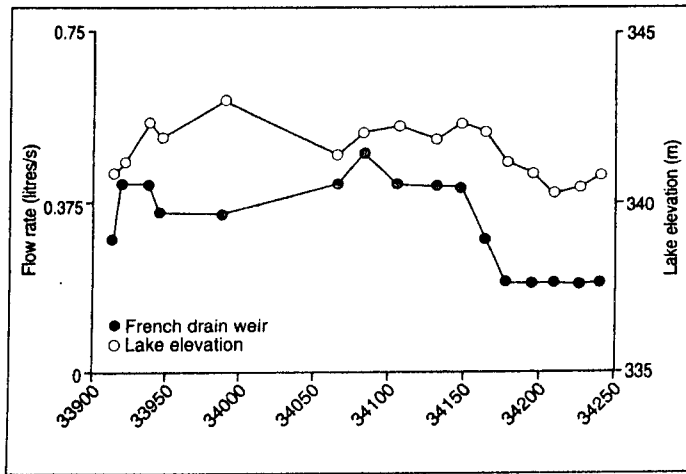
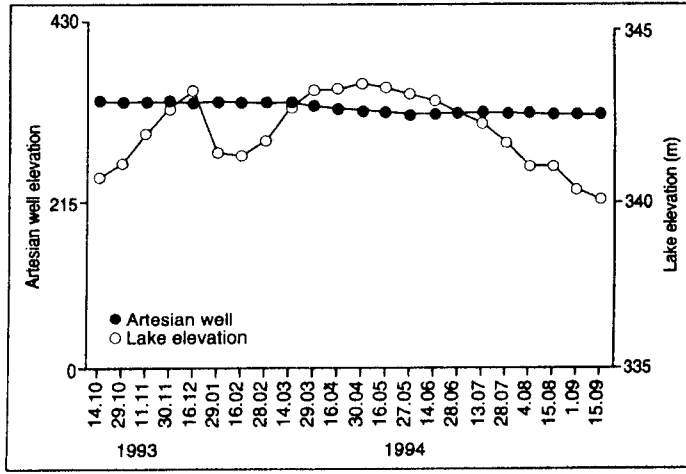
TOP LEFT and LEFT: **Figure 8.** Evolution of seepage volumes: French Drain Weir.

Seepage area SA-2
 French Drain Weir: connects to Parshall Flume No2 (Figure 8).
 Artesian Well (Figure 9).
 Actual data are provided in Table 3.
