FOCUS ON GEOENVIRONMENTAL ENGINEERING

PILE WALL CUTS OFF SEEPAGE

DONALD A. BRUCE
GIOVANNI DUGNANI

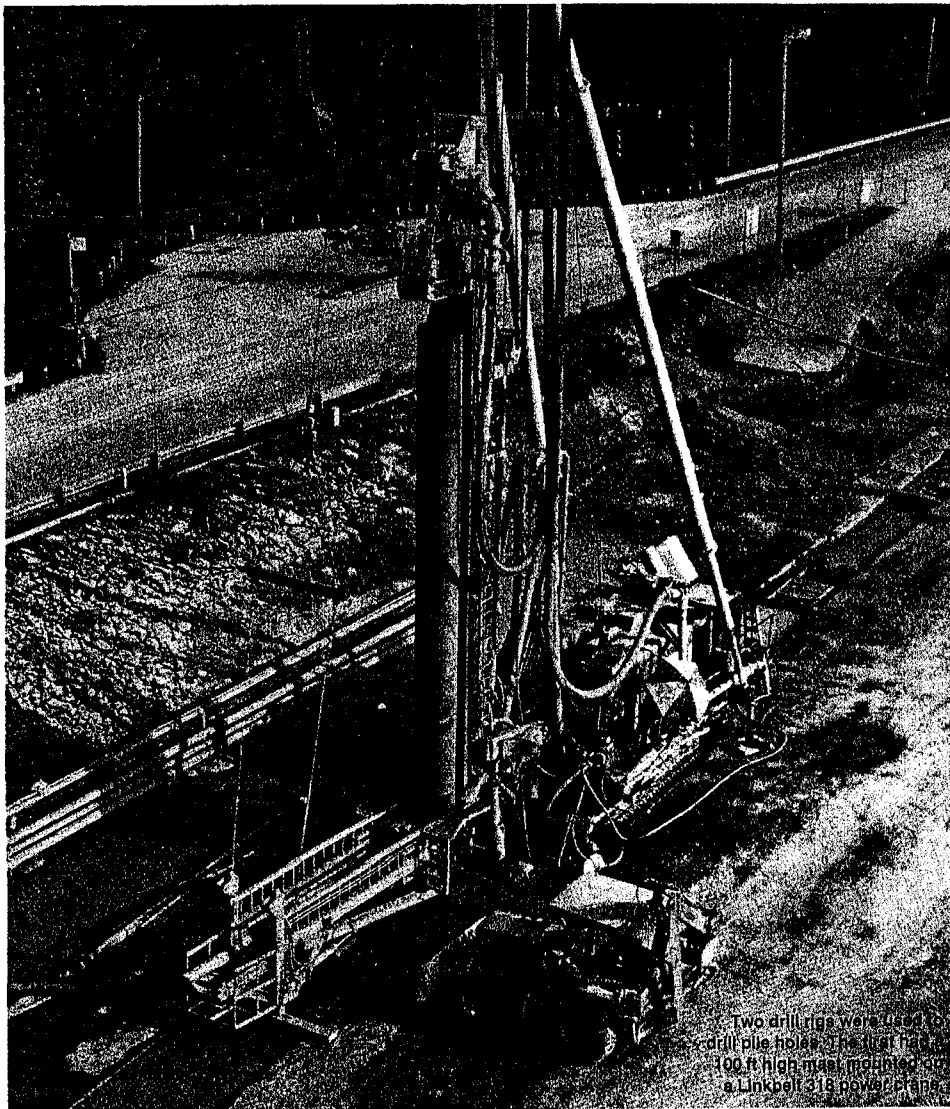
Two drill rigs were used to drill pile holes 200 ft long and 100 ft high made possible by a Linkbelt 318 power crane.
