MONITORING AND REMEDIATION OF RESERVOIR RIM LEAKAGE AT TVA'S TIMS FORD DAM

James A. Hamby¹ and Donald A. Bruce²

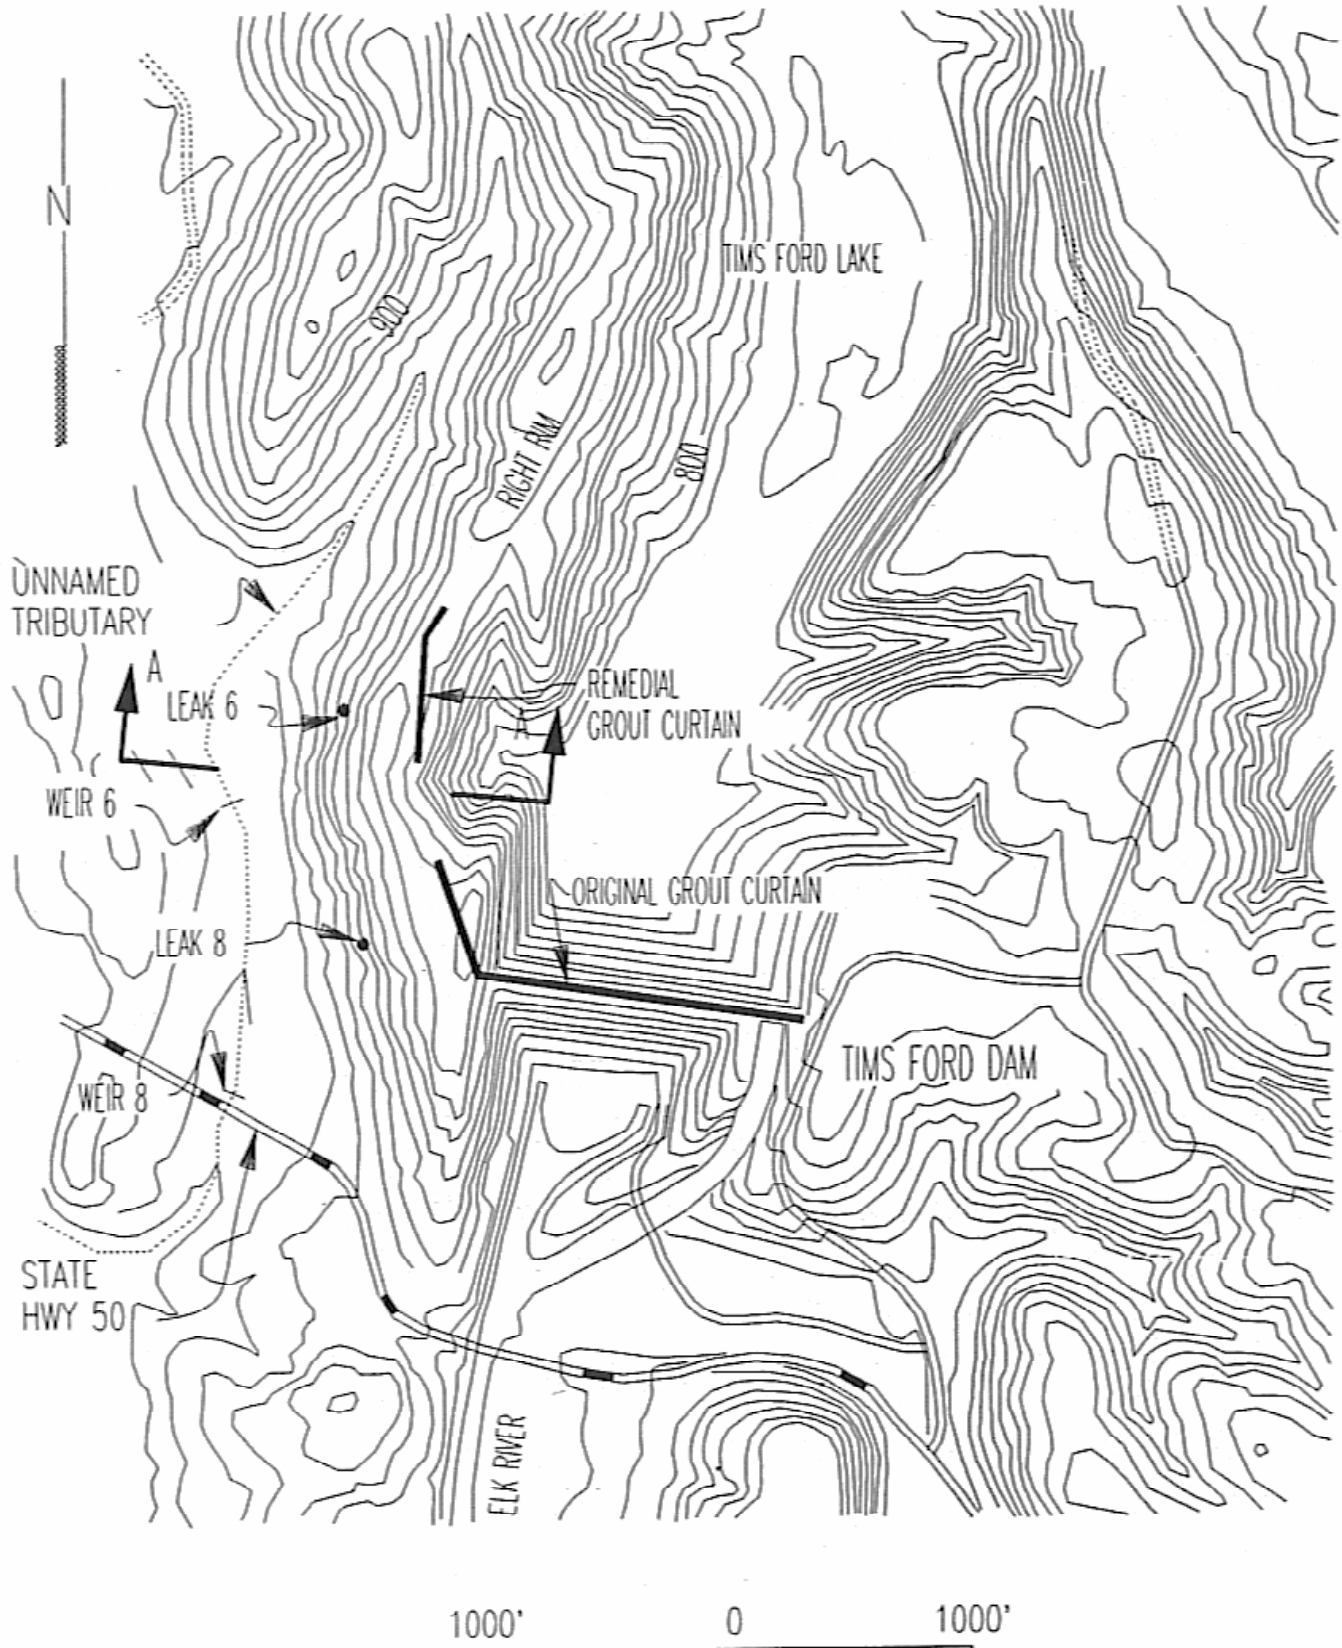
Figure 3. Plan of Tims Ford Dam and Reservoir

Leakage developed in two areas along the west side of the right rim (Figure 3) designated Leaks 6 and 8. Leak 6 was

approximately 1,000 feet upstream from the axis of the dam, while Leak 8 was approximately 150 feet upstream from the axis of the dam. Flowing springs were found adjacent to Leak 6 at elevation 852 feet and included a spring at about elevation 790 feet that was active before reservoir filling. Another minor wet area was located 2800 feet upstream of the dam baseline. Rectangular weirs were established on an unnamed tributary of the Elk River to monitor the rim leaks.

On the basis of the site investigation, a multirow, remedial grout curtain was designed, approximately 800 feet long (Figure 3). The holes were inclined at 30 degrees to the vertical to encourage intersection of (sub)vertical features and were oriented in opposite directions in the two outside

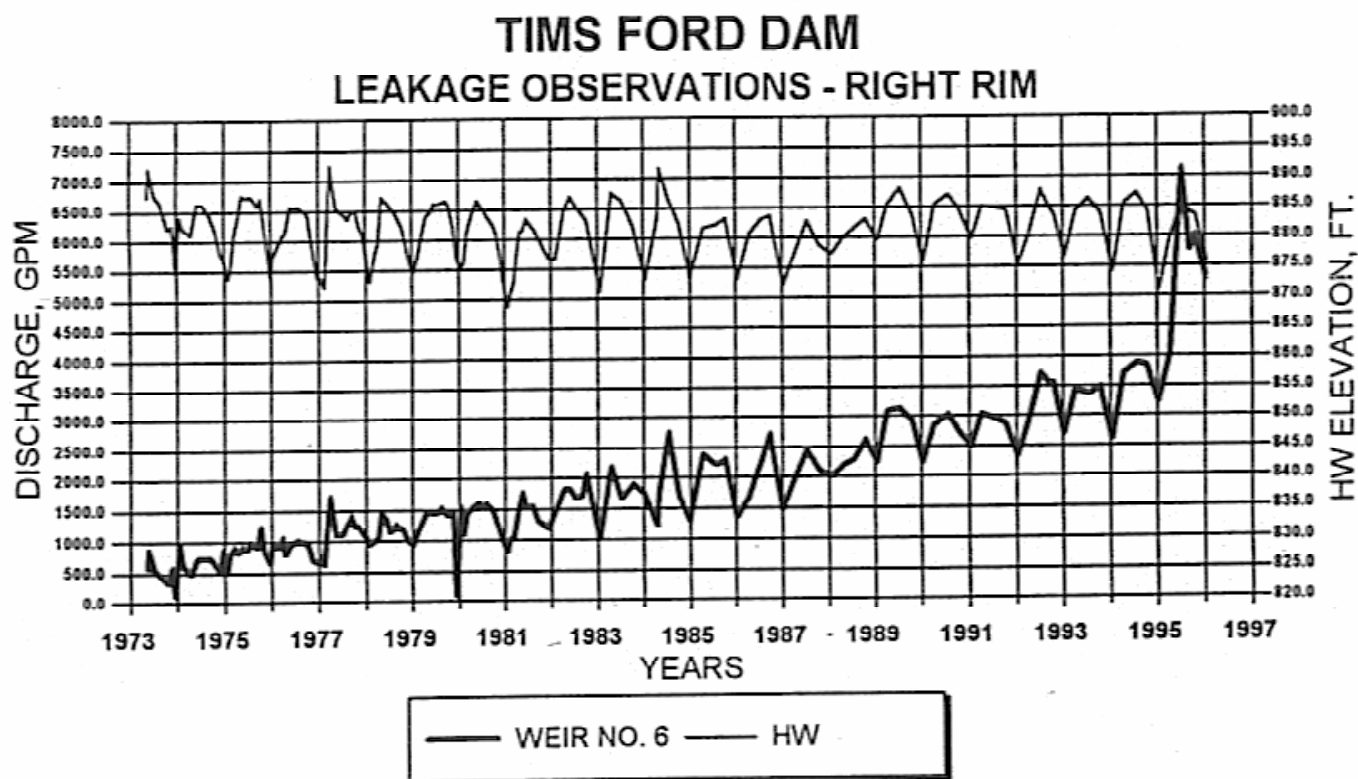
Figure 5. Discharge at Leak 6 through 1995

TVA then began a program of yearly rim inspections from the reservoir by boat, and monitoring the discharge of the leakage. Leakage increased steadily at Leak 6, reaching about 4,000 gallons per minute (gpm) at maximum pool in 1995. Later that year the rate of flow increased dramatically to just under 8,000 gpm at the same pool elevation, Figure 5. This was followed by a large washout of overburden on the hillside around Leak 6, resulting in heavy discharge of sediment from the leakage area into the unnamed tributary, and ultimately the Elk River. Inspection revealed the overburden at the elevation of discharge was saturated over a 200-foot width of the ridge.

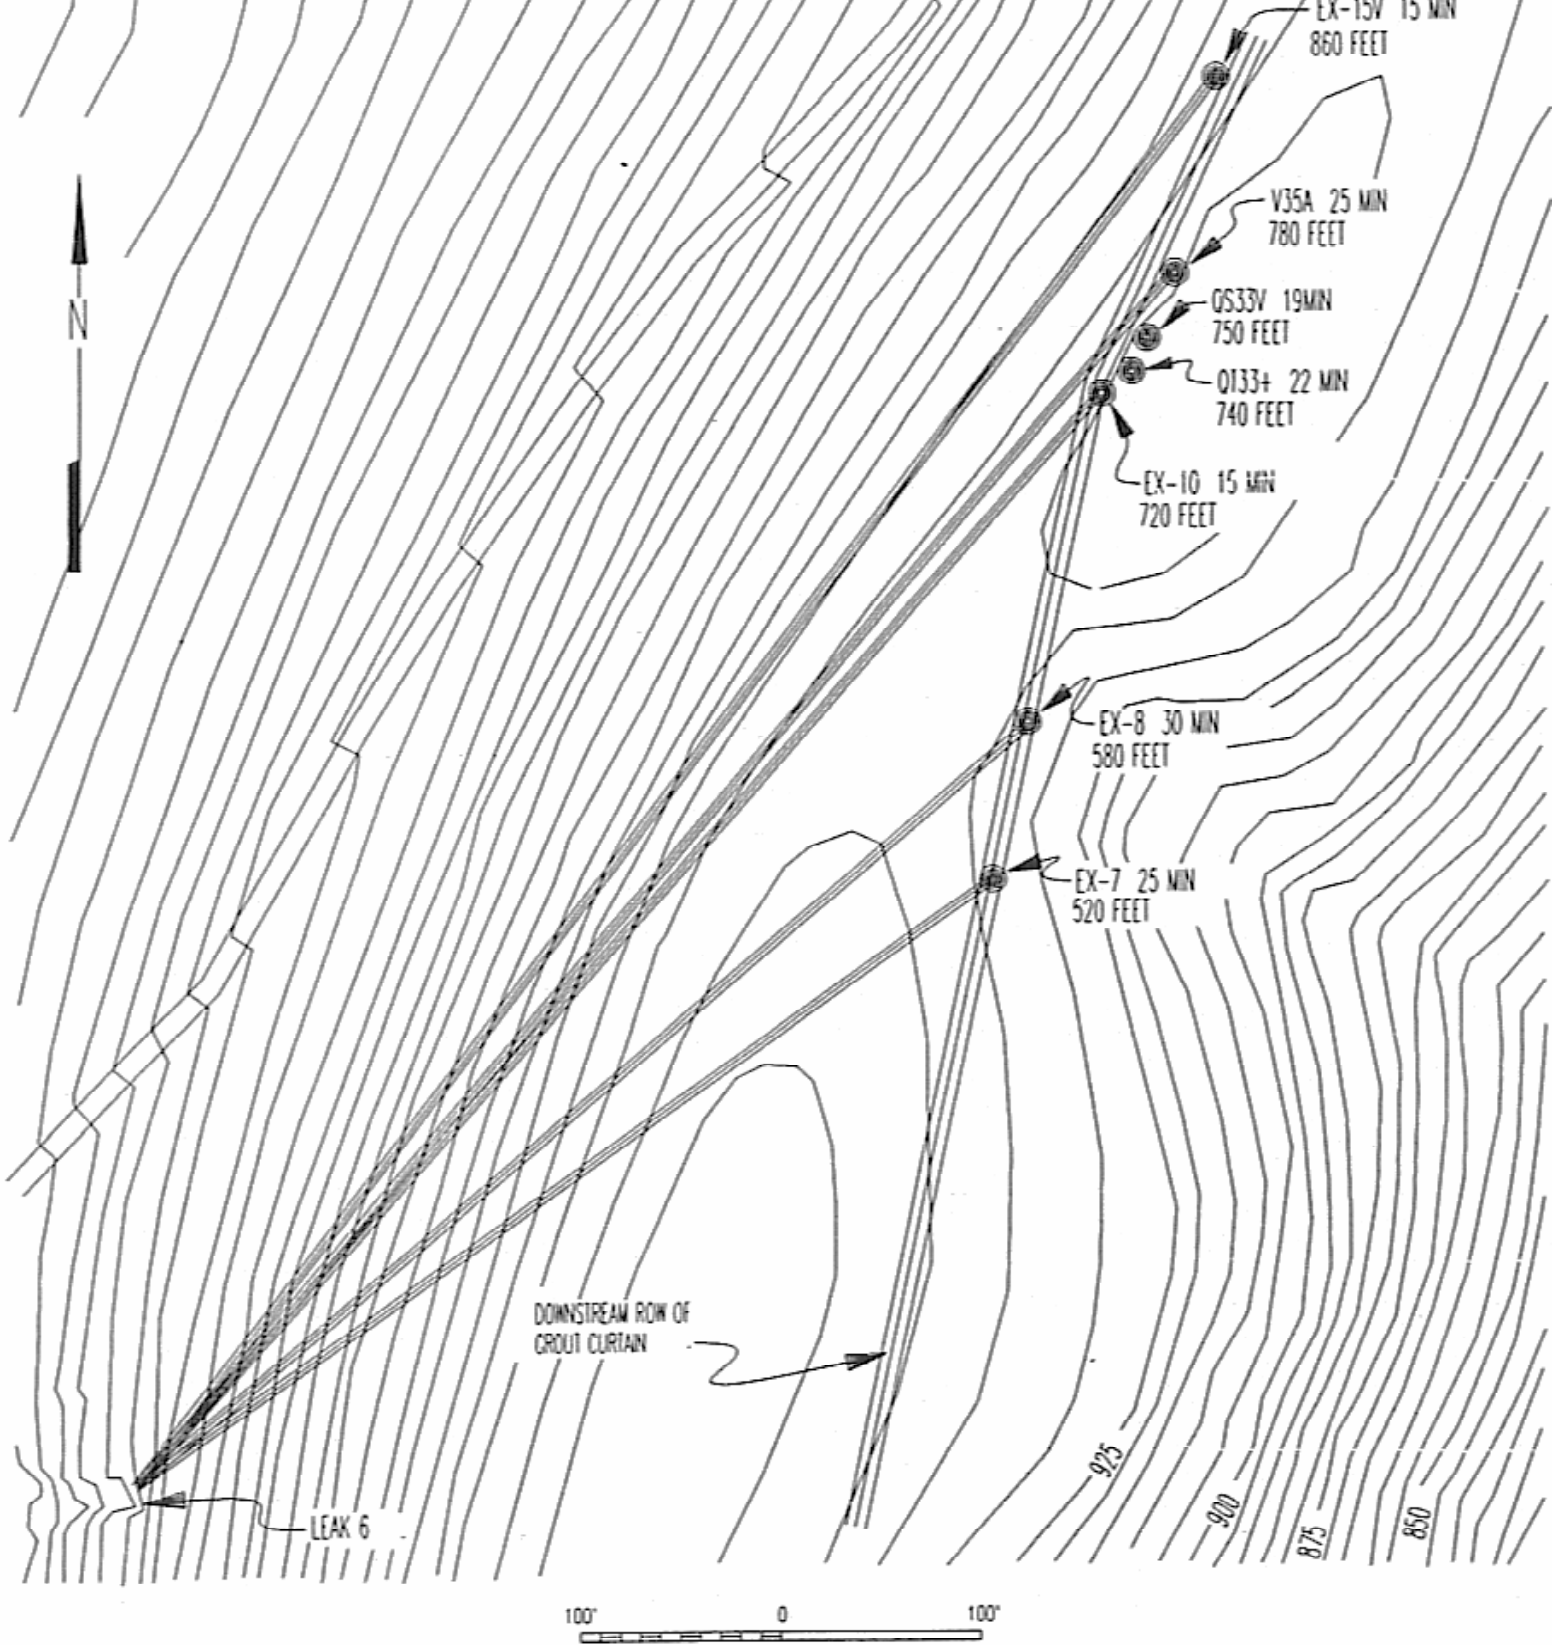
Figure 7. Tims Ford Reservoir - Plan of Flow Paths, Connection Times and Distances (Minutes and Feet)

As the contractor began the final stages of the grouting, quaternary and quinary holes were required to fully treat certain problem zones, dye tests were performed to identify connections to the leak and confirm the extent of the curtain, (Figure 7). By this time, it was apparent that flow was no longer spread out across the rim, but channeled by the grouting process to the north end of the grout curtain. The evaluation of connections, not only by dye tests, but also by observing washout of grout and turbidity in the leak, were instrumental in achieving the success that was attained under flowing conditions in the features of the karstic limestone. (The reservoir by this time was at elevations above 859 feet.)

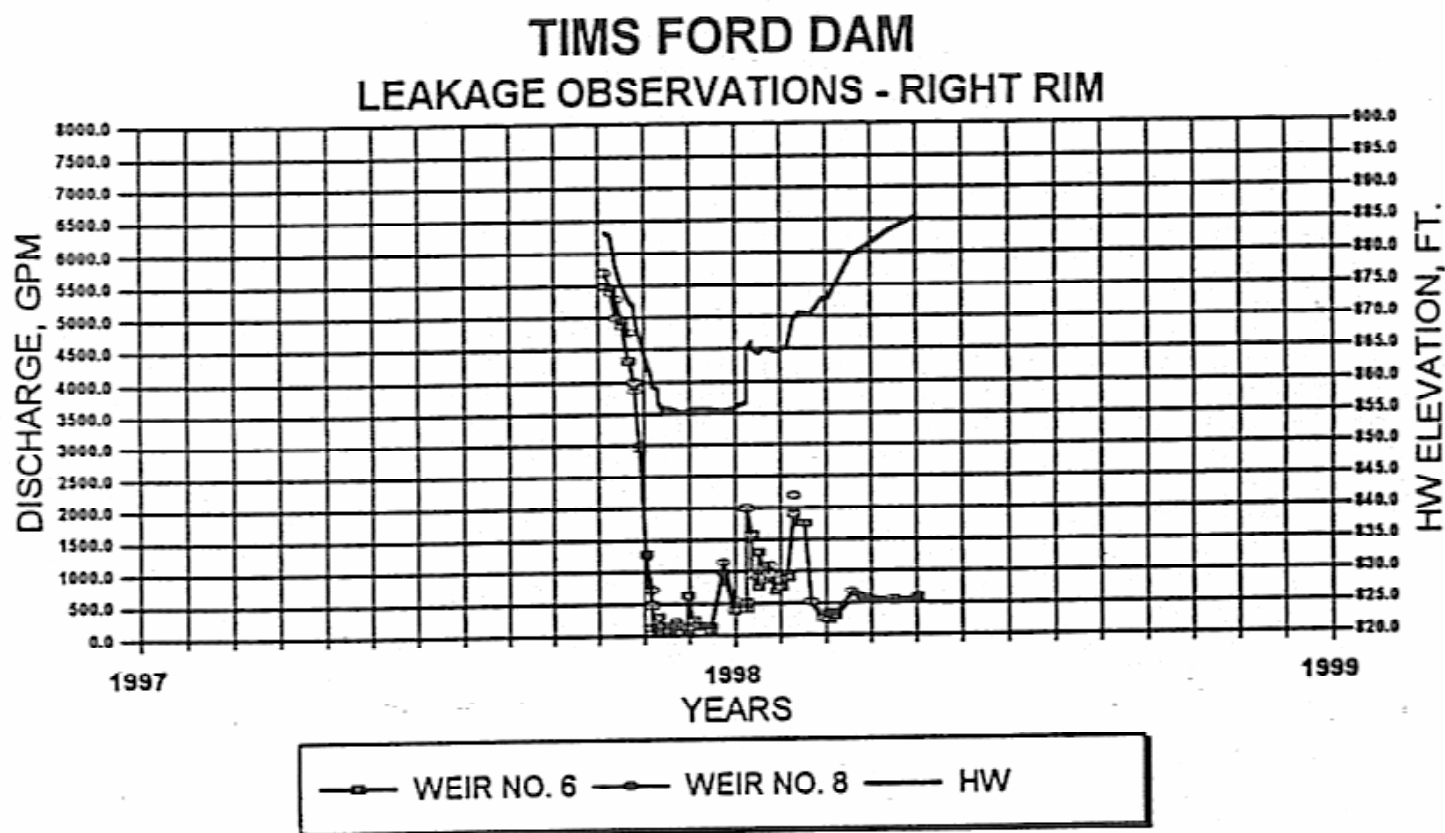
Figure 8. Discharge at Weirs 6 & 8 - October '97 through April '98

On February 16, 1998, while injecting compaction grout into a quinary hole that had a strong dye connection to the leak, leakage at the elevation 852' spring decreased from 1,075 gpm to less than 60 gpm. Groundwater at Piezometer PZ-10 dropped about 2 feet and ceased to be influenced by reservoir levels.

Monitoring during grouting included daily measurements at Weirs 6 and 8 (Figure 8) and observation of all known leaks. Also, engineers observed water surface elevations daily at piezometers installed prior to grouting (Figure 9). Groundwater measured at the piezometers was reduced about 10 feet after completion of grouting.

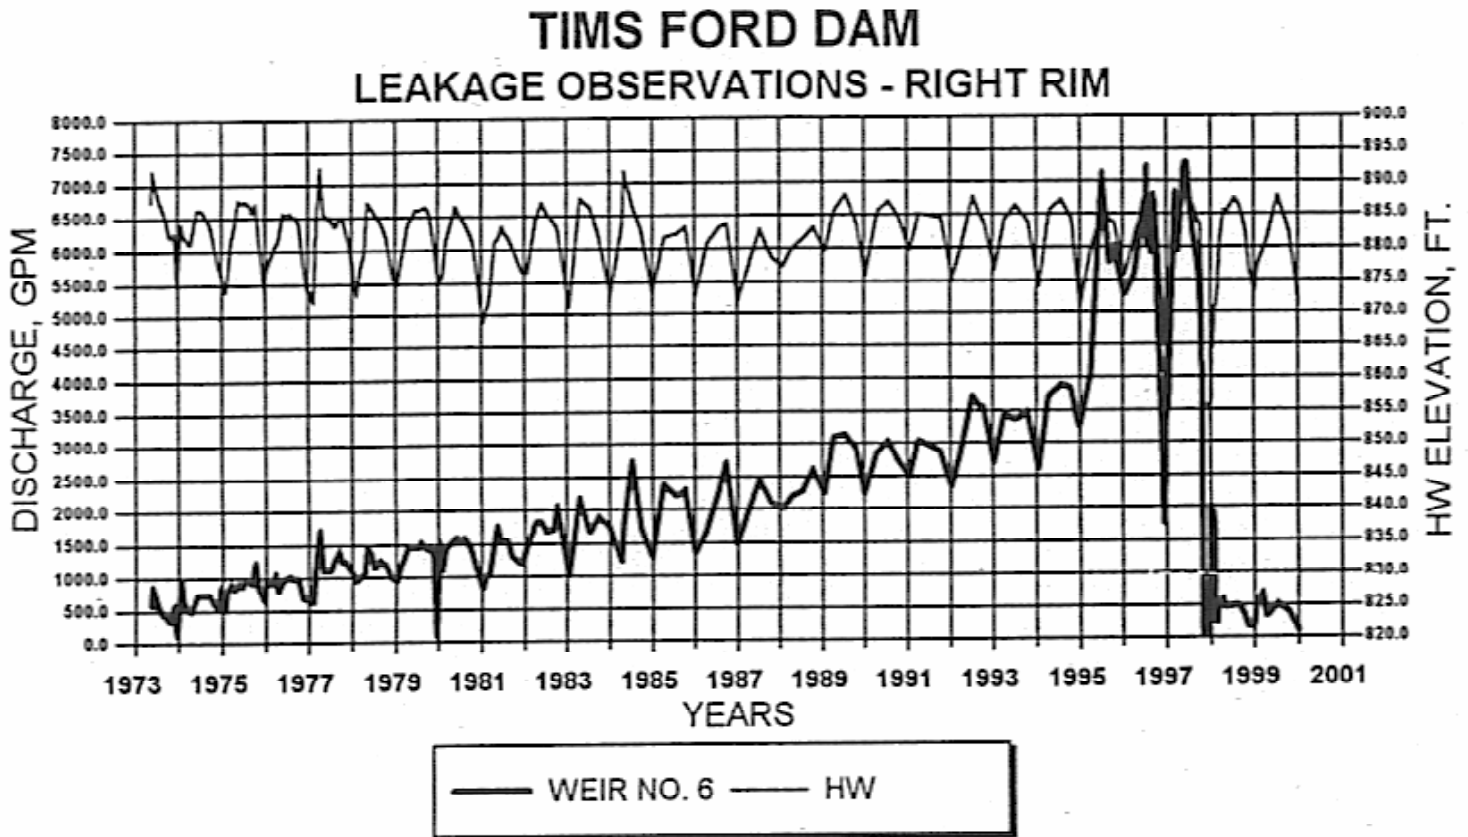
Figure 10. Tims Ford Right Rim-Current Discharge at Weir 6

Observations of the weirs and leakage are now scheduled monthly, while observations of the piezometers were discontinued, except for special observations. Overall rim leakage has been reduced from its pre-grouting maximum of 7,772 gpm to about 500 gpm at maximum normal pool levels

(Figure 10), well within the goal set for permanent reduction. Recent inspections of the rim have revealed no breakouts of new leaks, and the saturated overburden in the leak area 6 has dried completely.
