The Treatment by Jet Grouting of a Bridge Foundation on Karstic Limestone

D.A. Bruce¹, M. ASCE, S.T. Hague², and R. Hitt³

Abstract

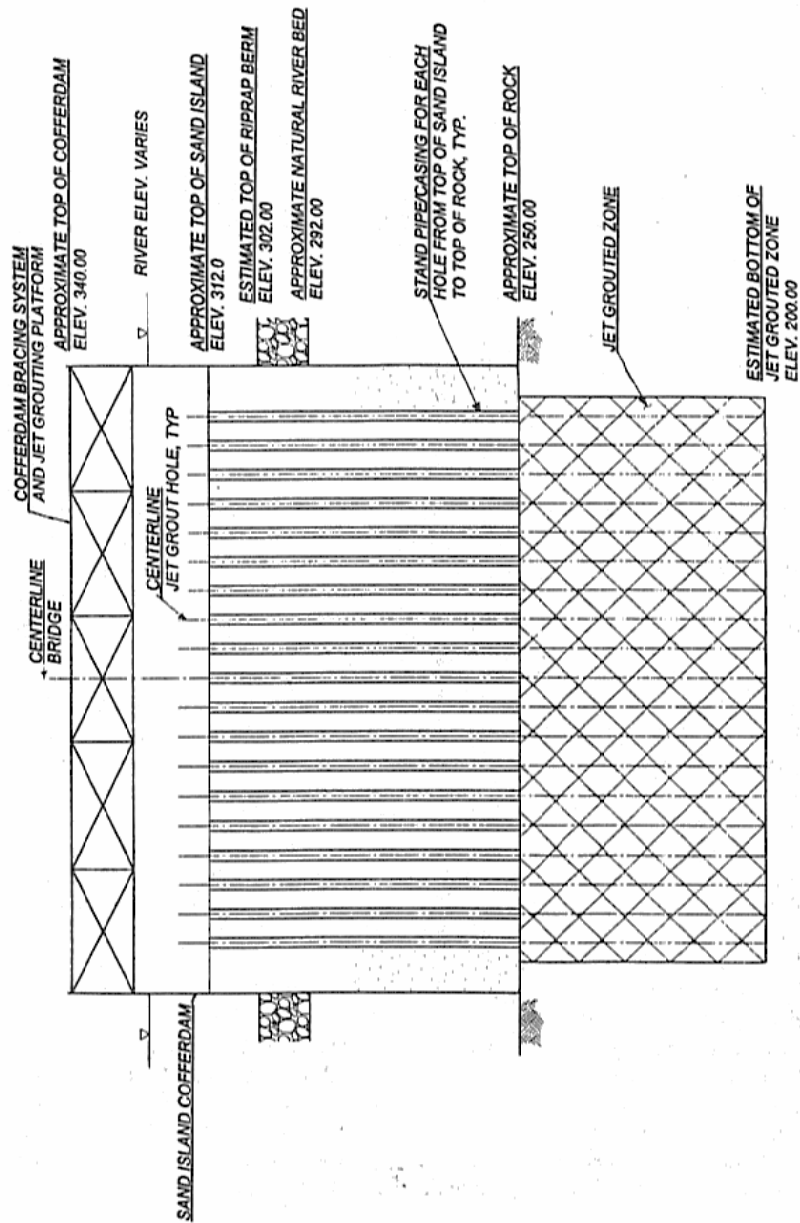
Figure 1. Elevation of treatment, from cofferdam, through water and sand island.

bearing pressure of 29 tsf (2.8 MPa), so, to provide a 25% increase to that, in the upper elevations, a treated karst strength of 500 psi (3.4 MPa) minimum was specified. These analyses, coupled with what was inferred about the vertical intensity of the solutioning dictated a maximum depth of treatment of El. 200 ft (61 m) (Figure 1).

The drilling and grouting operations were conducted from an existing platform over the cofferdam. Key elevations are shown in Figure 1. Barges were used for the other support operations, including cement storage, grout batching, grout pumping, and spoils containment.

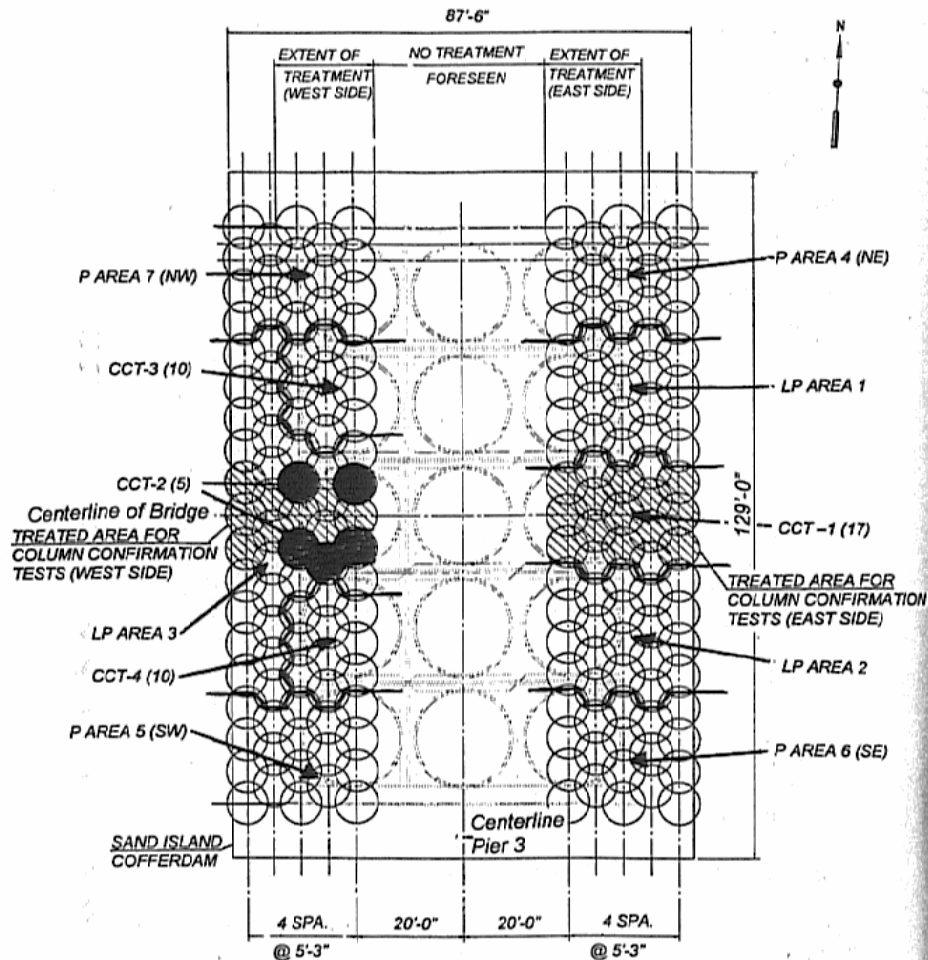
Figure 2. Conceptual grout hole layout, and CCT area locations.

Since the precise locations and extent of features in a karstic limestone are largely unpredictable, a systematic approach to treatment geometry was necessitated. A regular distribution of holes was shown on the plans as a common basis for bidders (Figure 2). However, provision was made to install

the columns in a Primary-Secondary-Tertiary sequence, with the exact locations of the higher order holes determined in the field based on progressive analysis of drilling and grouting data from the Primary holes.

HOLE	AREA*	LIMESTONE (M)	UNTREATED CLAY (M)	GROUTED MATERIAL (M)	TOTAL LENGTH (M)
P1	4	10	0	3	13
P2	4	4	0	9	13
P3	6	4	4	6	14
P4	6	3	4	6	13
P5	5	3	0	12	15
P6	5	4	0	11	15
P7	7	1	3	6	10
P7A	7	6	3	2	11
P8	7	2	3	11	16
P9	7	6	0	8	15
P10	6	6	2	7	15
Total		49	19	81	150
%		33%	13%	54%	100%

*Production area as shown in Figure 2.

- Areas around P3 and P4 were remediated by installing an adjacent additional jet grout column.
- Areas around P7 and P7A were judged unnecessary to be remediated based upon the elevation and distribution of the soft material.
- P8 was not remediated based upon some of the core loss being ascribed to chert grinding the grouted core, and also upon the elevation and distribution of the soft material.
