STABILIZATION OF RETAINING WALL ALONG TAILRACE CHANNEL OF HODENPYL DAM

ABSTRACT

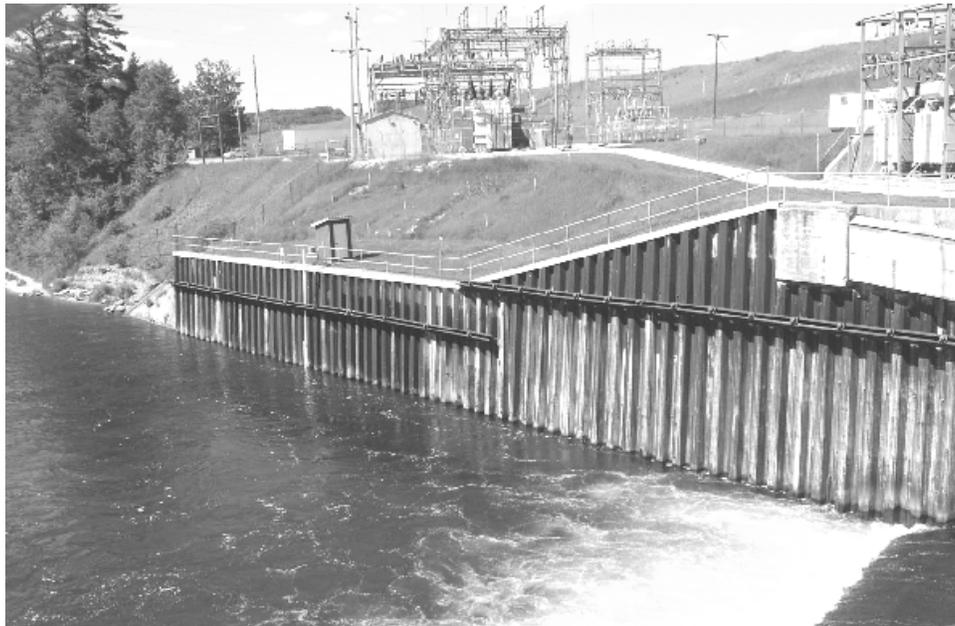
FIG. 1. View of the tailrace channel and east retaining wall. Note the existing tiebacks installed in 1996. The sheetpiles were also added in 1996 as a facing and do not penetrate below the footing

The east wall was first repaired in 1996. The wall had undergone visible lateral displacements. A repair attempt was carried out using conventional strand tiebacks. Subsequent monitoring of the wall revealed that lateral displacement of the wall continued to develop, and that additional stabilization measures were required.

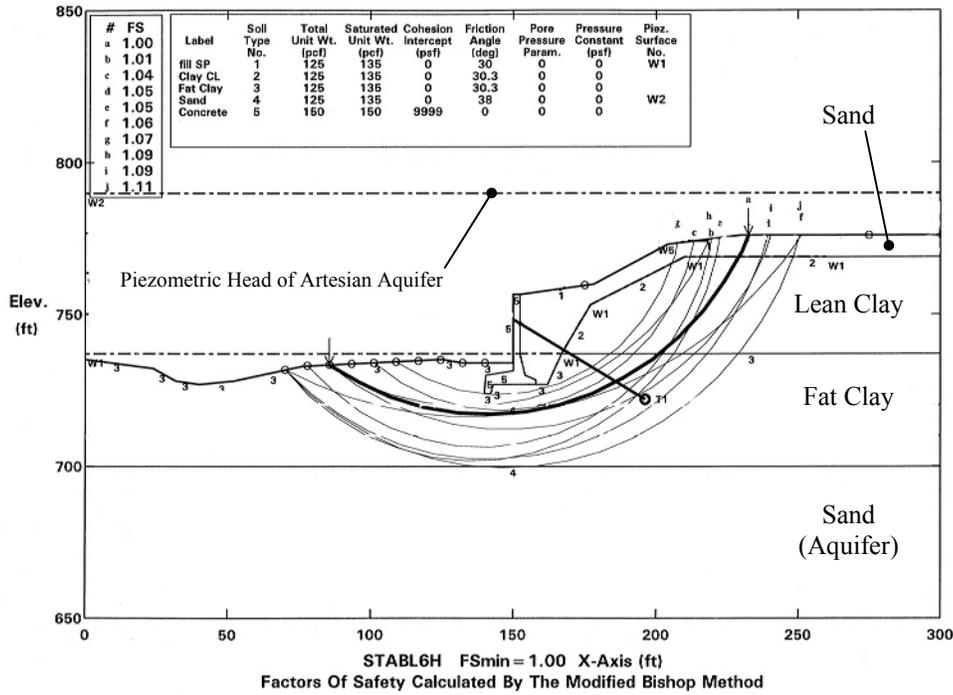
FIG. 2. Typical Section through East Tailrace Wall looking Downstream. Preliminary Stability Analyses Results are shown.

Circular slip surfaces were analyzed in terms of effective stresses using the Bishop's modified procedure in the program PCSTABL. The analyses suggested that the critical slip surface passed below the wall footing and intercepted the bond zone of the existing tiebacks, as illustrated in Figure 2. A factor of safety of one against

circular failure was obtained for a residual friction angle of 30 to 31 degrees, which were the lowest expected values according to the laboratory test results.

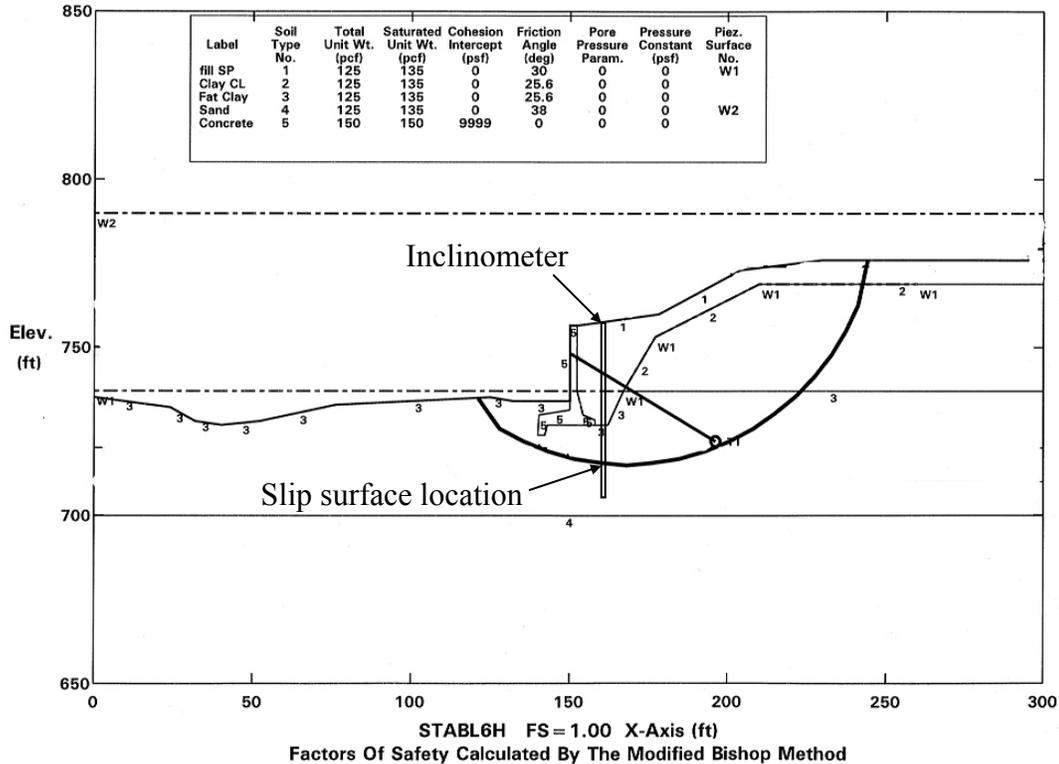
The stability of the wall was re-analyzed considering the surveying data and the location of the slip surface revealed by the inclinometers, as illustrated in Figure 3. These analyses were performed for final design of the remediation solution. The procedure followed consisted of establishing slip surfaces and back calculating the strength parameters of the clay to obtain a factor of safety of one. The shape and location of the slip surfaces was estimated based, primarily, on the inclinometer data.

Two mechanisms of sliding were analyzed. A circular slip surface using Bishop's modified method was first considered as illustrated in Figure 3. In the figure it can be observed that the circular slip surface daylighted behind the crest of the slope. This condition was not confirmed by field observations, which indicated that most of the surface movement appeared to occur on the slope itself. Therefore, composite or block slide mechanisms were also analyzed using the modified Janbu method, where the extent of the block behind the wall was limited to match field observations. The composite slide mechanism is not represented in the figure. Further details on stability analysis techniques can be found in Duncan (1996).

FIG. 3. Results of Back Analysis of the East Tailrace Wall.

Although the existing tiebacks were included in the analyses, their contribution to stability was negligible as the sliding mass typically encompassed them entirely.

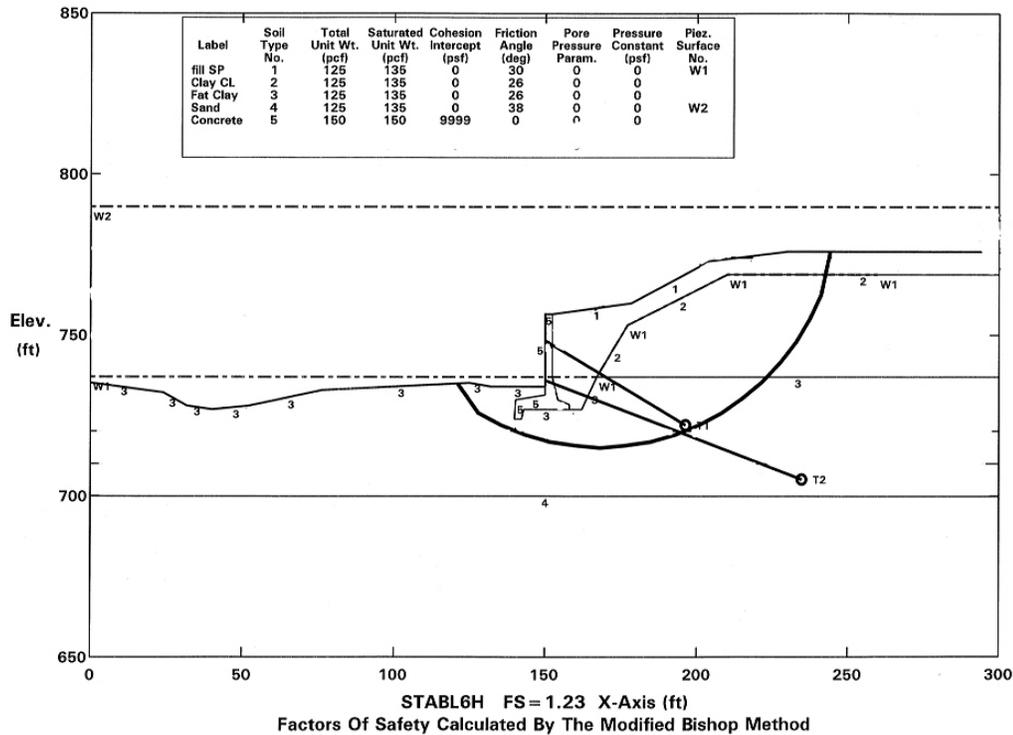
Figure 4 illustrates the results of one of the stability analyses performed to establish the remediation requirements. Analyses were performed using the same slip surfaces and procedures used for the back analyses described in the previous section. For clarity, only the circular slip surface is represented in the figure. The analyses were performed using the corresponding soil properties listed in Table 2.

FIG. 4. Stability Analysis of the East Tailrace Wall for Remediation Design.

After consultation with the Owner, the target factor of safety was established at 1.2 to 1.25. Such a factor of safety could be achieved using one row of tiebacks with reasonably attainable capacity requirements. At that time, it was important to provide additional and immediate support for the wall rather than designing a final remediation solution, which would have required the acquisition and analysis of more monitoring data for a longer period, and installation of additional instrumentation. A well-defined monitoring/action plan after construction was established in order to assess the effectiveness of the remediation. The plan included threshold displacement values for performing further analyses and development of additional remedial measures if necessary.

The tiebacks forces required for the desired factor of safety were thus determined for the different slip mechanisms and types of analyses. The tiebacks would be installed at an inclination of 20 degrees from horizontal. The free length was established at approximately 15 m (50 ft). A maximum bond length of 12 m (40 ft) was required to avoid penetration into the aquifer. The tiebacks would have a minimum capacity of 600 kN (135 kip), and would be installed at a center-to-center spacing of 1.8 m (6 ft).

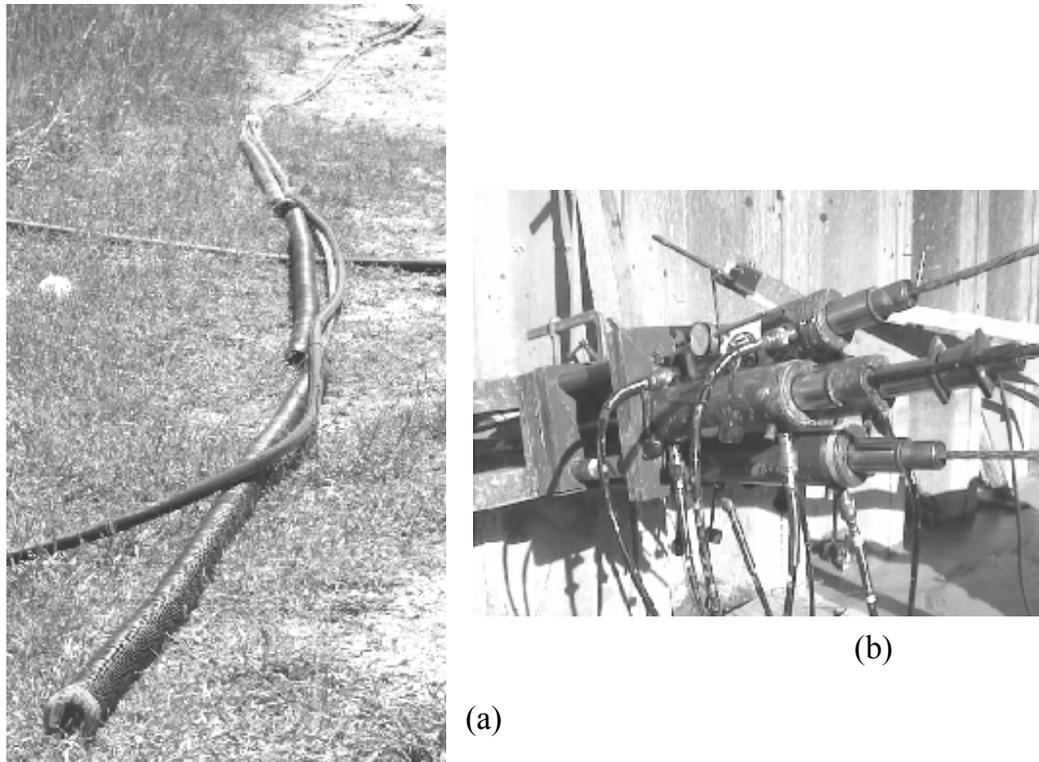
FIG. 5. (a) String of SBMA units almost ready for installation; (b) Performance testing of a production SBMA. Note the multiple jacks for stressing of each strand.

The SBMA technology was developed to reduce these limitations. In this system, the bond length comprises a set of shorter and staggered individual unit anchors, each of which is fitted with one or more strands and is tensioned using an independent jack (see Figure 5). A more detailed description of the SBMA system is presented in a companion paper by Bruce et al. (2004).

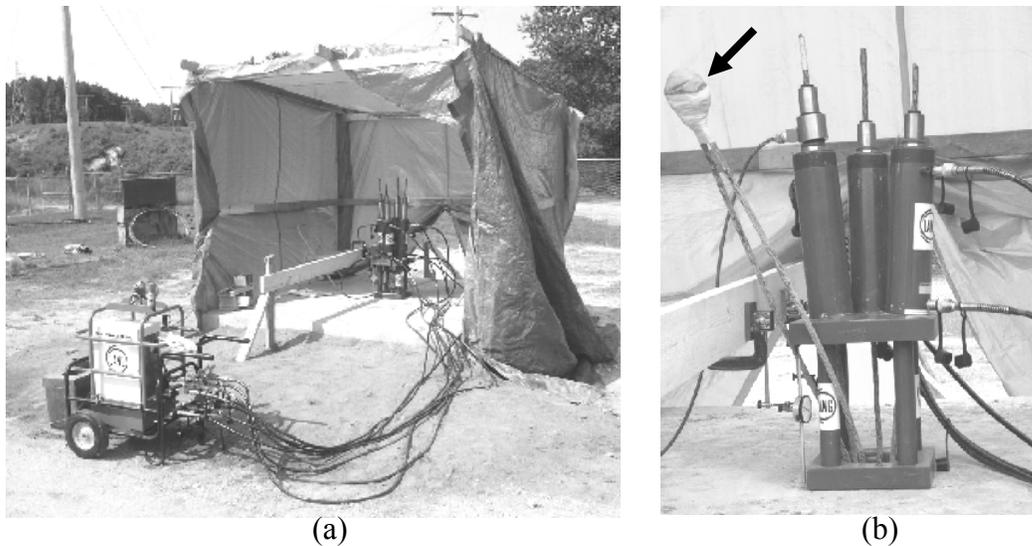
FIG. 6. (a) View of the setup for sacrificial anchor testing; (b) Detail of the stressing arrangement. Note the two additional strands not engaged during the first portion of the test.

A sacrificial test anchor was installed and tested before the start of construction to verify the capacity and response of the proposed SBMA design (see Figure 6). Due to space restrictions, the sacrificial anchor was located on the embankment above the wall and was installed in a vertical position. To prevent drilling into the aquifer, a shorter bond length consisting of three 10-ft bond units was used for the sacrificial anchor. Two strands were used for each of the upper two units. This modification with respect to the production design was introduced for research purposes in order to attempt to induce bond failure of the upper bond units during a secondary test phase.

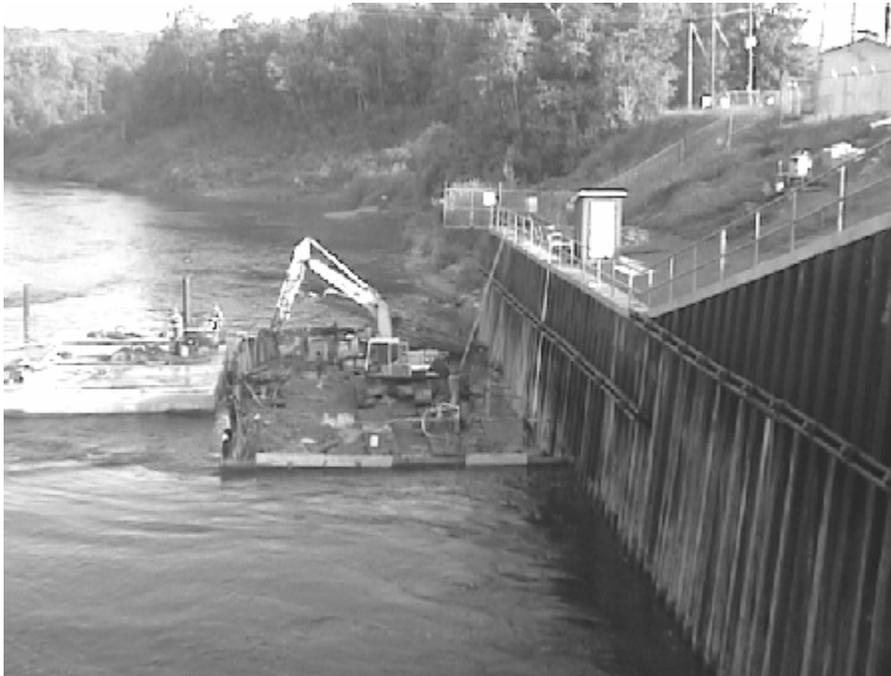
FIG. 7. View of the site during installation of the SBMA elements. a sheet piling cofferdam provided a dry working area below the tailrace water level. Note service barge on the left.

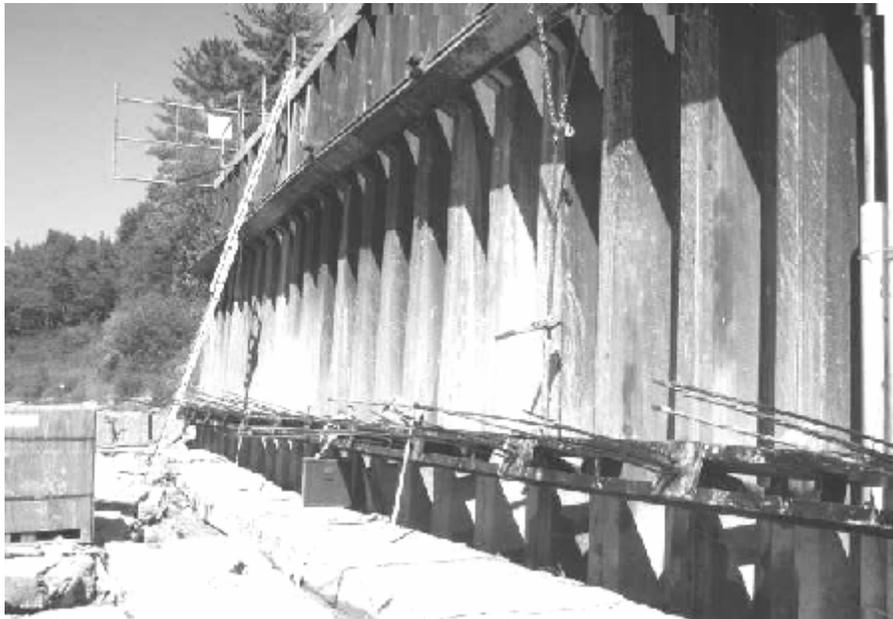
FIG. 8. View of the wall at near completion of the installation of the SBMA elements near the bottom of the wall. The strands are to be saw-cut and covered. The old tieback installation is visible near top of photo.

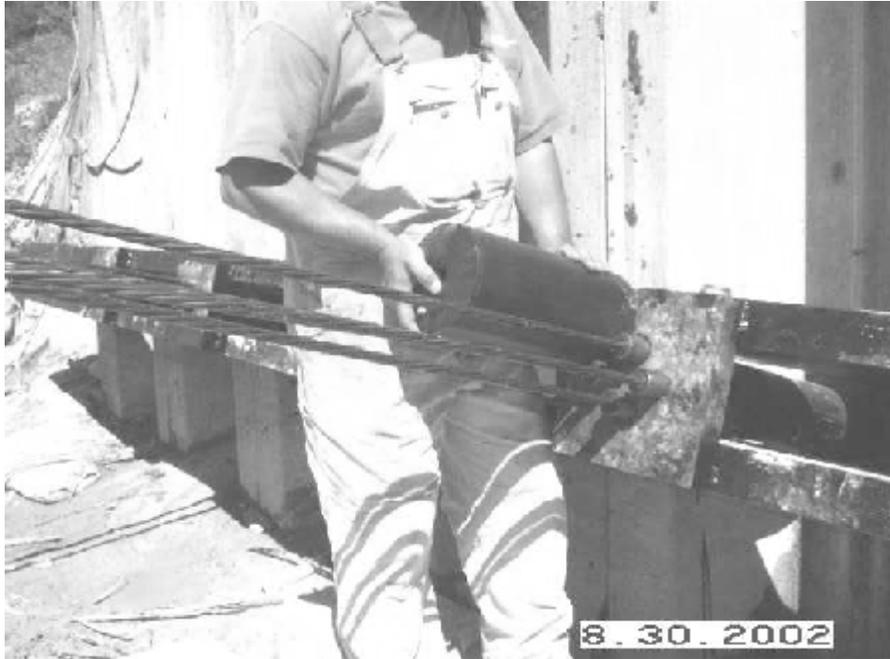
FIG. 9. Detail showing the anchorage elements. The strands are about to be cut and covered with the grease-filled housing.

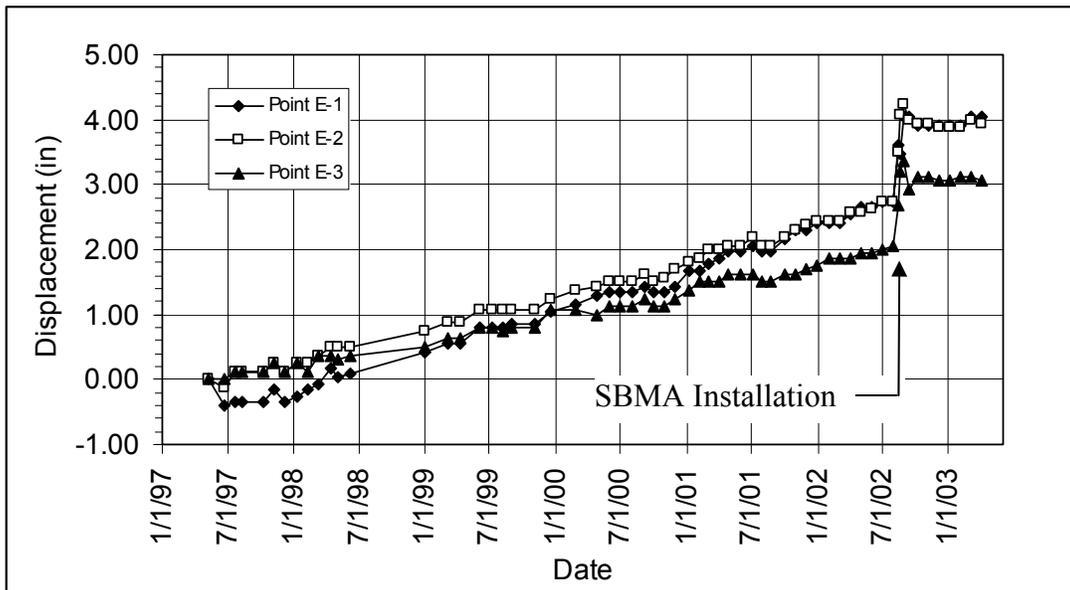
Figure 10 summarizes the survey data at selected locations along the wall. It is seen that displacements of the wall were steadily increasing before remediation. After a temporary and expected disturbance during installation of the tiebacks, the rate of movement decreased significantly.

The inclinometer data shows a similar trend. However, at the time this paper was written, some displacement at the slip surface continued to occur at a reduced rate. It is believed that this movement is due to redistribution of stresses within the clay mass.

FIG. 10. Relative Displacement of the East Tailrace Wall (Values measured along the Cap of the Downstream End of the Wall).
