CONSTRUCTION OF PERMANENT INTRUDED PLUGS AT SOUTH DEEP GOLD MINE

Dr. D.A. Bruce, International Review Panel, M. F. Wells, Cementation Mining Skanska, and J. Venter, SRK Consulting

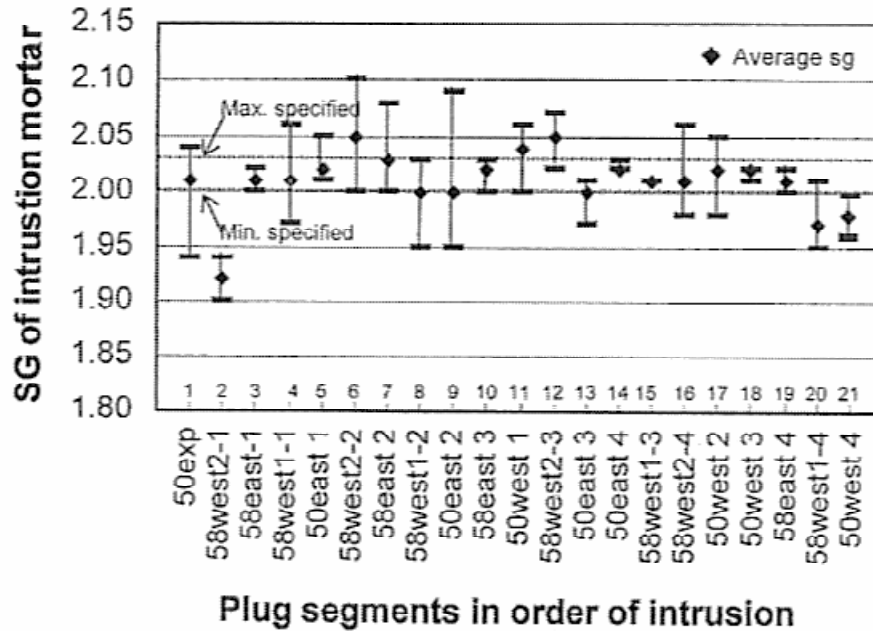
Figure 1. Salter SG Values in Order of Segment Intrusion

The compliance of the constituent mortar materials to the Method Statement was confirmed. For the fluid mortar, Figure 1 shows the specific gravity readings (by Salter Scale) for each segment. Although three segments recorded values below the specified range, other key properties, specifically bleed and strength, were acceptable. The individual computer records generated during batching confirmed compliant water/cement ratios and sand/cement ratios.

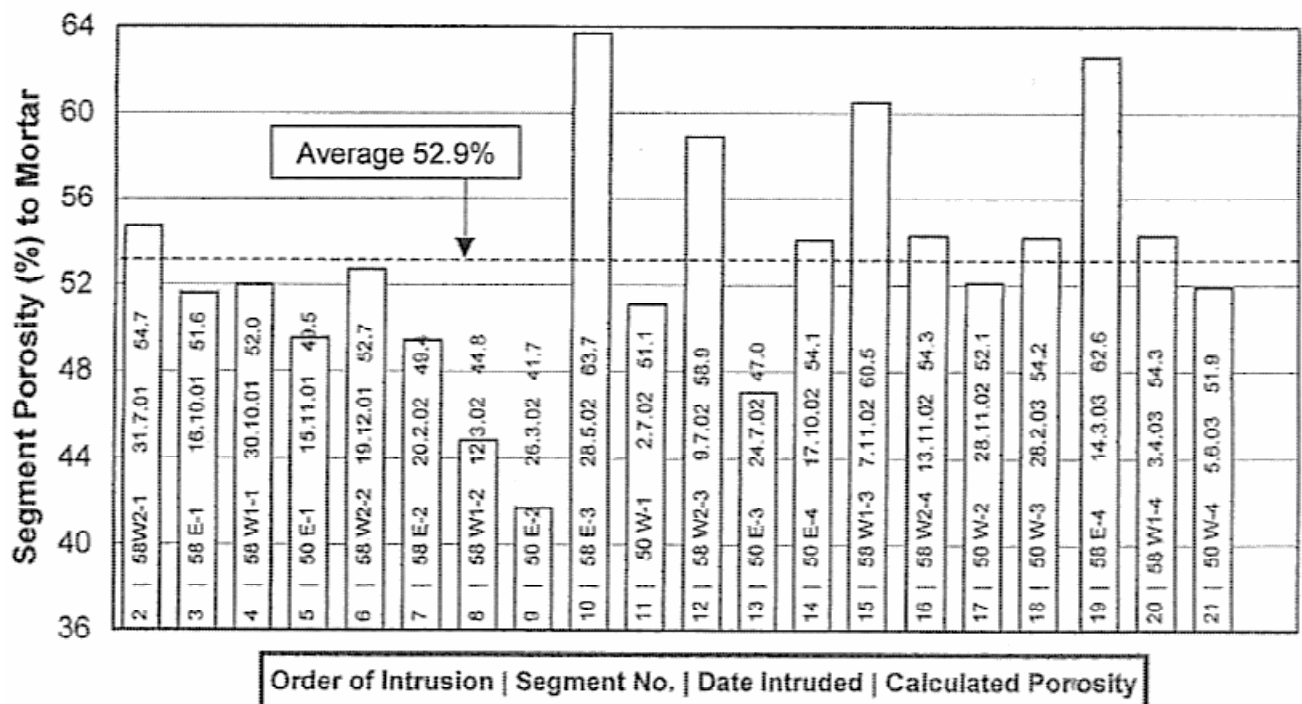
Figure 2. Details of Plug Porosities by Order of Segment Intrusion (excluding Experimental Plug).

Figure 2 shows the apparent variation in segment porosity to mortar. The average of 52.9% compares closely with the 52.4% figure calculated from 210 liter drum injections, and the 51.3% obtained in the Experimental Plug. Significant variations from the average (e.g., as low as 41.7% and as high as 63.7%) were considered due to variations in the plum size gradations and/or in inherent inaccuracies in the calculation of the segment volumes prior to placing the plums.

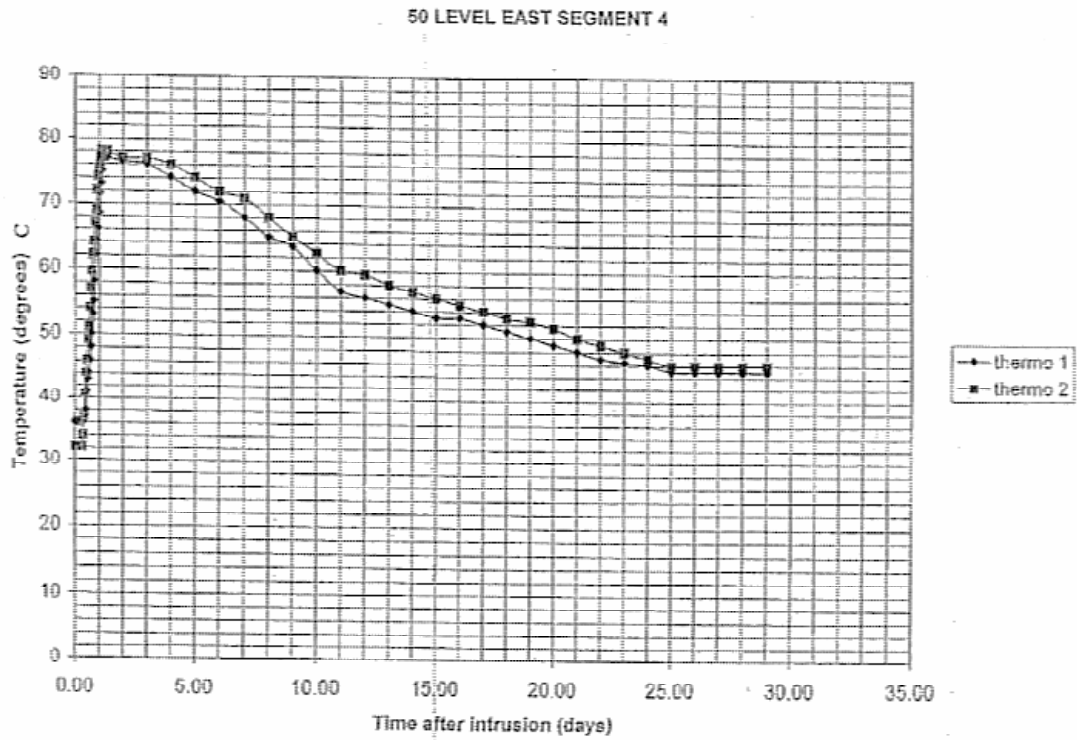
Figure 3. Temperature after intrusion.

For all segments, the typical profile was a very rapid temperature rise peaking typically 1 to 4 days after intrusion (e.g., Figure 3), although some segments took several days longer to reach maximum temperature. Initial temperatures within the aggregate ranged from 25 to 39°C, being consistently higher in the level 58 plugs (33 to 39°C). Peaks of 60 to 82°C indicate a range of temperature rises from 30 to 50°C, average 40°C. Readings between each pair of thermocouples in each segment were generally in good accordance, with only 3 examples of a significant difference (up to 11°C) in the amount of temperature rise measured by each pair. Such discrepancies most probably reflect instrument malfunction. For comparison, the average increase as measured by thermocouples 1 and 2, was 39.3° and 40.5° respectively.

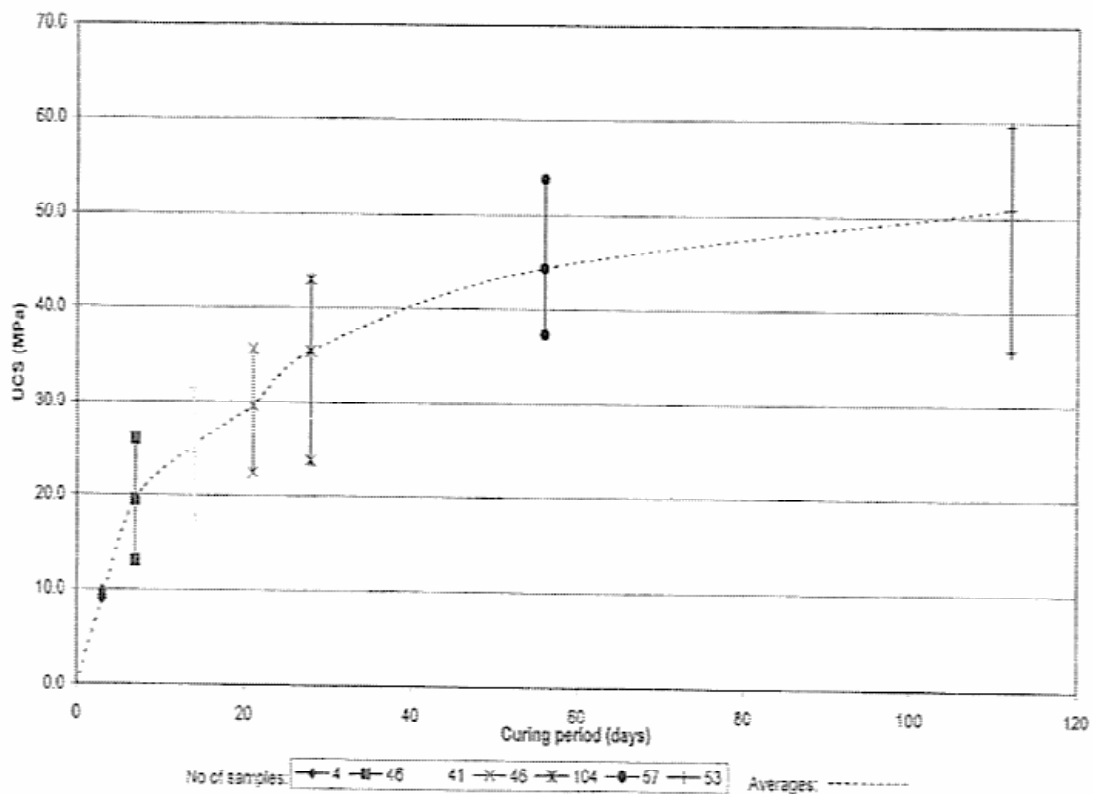
Figure 4. Range and average of mortar cube strengths based on individual segment averages.

Overall, the mortar cube strength development with time can be summarized as shown in Figure 4. The key acceptance criterion – a minimum of 25MPa at 28 days – was met, on average by every segment of every plug, the overall average being 35.6MPa. The average figures are based on the testing of at least three cube samples.
