# ANCHOR FIELD TESTS IN CARBONIFEROUS STRATA

## Essais en place d'ancrage dans un sédiment carbonifère

The paper discusses the preliminary findings of full scale tests on 57 anchors installed in carboniferous sediments. The site geology is briefly described together with the anchor construction and testing methods adopted. To investigate the influence of anchor geometry on failure mode, anchors ranging in overall depth from 0.75 to 12 metres were tested with grouted fixed anchor lengths of 0.75 to 6 metres. The observed effects of depth of embedment, grout surcharge, tendon configuration, interstrand spacing and tendon density on anchor performance are discussed in relation to current practice. Measurements of interfacial bond and load transmission are presented.

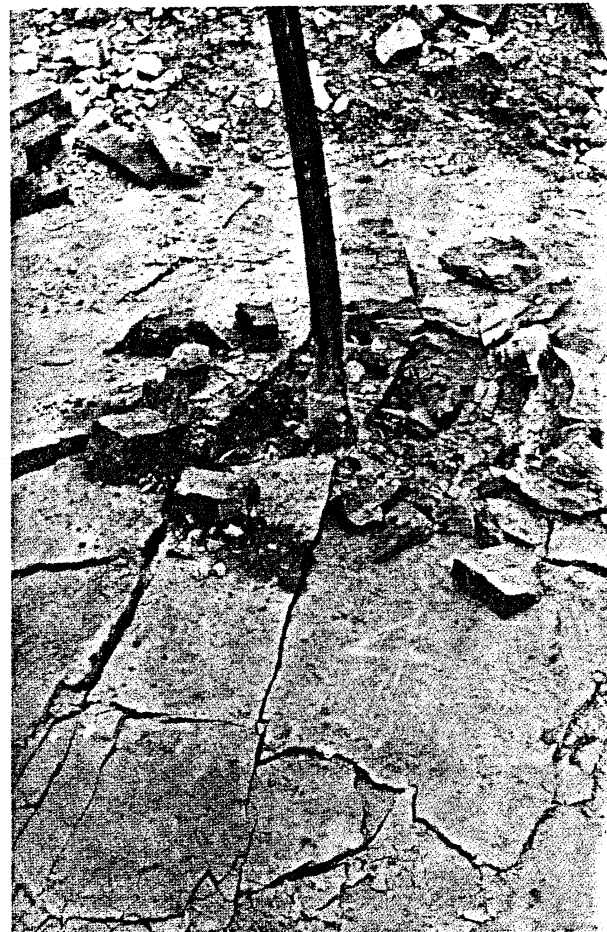
Fig. 2. — Failure volume induced at anchor 4, showing the control of the dominant NW-SE joints.

Up to embedment depths of 1.5 m, failure occurred mainly in the rock mass. For greater depths failure tended to be localised at one of the grout interfaces. For rock mass failure, the shape of the rock volume mobilised in each case was strongly controlled by the incipient rock mass structure (fig. 2).

For example, the major radial fractures developed along the trends of the major joint directions, whilst the projected shape of the rock volume mobilised below the surface was strongly influenced by the laminar nature of the mass. Under similar conditions, underreamed anchors sustained higher loads than their straight shaft counterparts. Underreaming was carried out with a UAC patented tool to form pairs of «bells» of 230 mm diameter and whilst a greater extent of rock was mobilised, the pattern of surface fracturing was not radically different.

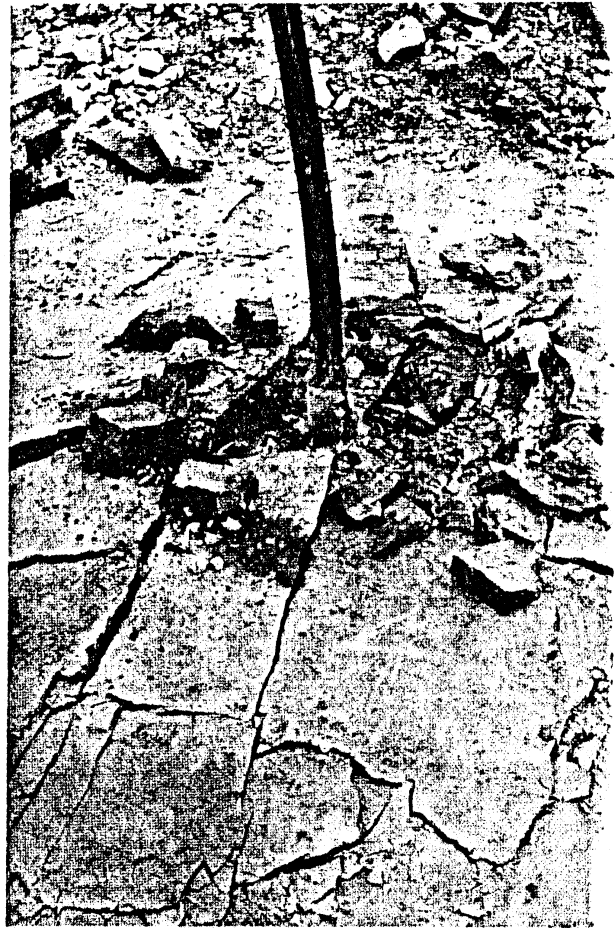
Fig. 2. — Failure volume induced at anchor 4, showing the control of the dominant NW-SE joints.

Up to embedment depths of 1.5 m, failure occurred mainly in the rock mass. For greater depths failure tended to be localised at one of the grout interfaces. For rock mass failure, the shape of the rock volume mobilised in each case was strongly controlled by the incipient rock mass structure (fig. 2).

For example, the major radial fractures developed along the trends of the major joint directions, whilst the projected shape of the rock volume mobilised below the surface was strongly influenced by the laminar nature of the mass. Under similar conditions, underreamed anchors sustained higher loads than their straight shaft counterparts. Underreaming was carried out with a UAC patented tool to form pairs of «bells» of 230 mm diameter and whilst a greater extent of rock was mobilised, the pattern of surface fracturing was not radically different.
