GROUND ENGINEERING

Enhancing the performance of large diameter piles by grouting ... 1

by D.A. BRUCE⁵, BSc, PhD, CEng, MICE, MIWES, MASCE, MHKIE, FGS

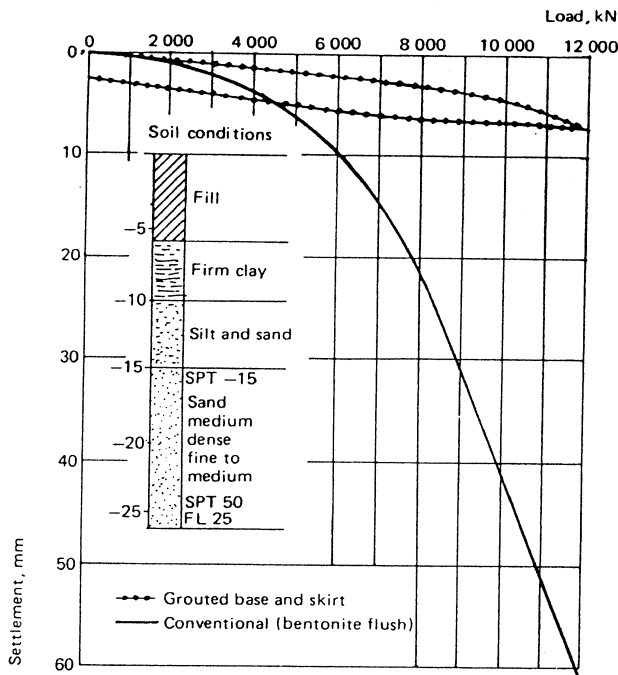
Fig. 7 (above). Comparative performance of two 1500mm diameter bored piles, on the same site, one grouted, one conventional (Sliwinski & Fleming, 1984)

experimentation "some years ago" (Fig. 6). The same authors also quoted results from "a company working in the Middle East" (Fig. 7) featuring systems designed to incorporate improvement in shaft friction as well. However, on this particular topic, the most comprehensive and quantitative contribution appears to have been made by Stocker (1983).

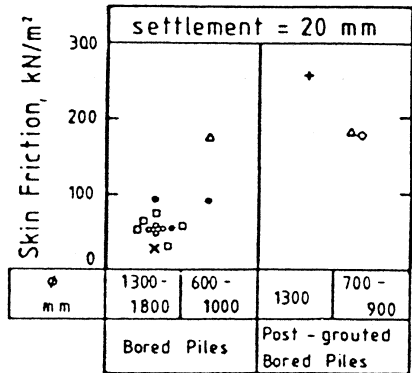
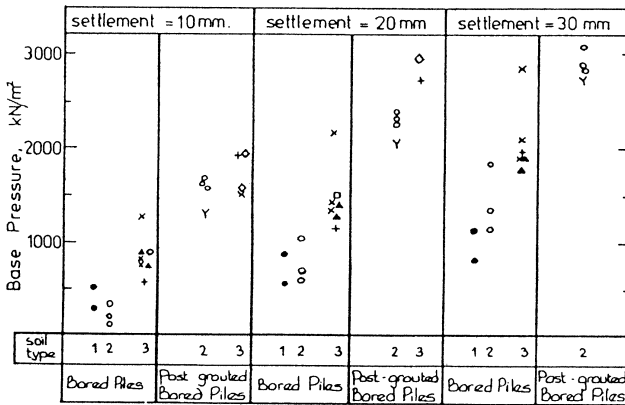
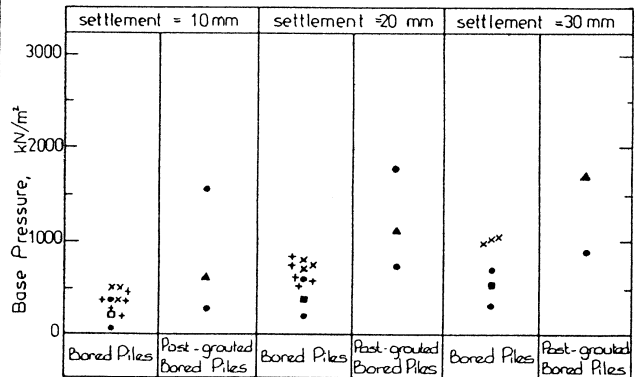
Fig. 13 (right). Skin friction of cast-in-situ bored piles with and without post-grouting at a settlement of 20mm in cohesive soils (Stocker, 1983)

Fig. 14 (below, left). Base pressure of bored piles with and without post-grouting in non-cohesive soil at settlements of 10, 20 and 30mm (Soil type: 1 = sand, medium density, 2 = sand, high density, 3 = gravel, medium to high density) (Stocker, 1983)

Fig. 15 (below, right). Base pressure of bored piles with and without post-grouting in cohesive soils at settlements of 10, 20 and 30mm (Stocker, 1983)

Fig. 14. Although theoretical studies (Meissner, 1982) have shown a clear relationship between end-bearing capacity

Fig. 15. These data are for piles from 620 to 1800mm in diameter. From limited results it would appear that post-grouting increases the bearing capacity significantly (but less than in non cohesive soils) within the range of working loads considered.
