LOCKING INTO SUCCESS

Taking lessons from a 30-year-old failure, designers used hundreds of prestressed rock anchors and help from an extensive instrumentation system to incorporate an existing navigation lock into the cofferdam for a new lock and a 50% cost savings. The navigation lock on the Monongahela River in southwest Pennsylvania began operating last December.

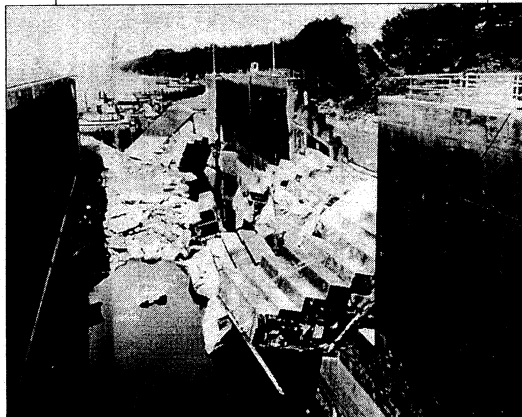
IN 1961, WORKERS TRIED TO INCORPORATE AN EXISTING LOCK WALL INTO A NEW COFFERDAM. A MAJOR PORTION OF THE LAND WALL SLID INTO DEWATERED EXCAVATION KILLING SEVERAL PEOPLE.

In 1961, at Wheeler Lock in Alabama, the Tennessee Valley Authority tried to incorporate an existing lock wall into a new cofferdam. A major portion of the land wall slid about 30 ft into the dewatered excavation being used to construct the adjoining lock, killing several people. Reportedly, sliding occurred on an undetected weak clay seam in the foundation rock. No stabilization measures or instrumentation systems had been implemented.
