Construction of permanent intruded plugs at South Deep Gold Mine

by D.A. Bruce*, M.F. Wells†, and J. Venter‡

Synopsis

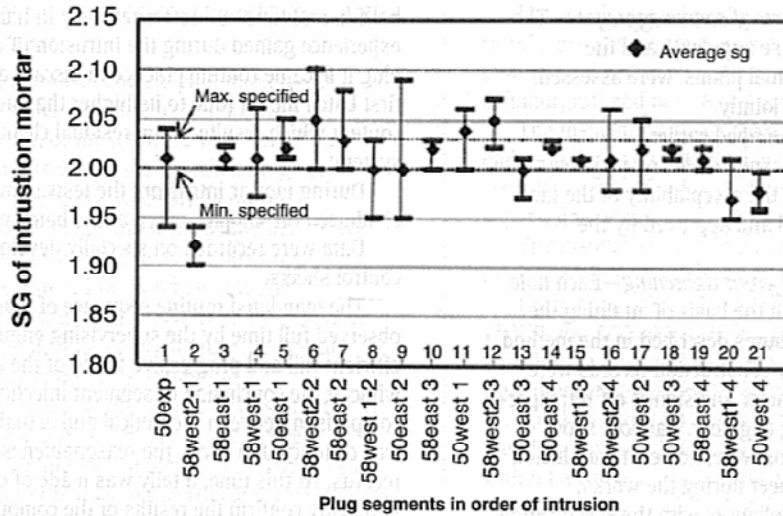
Figure 1—Salter SG values in order of segment intrusion

The compliance of the constituent mortar materials to the method statement was confirmed. For the fluid mortar, Figure 1, shows the specific gravity readings (by Salter Scale) for each segment. Although three segments recorded values below the specified range, other key properties, specifically bleed and strength, were acceptable. The individual computer records generated during batching confirmed compliant water/cement ratios and sand/cement ratios.

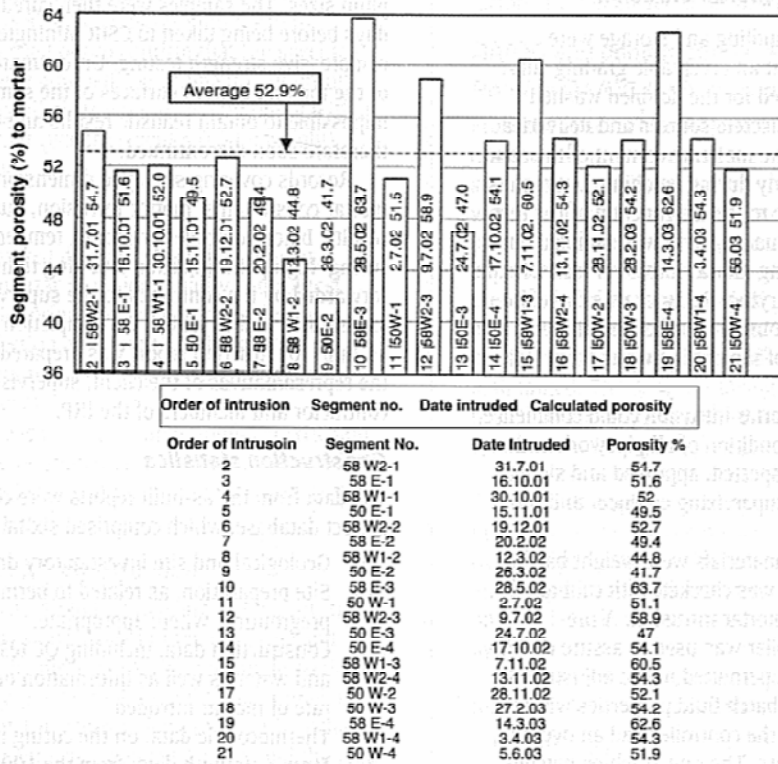
Figure 2. Details of plug porosities by order of segment intrusion (excluding experimental plug)

Figure 2 shows the apparent variation in segment porosity to mortar. The average of 52.9% compares closely with the 52.4% figure calculated from 210 litre drum injections, and the 51.3% obtained in the experimental plug. Significant variations from the average (e.g., as low as 41.7% and as high as 63.7%) were considered due to variations in the plum size gradations and/or in inherent inaccuracies in the calculation of the segment volumes prior to placing the plums.

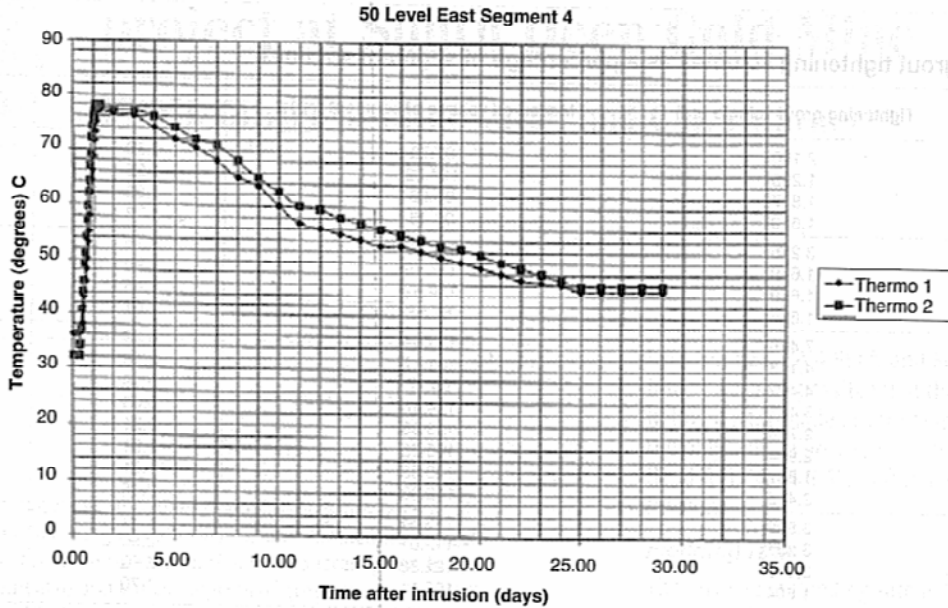
Figure 3—Temperature after Intrusion

For all segments, the typical profile was a very rapid temperature rise peaking typically 1 to 4 days after intrusion (e.g., Figure 3), although some segments took several days longer to reach maximum temperature. Initial temperatures within the aggregate ranged from 25 to 39°C, being consistently higher in the Level 58 plugs (33 to 39°C). Peaks of 60 to 82°C indicate a range of temperature rises from 30 to 50°C, average 40°C. Readings between each pair of thermocouples

in each segment were generally in good accordance, with only 3 examples of a significant difference (up to 11°C) in the amount of temperature rise measured by each pair. Such discrepancies most probably reflect instrument malfunction. For comparison, the average increase as measured by thermocouples 1 and 2, was 39.3° and 40.5° respectively.

Day 28 temperatures varied from 28° to 54°C, following slow and steady decline. These represented drops of between 17 and 42°C (average 28.5°C) relative to the peaks recorded. The average difference between peak and 28-day temperatures for thermocouple 1 and 2 was 29.3° and 27.6° respectively.

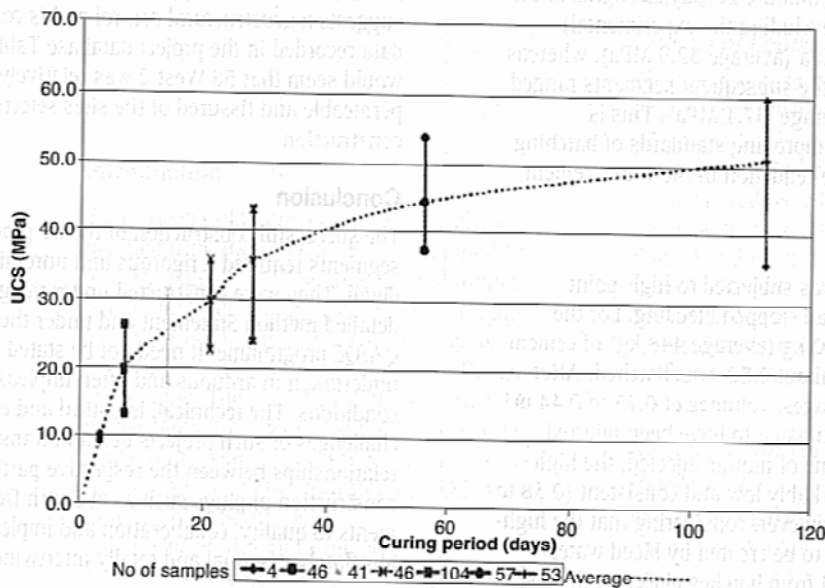
Figure 4—Range and average of mortar cube strengths based on individual segment averages

Overall, the mortar cube strength development with time can be summarized as shown in Figure 4. The key acceptance criterion—a minimum of 25 MPa at 28 days—was met, on average by every segment of every plug, the overall average being 35.6 MPa. The average figures are based on the testing of at least three cube samples.

It may also be observed that the 28-day strengths of the first 7 segments intruded (excluding the experimental) ranged from 25.5 to 40.8 MPa (average 32.9 MPa), whereas the corresponding data for the subsequent segments ranged from 32.3 to 41.4 MPa (average 37.1 MPa). This is indicative of progressively improving standards of batching with time and a progressive reduction in the water/cement ratio.
