Aspects of minipiling practice in the United States

by D A Bruce* BSc, PhD, CEng, MICE, MASCE, MAEG, MHKIE, FGS.

Minipiling has gained acceptance in the US during the past decade. Bruce describes a variety of tasks completed by his firm using the technique.

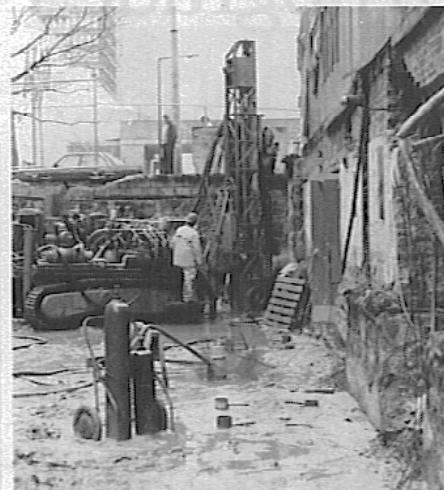
Fig. 1. Typical minipile installation conditions. Boylston St. Boston, MA.

The structure was founded originally on pile caps bearing on timber piles. To accommodate the increased loadings from the new construction, additional support was required under enlarged pile caps (Fig. 1).

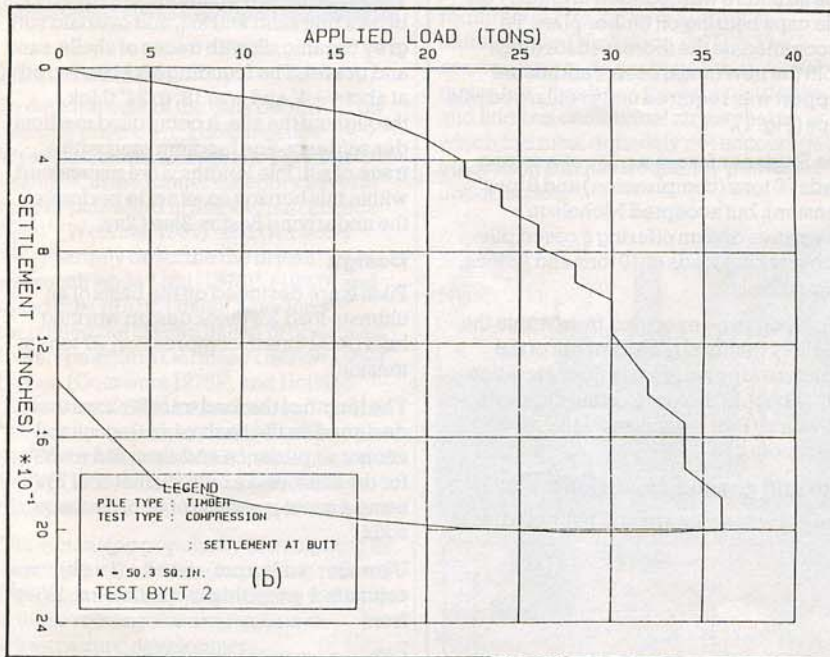
Fig. 3b. Performance of timber pile, same site.

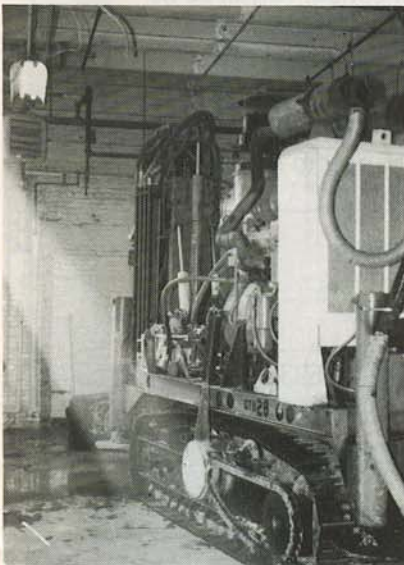
Fig. 3. Special low headroom drilling equipment (8' mast). Coney Island, NY.

The access and headroom restraints over much of the site demanded the use of specially constructed drilling equipment (Pic. 3) featuring short masts and remote power units. Whenever possible, conventional crawler mounted units were

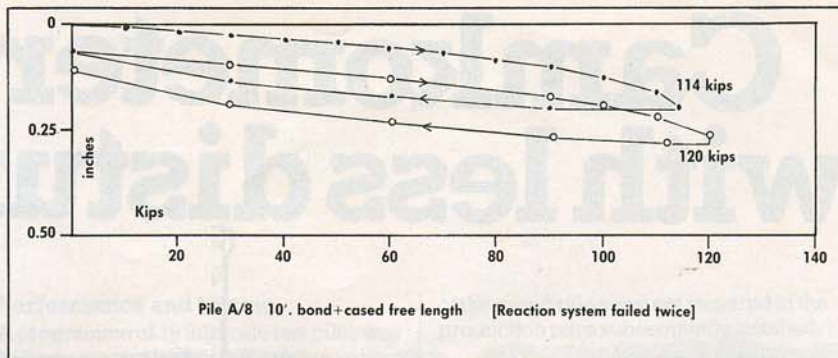
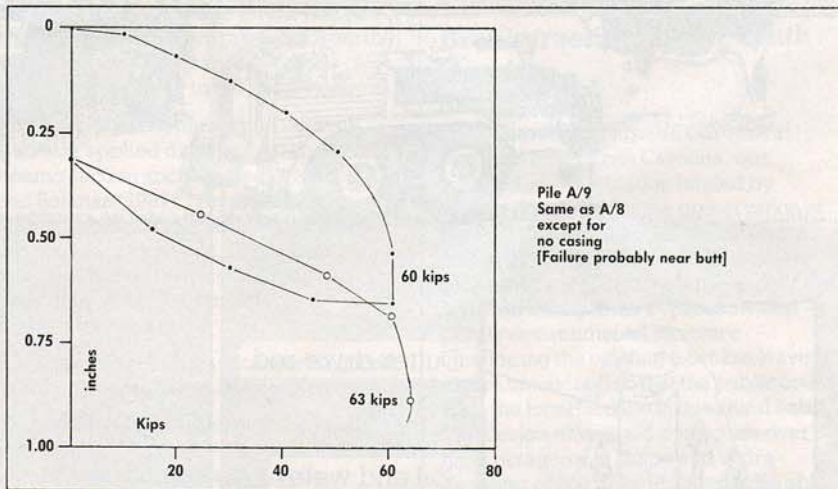
Fig. 8. Comparative test performances of two 35' long minipiles, with and without permanent casing. Coney Island, NY.

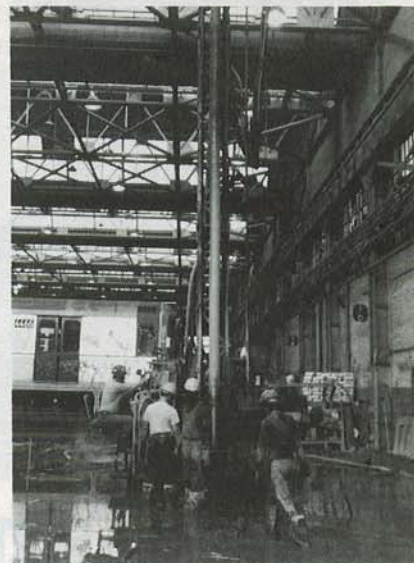
Fig. 4. Standard diesel hydraulic drill rig. Coney Island, NY.

employed (Pic. 4) with special care having to be taken in all cases with exhaust fumes and drilling spoil disposal.

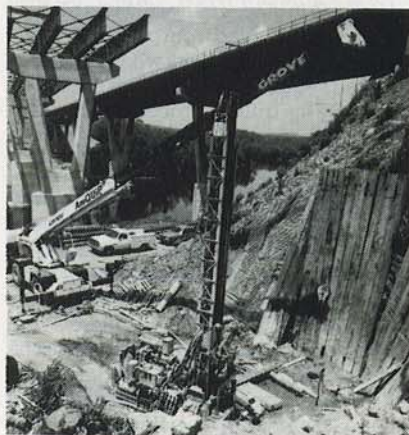
Pic. 5. Installation of minipiles to underpin bridge pier 6E over the Delaware river. Warren County, NJ.

The I-78 dual highway crosses the Delaware river between Pennsylvania and New Jersey (Warren Co) on seven span, multigirder bridges (Pic. 5). Generally foundations on the Pennsylvania side incorporated driven H piles whereas the river piers and the New Jersey piers were foreseen as founded on solid rock. This proved to be valid except for pier E-6 on the eastbound structure.
