# Monitoring and quality control of a 100 metre deep diaphragm wall

D.A. Bruce B. De Paoli C. Mascardi E. Mongilardi

To check the feasibility and the quality of a very deep diaphragm wall, a tern of adjacent panels has been constructed, up to a depth of 100 m, in the Milan sandy gravelly soil by means of a hydraulically driven milling machine with reverse circulation of mud. The results of the monitoring carried out in order to evaluate the panel geometry and the quality of both joints and concrete are described.

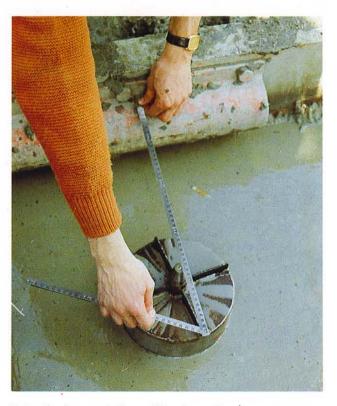
Inverted pendulum floater during measuring.

The instrument consists of two floaters, also shown in Figure 4b, each connected to a 1.6 mm dia. steel wire. These wires passed through a pair of pulleys on the Romill head and were attached to winches at the surface, bearing on a reference frame. Readings could be taken, once excavation was complete, by lowering the Romill to predetermined depths in the excavation.

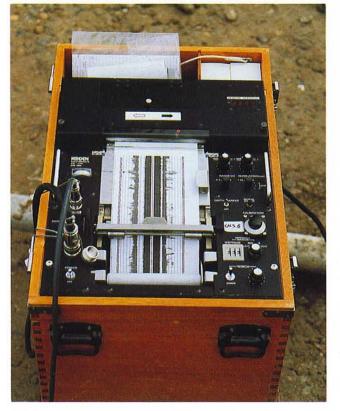
KODEN ultrasonic echometer.

With this instrument (Koden 1984), both the three dimensional orientations, and the actual dimensions of a panel can be continuously checked. A cable suspended ultrasonic probe is lowered into the trench, continuously emitting waves in orthogonal directions which are reflected off the walls. The return waves are received by the probe sensors which transmit the return time to the surface recording station. As the wave velocity is known, distance can be calculated, and a chart is produced showing the distance between the probe and the walls, with depth.
