A HYDRAULIC CUT-OFF THROUGH
UNCONSOLIDATED MINE DUMP MATERIAL

Dr. Donald A. Bruce
Technical Director
Nicholson Construction of America
and
Joseph W. Pratt
Project Manager
Nicholson Construction Company

Abstract

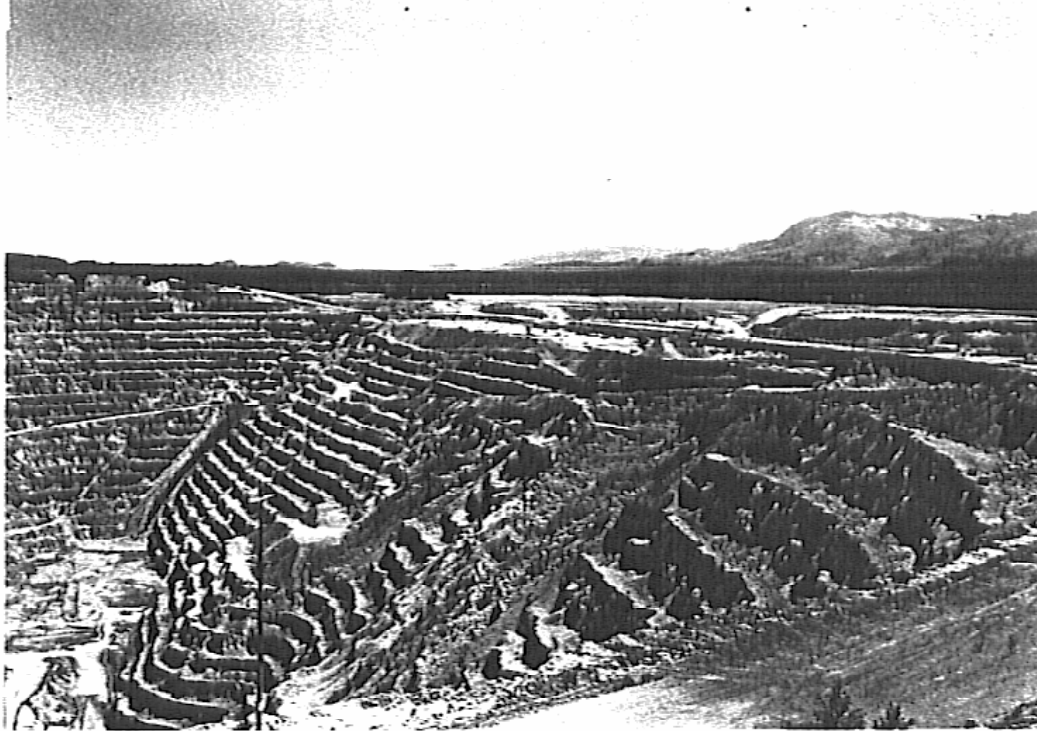
Photograph 1. General view of the site, showing south wall of 800' open pit, the marine inlet, and the cut-off wall between.

Copper and other metal ores are mined from an 800' deep open pit at the Island Copper Mine, near Port Hardy, British Columbia, (Photograph 1). The mine wished to extract ore from the pit's south side, closest to a marine inlet, in an operation called the "Southwall Push Back" (Figure 1). This operation entails the removal of a ridge of the naturally impermeable andesitic bedrock, and the upper part of the wall will therefore be formed by waste, mine dump material. Highly permeable, this dump consists of angular shot debris and boulders of maximum volume 150 c.f. and dimension 7'. It was necessary to therefore

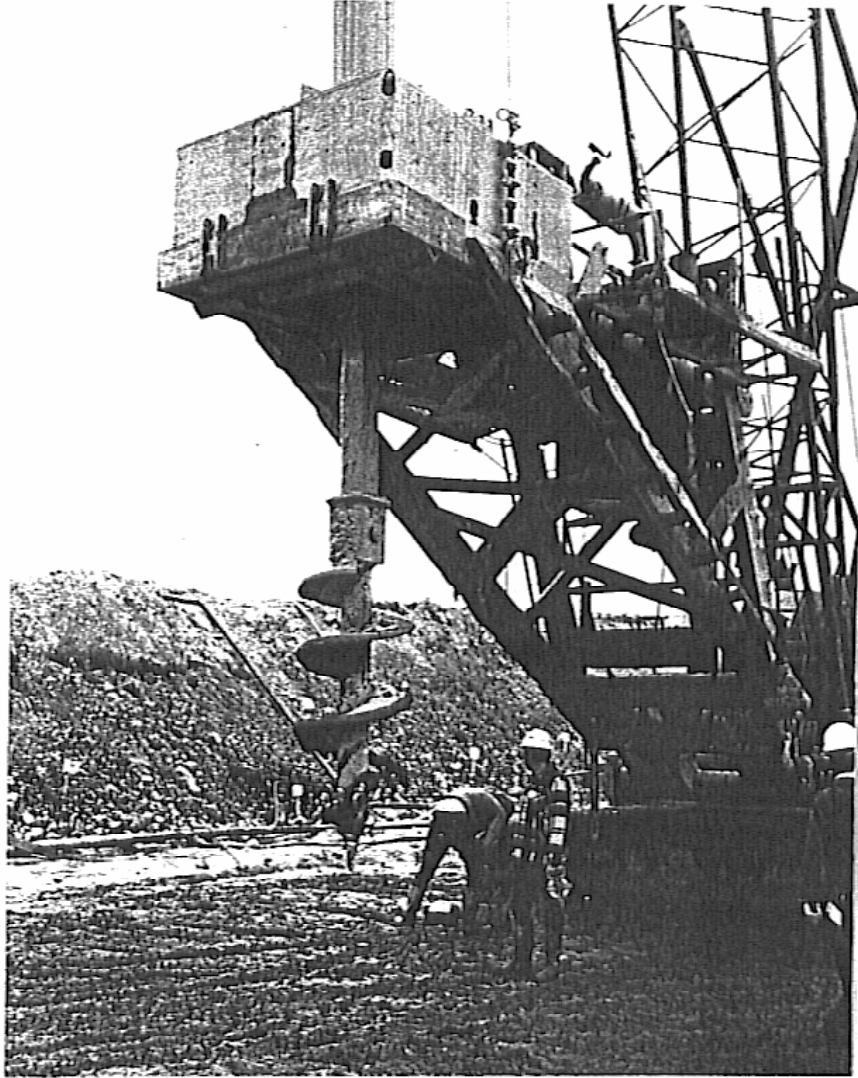
Photograph 3. Large diameter auger used to predrill through the till.

The extreme hardness of the till prevented the buckets from grabbing significant volumes in each pass. Therefore, systematic predrilling of 8' of till in problem panels was conducted at 4' centers with a 32" diameter crane mounted rock auger (Photograph 3). A total of 3,549 l.f. of such predrilling was conducted.

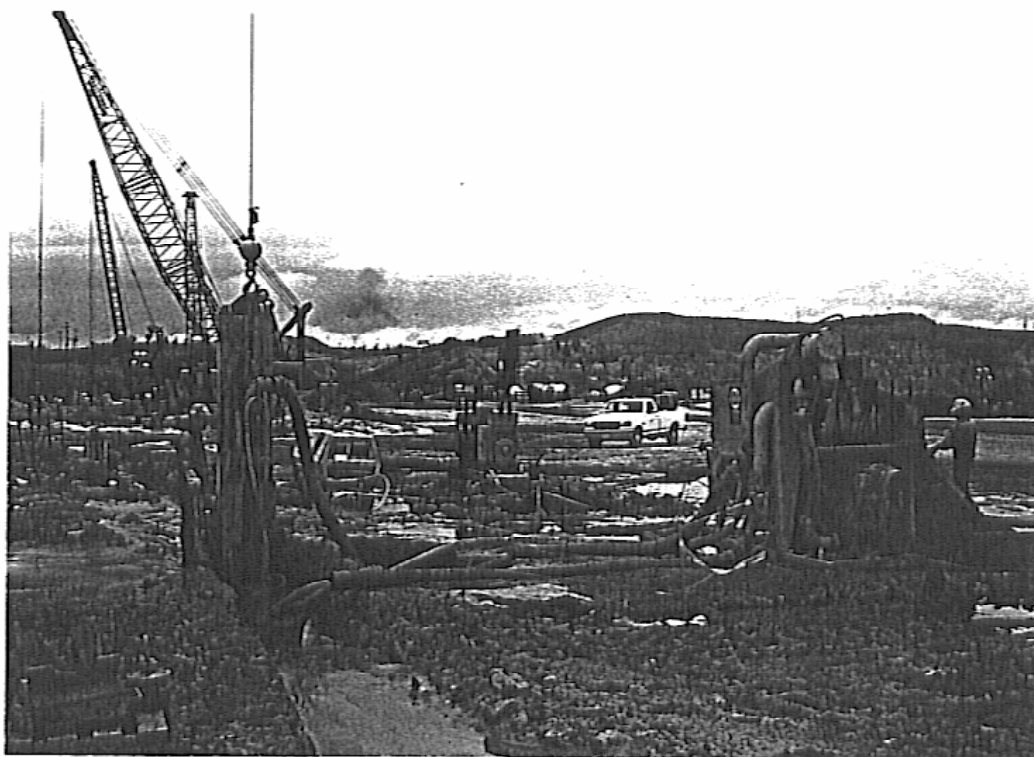
Photograph 4. Desanding of Secondary panel prior to concreting. End stop shown at far end of panel.

Several mobile desanders were used to "clean" and lighten the slurry sufficiently prior to concreting the panels, to a maximum sand content of 5%. These operated via 8" diameter steel pipes, suspended 1' off the base of the excavation. The lifting process was aided by the action of a 1" diameter compressed air line, exiting near the bottom of the steel line, and agitating loose soil and other debris. (Photograph 4)

The one (Secondary panel) or two (Primary panel) steel endstops were placed by crane at the extremities of each panel before desanding. About 3-6 hours after concreting, these endstops were lifted slightly to break the adhesive bond between the steel and concrete. They were fully extracted about six hours later.

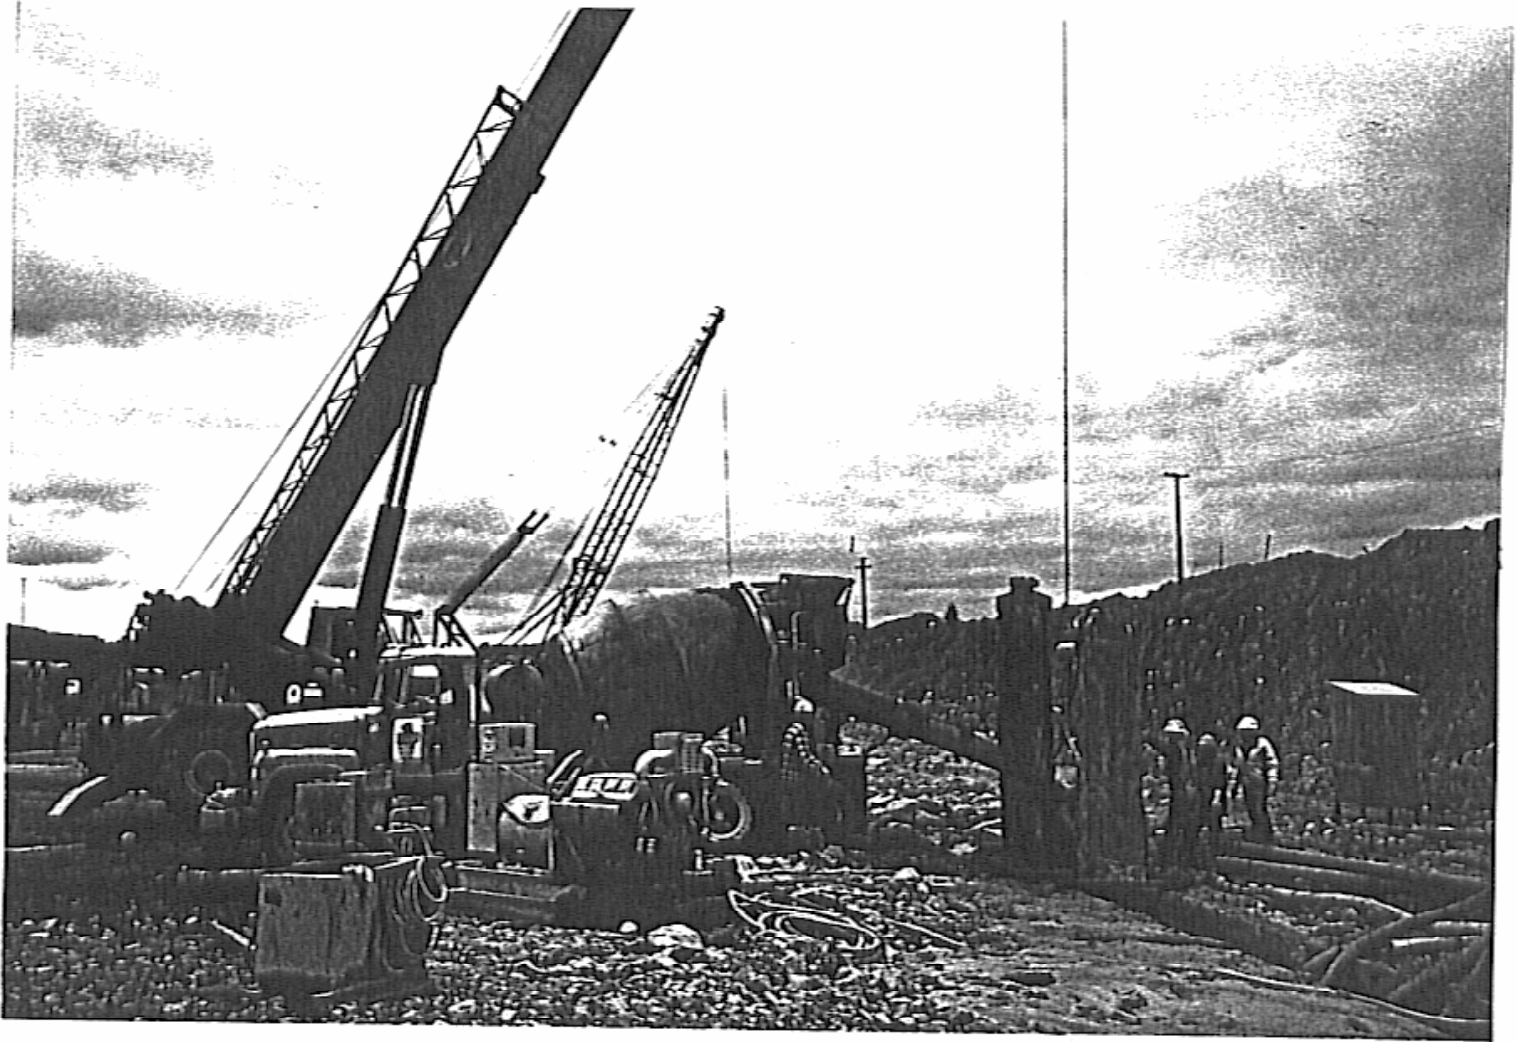
Photograph 5. Concreting of Primary panel with two end stops in place.

The concrete was then tremied into each panel (Photograph 5) via a single 10" diameter steel pipe, careful records being made of the correlation between concrete volume placed and the depth of concrete measured. The tremie was lifted periodically, but care was taken to ensure the outlet was at least 20' below the slurry/concrete interface. Concrete placement rates ranged from
