**THE RODUR PROCESS
OF CONCRETE DAM REPAIR:
A RECENT CASE HISTORY**

D.A. Bruce, Nicholson Construction Company
and
P. DePorcellinis, RODIO, Spain

Presented at International Conference on
Structural Faults and Repair,
London, June 27 - 29, 1989

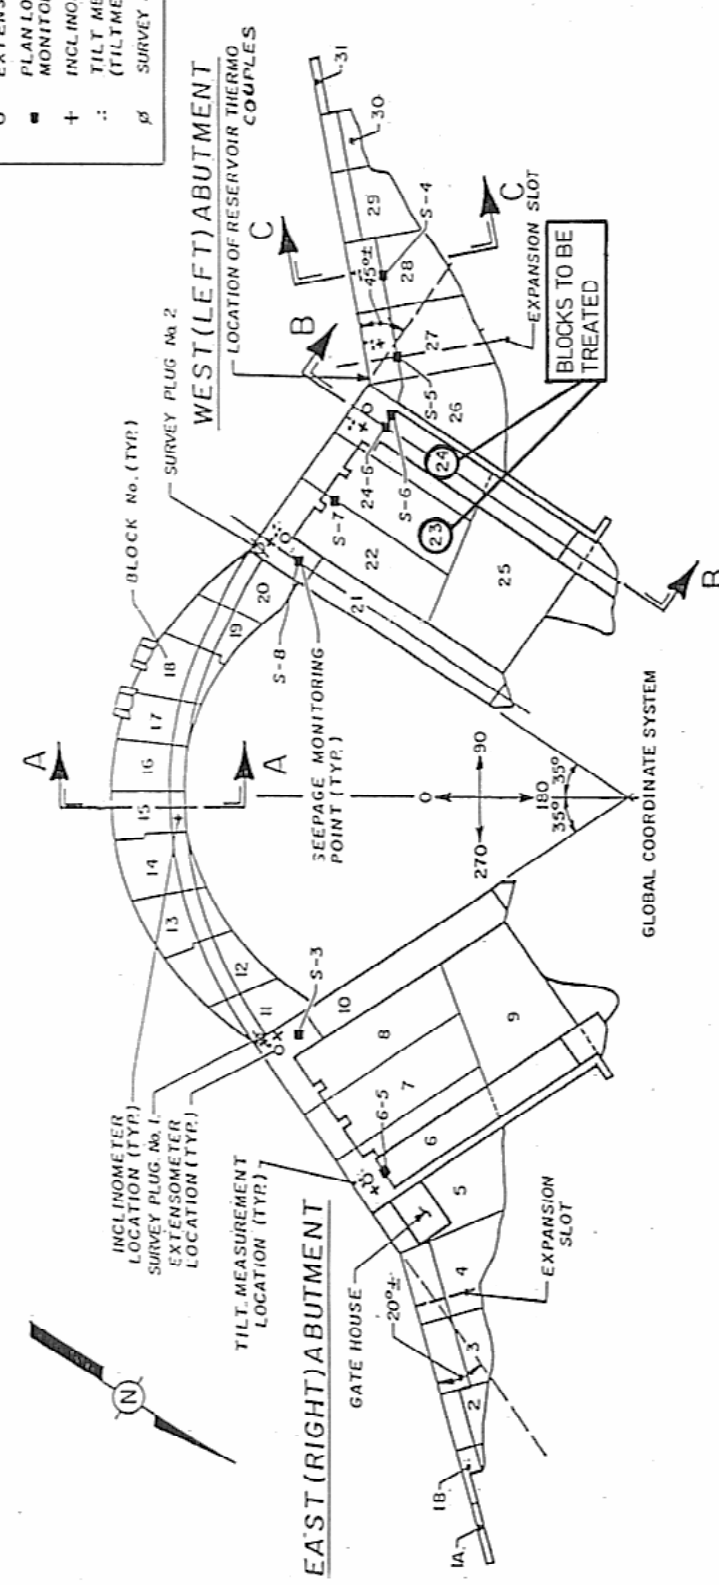
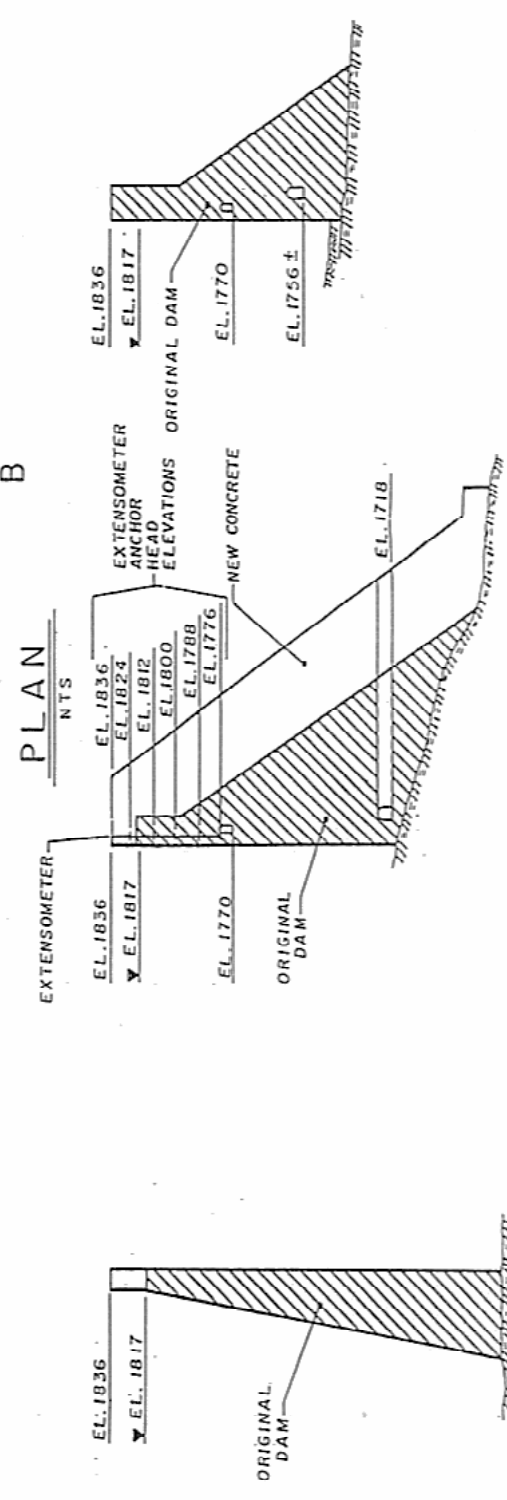
The dam is a 320m long concrete arch structure with gravity abutments and two spillways (Figure 4). It stands a maximum of 65 m above the river bed, and impounds water for hydroelectric generation at another installation.

Figure 4. Plan and typical sections showing instrumentation locations and blocks to be grouted. (Dimensions in feet)

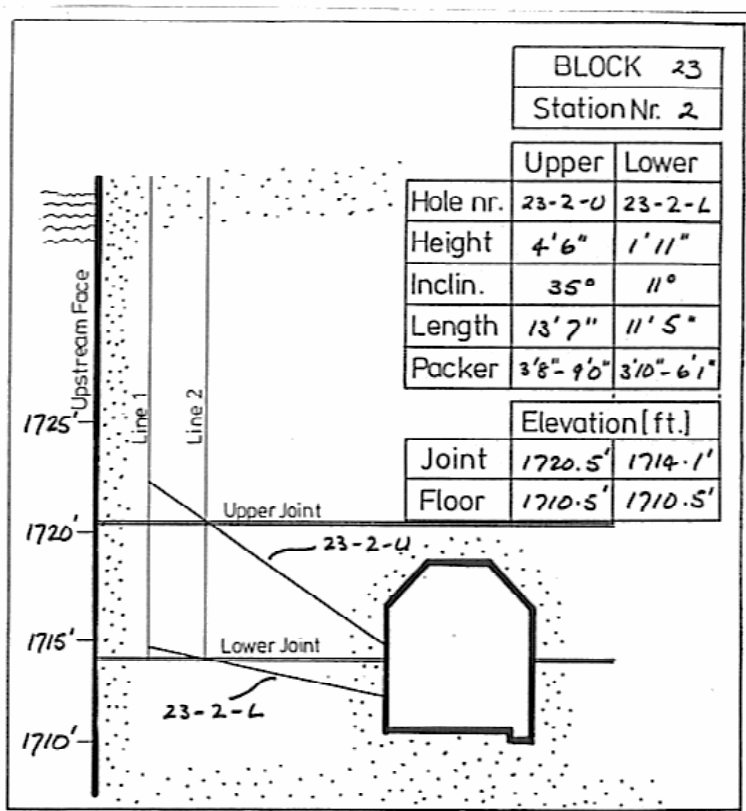
Figure 7. Typical section showing intended joint interceptions at one station.

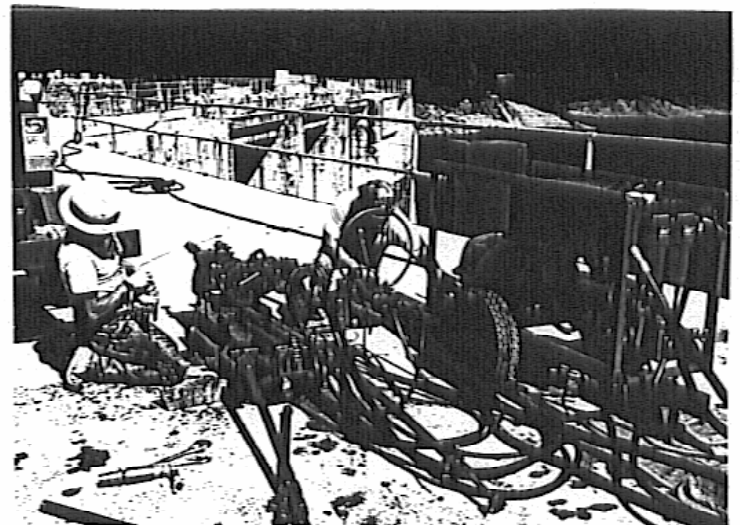
A special modular frame mounted electrohydraulic rig was used (Photograph 4) to provide holes of 46mm diameter and cores of 36mm diameter. The length at which the joint was intercepted was carefully measured to give the real perforation pattern. Further analysis indicated the "roughness" of the joint as summarized in Table 3. The Secondary holes were located with respect to observations made during the Primary grouting. They were thus drilled into particularly "difficult" zones, or areas known to require close treatment (e.g. near large diameter drains or vertical construction joints). Each Tertiary hole was designed to penetrate both upper and lower joints about 1.5m and 3m back from the dam face respectively. Afterwards they were left open to act as seepage "tell tales" for the future. A summary of drilling quantities is given in Table 4.

Photograph 4. Components of the electrohydraulic coring rig. From left to right: mast with head, controls, power pack.

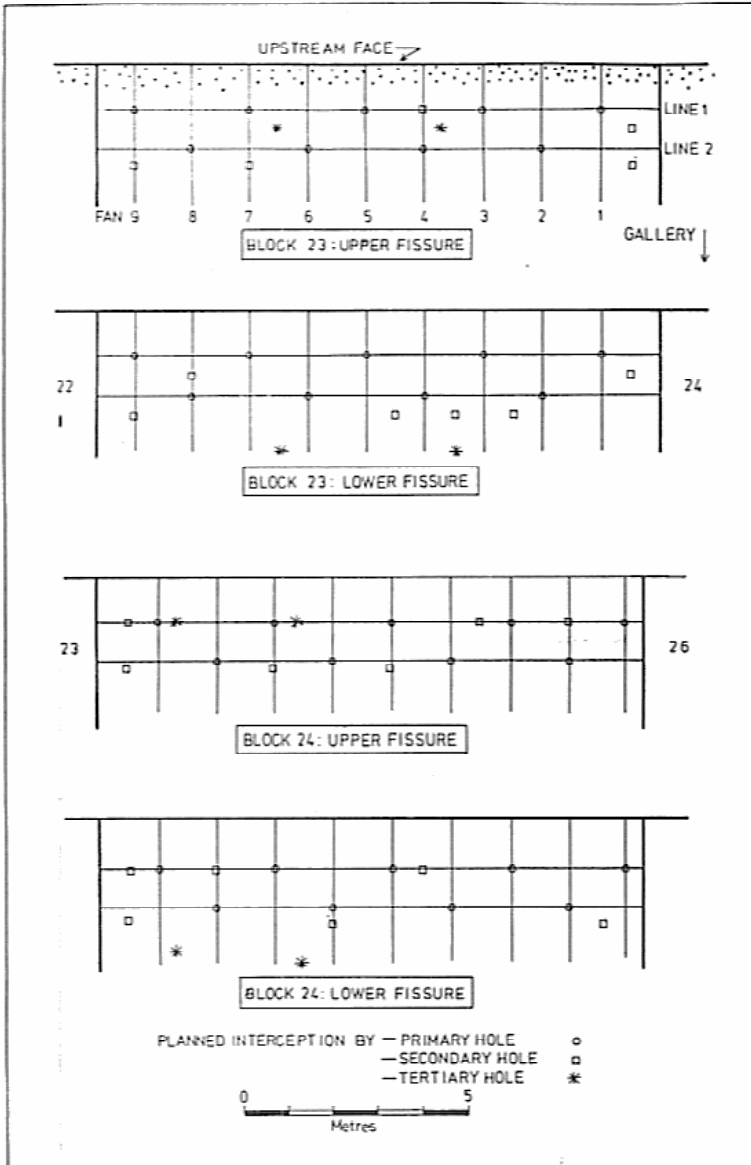
For each horizontal joint in each of the two blocks (23 and 24) being treated, holes were designed to intersect it at regular intervals (Figure 6). The two Primary rows were to be drilled and grouted before locating and drilling Secondary and later holes. As shown in Figure 5 the elevation of the Lower Gallery was not constant and so its position relative to the joints being drilled varied constantly. Therefore, to ensure the correct points of intersection of the joint, a scaled section had to be drawn for each hole location to calculate hole length, inclination and gallery wall entry point (Figure 7). At each station two holes were drilled—one into each joint—and these were oriented orthogonal to the Gallery wall and so the dam's face. Each hole was designed to terminate slightly beyond the target joint so that the concrete both above and below it could be studied.

Figure 6. Plans of foreseen joint interception patterns.
