TIMS FORD DAM, TENNESSEE: REMEDIAL GROUTING OF RIGHT RIM

D.A. Bruce, Ph.D., C.Eng.¹, J.A. Hamby, P.E.², J.F. Henry, P.E.³

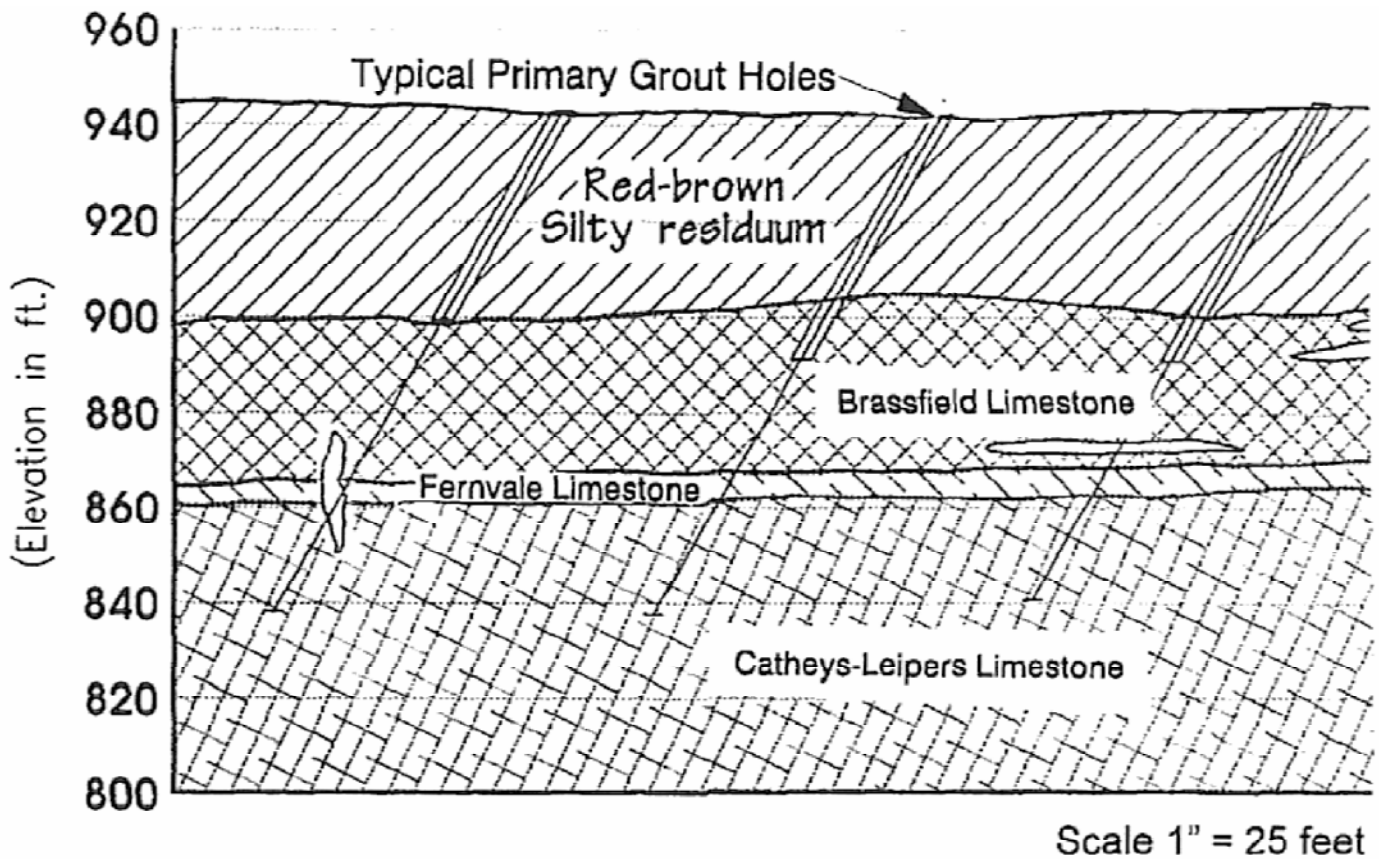
Figure 2. Tims Ford Reservoir simplified geological cross-section.

The right (west) abutment of the embankment intersects orthogonally a natural ridge running nearly north-south and rising to Elevations 942 to 958 feet (Figure 1). This ridge comprises overburden above Elevation 900 feet, and various types of limestones, some karstic, below (Figure 2).
