Slab-jacking at Tarbela Dam, Pakistan

by D.A. BRUCE AND G.M. JOYCE

This Paper describes a major slab-jacking programme conducted recently at Tarbela Dam, Pakistan. Some 375m³ of mainly cement-bentonite grouts were injected through 1 302 holes drilled through 39 of the concrete panels forming the protective apron to the upstream clay blanket material of the auxiliary spillway.

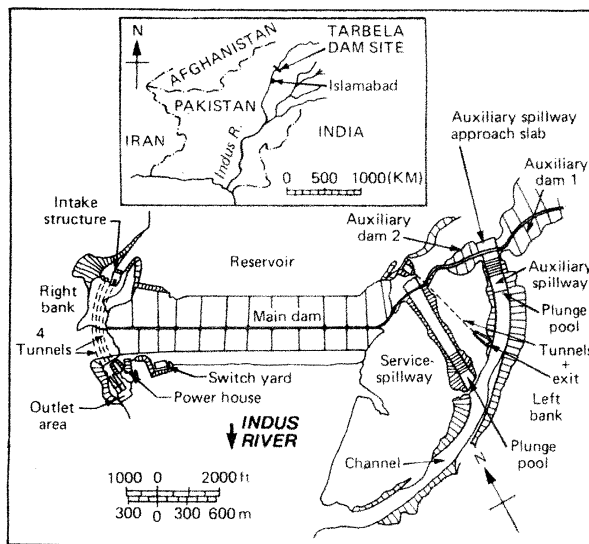
Fig. 1. Tarbela Dam complex, Pakistan

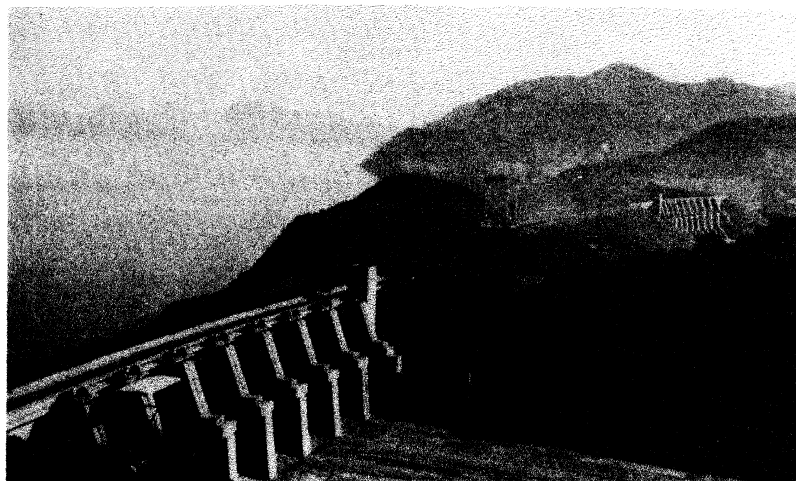
Fig. 2. General view of service spillway gates (foreground), Auxiliary Dam 2, auxiliary spillway gates, and the curved Auxiliary Dam 1, right
