# DESIGN AND CONSTRUCTION OF SEEPAGE CUT-OFF WALLS UNDER A

# CONCRETE DAM WITH A FULL RESERVOIR

Peter D. Amos • Donald A. Bruce • Marco Lucchi • Neil Watkins • Nick Wharmby

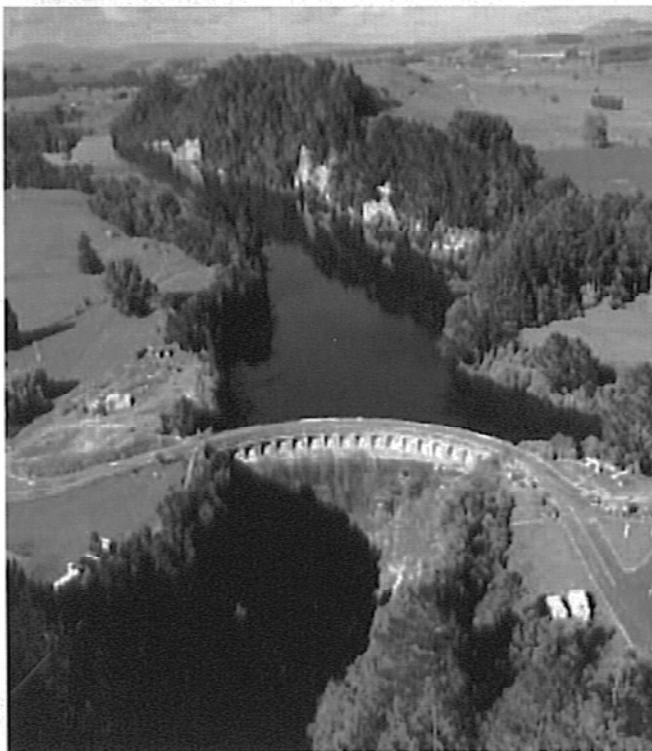
Figure 1. Arapuni Dam, New Zealand, looking West

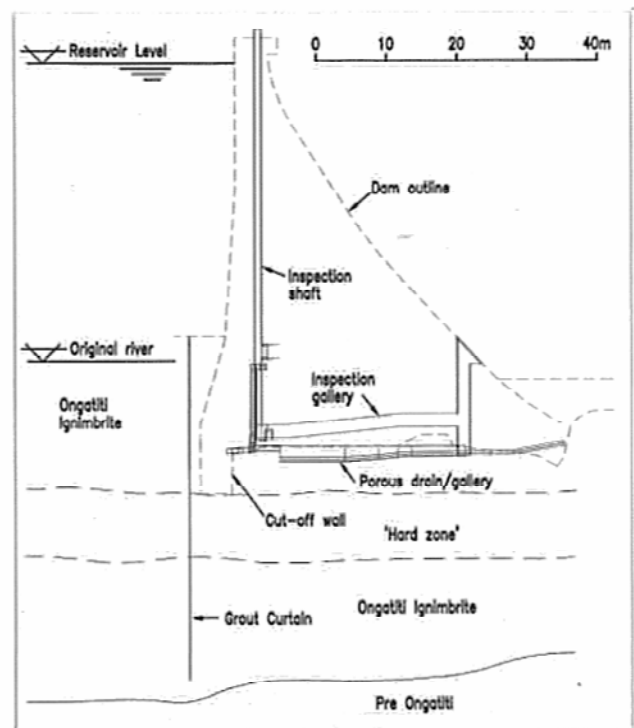
Figure 2. Cross Section of Arapuni Dam (Note the spatial separation of the grout curtain from the dam)

The 600mm high x 600mm wide (2ft x 2ft) "no-fines concrete" porous drain network (Figures 2 and 3) is the main uplift control at the dam/foundation interface. The underdrain includes a continuous drain sited parallel to, and immediately downstream of, the original cut-off wall with radial porous drains to discharge seepage water to the downstream toe.

In June 1930 the reservoir was completely dewatered for a number of repairs including construction of a grout curtain along the upstream heel of the dam and along the front of both abutment cut-off walls. The grout curtain was a single row cement curtain with mostly vertical grout holes at 3m (10ft) centres constructed just upstream of the dam and cut-off walls, but the curtain is not physically connected to the dam (Figure 2). Where grout holes intersected open voids in vertical joints, grout would have sealed that void, and leakage at the dam was considerably less once the reservoir was refilled in 1932. However this grouting operation would not have intersected all vertical rock joints or displaced clay infill in joints, hence future leakage incidents were always likely to occur.

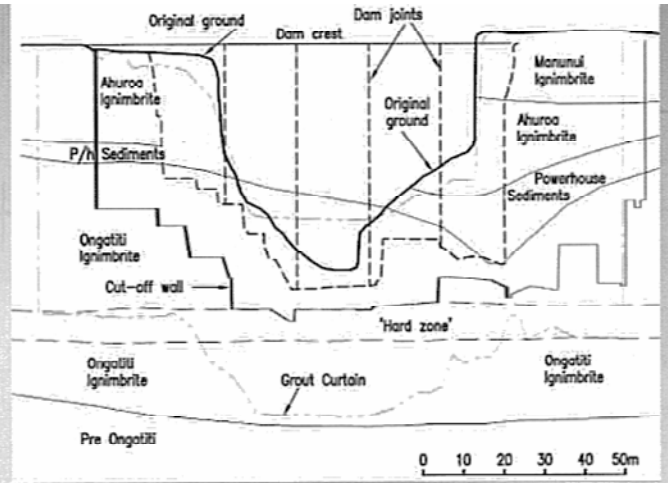
Original features of the dam include concrete cut-off walls and a network of porous (no-fines) concrete drains at the dam/foundation interface (the "underdrain"). The original cut-off walls extend beneath the dam to a depth of 65m (210ft) below the dam crest and extend 20m (66ft) and 33m (108ft) into the left and right abutments respectively, for the full height of the dam as shown on Figures 3 and 4.

At interfaces between ignimbrite sheets there is usually unwelded material, either airfall tephros or unwelded ignimbrite. The most extensive interface deposit is between the Ahuroa and Ongatiti ignimbrite units, known as the Powerhouse Sediments (Figure 4), with a thickness of 4 to 8m (13-26ft). There was genuine concern during the 2001 incident that high pressure could potentially blow out remaining fracture infill at the dam toe, and the resulting jet of water then erode Powerhouse Sediments on the left abutment, destabilising the abutment rock face above.

Figure 4. Elevation of Arapuni Dam, looking downstream
