## **THE BEAR CREEK DAM, ALABAMA**

Keith A. Ferguson, P.E.<sup>1</sup>  
Donald A. Bruce, PhD, C.Eng.<sup>2</sup>

### **ABSTRACT**

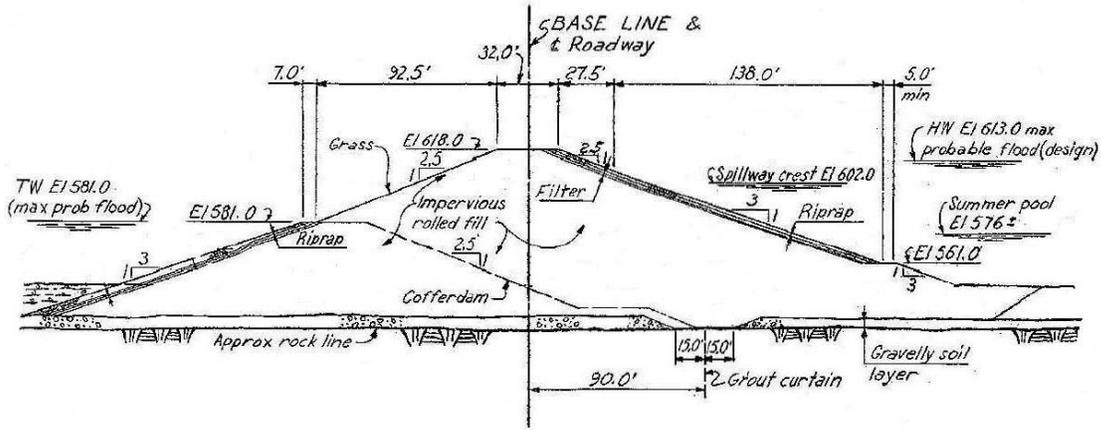
Figure 1. General Cross-section of Bear Creek Dam

The dam was originally constructed with an incomplete single line grout curtain installed from the bottom of a key trench excavated under the upstream shell of the dam. The key trench and grout curtain were omitted in the upper left abutment beginning about 300 feet right of the spillway structure. No foundation grouting or treatment was performed under the spillway structure. During key trench excavation, numerous solution features and voids were encountered: some portions of the soft materials filling these karst features and the highly weathered bedrock were removed and replaced with embankment materials. No other foundation treatment such as dental concrete was conducted. Large grout takes were common during the grouting program.

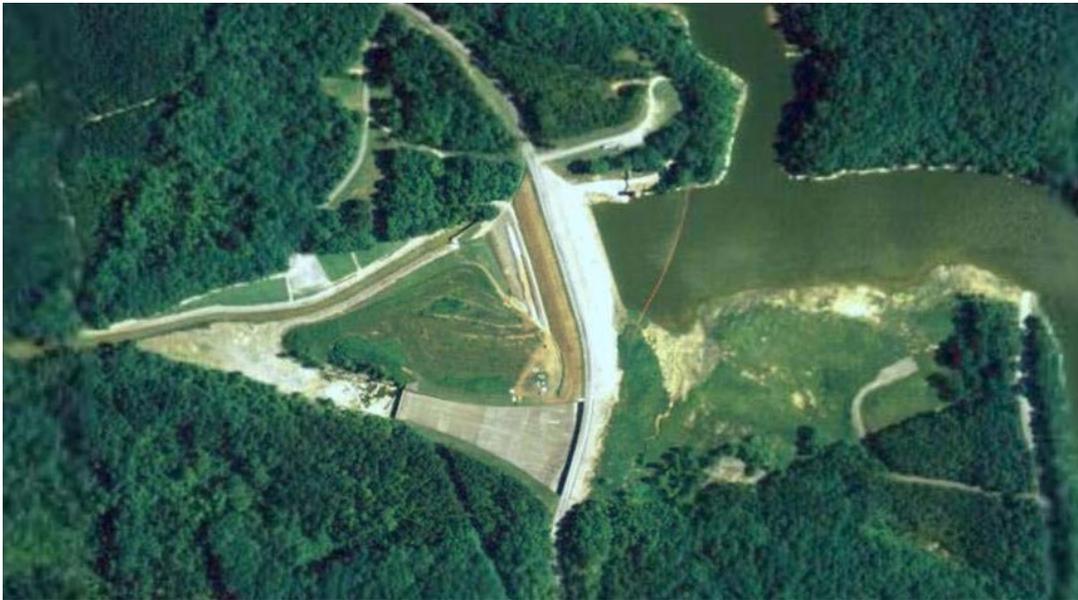
Figure 2. Photograph of Bear Creek Dam, Spillway and Outlet Works

and reduce seepage flows and allay safety concerns. During a high water event in December 2004, a number of boils, small sinkholes, and increased seepage flows of between 1200 and 1500 gpm were observed along the toe of the dam. Subsequently, TVA completed an exploratory drilling program including coring of the foundation bedrock, and installation of piezometers. Cone penetration testing was also completed in the embankment and foundation soils under the dam to determine if any damage had occurred as a result of the increased foundation seepage. TVA determined that the primary source of the seepage was via the karstic formations in the left abutment foundation, and a second remedial grouting program was initiated in 2004 and 2005 along the upstream slope of the dam. However, grouting operations were interrupted by a flood and the grout curtain could not be economically brought to closure.

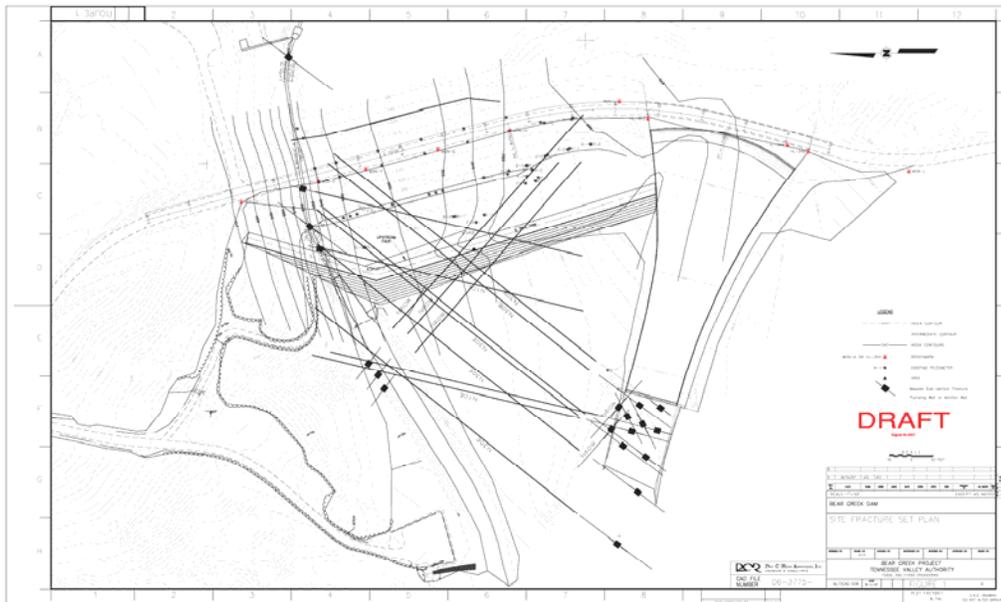
Figure 3. Bedrock Structure

A summary of the primary rock structure (stratigraphy and joints) at the site is shown on Figure 3. A summary of all of the notable voids and tools drops during various field exploration programs is shown on Figure 4. Considering only the information obtained for this site, close examination of the various families of field exploration data suggested some notable differences between the possible characteristics of the karst. For example, the joint orientation data shown on Figure 3, compared to the seismic refraction and micro-gravity data, do not give a consistent indication of the number, size, orientation and depth of the major karsts anticipated in the foundation. The seismic refraction data provided a general indication of the quality of the rock for assisting in establishing the foundation excavation objective but did not reveal any specific large karst feature locations, only some indicators of possible locations. The micro-gravity results suggested several large karst features including some features under the existing spillway,

but the orientation of these features was not consistent with the orientation of any of the major joint sets shown on Figure 3. The seismic refraction along with the void and tool drop information on Figure 4 provided a hint of some potential stratigraphic controlled karst development. However, there were clear indications that karst development in the maximum section area had the potential to extend down to and through the Bangor Shale layer and possibly into the lower Bangor Formation. Hence there was uncertainty and risk in defining the amount of karst and corresponding treatment requirements and the time required to effectively treat the conditions.

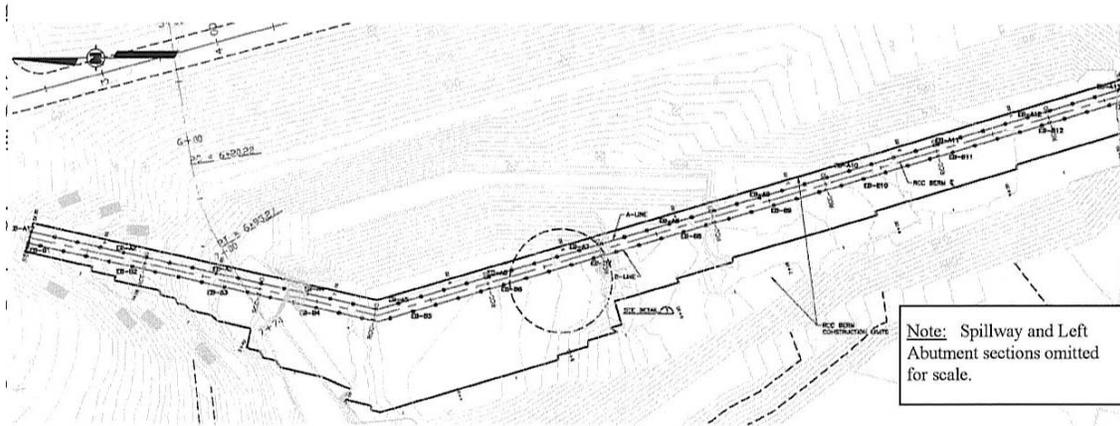
Figure 8. Layout of Curtain and Exploratory Holes (Ginther et al. 2009).

- Thirty-four exploratory HQ core holes were first installed at 80-foot centers on both sides of the two-row curtain (Figure 8). Core was logged, and the holes geophysically and optically surveyed before being subjected to multi-step water pressure testing. This process “baselined” precisely the rock conditions under the heel of the new RCC structure.

- The curtain was brought to closure at a maximum of 5 Lugeons, as measured by verification holes drilled and tested at regular intervals between the two rows.

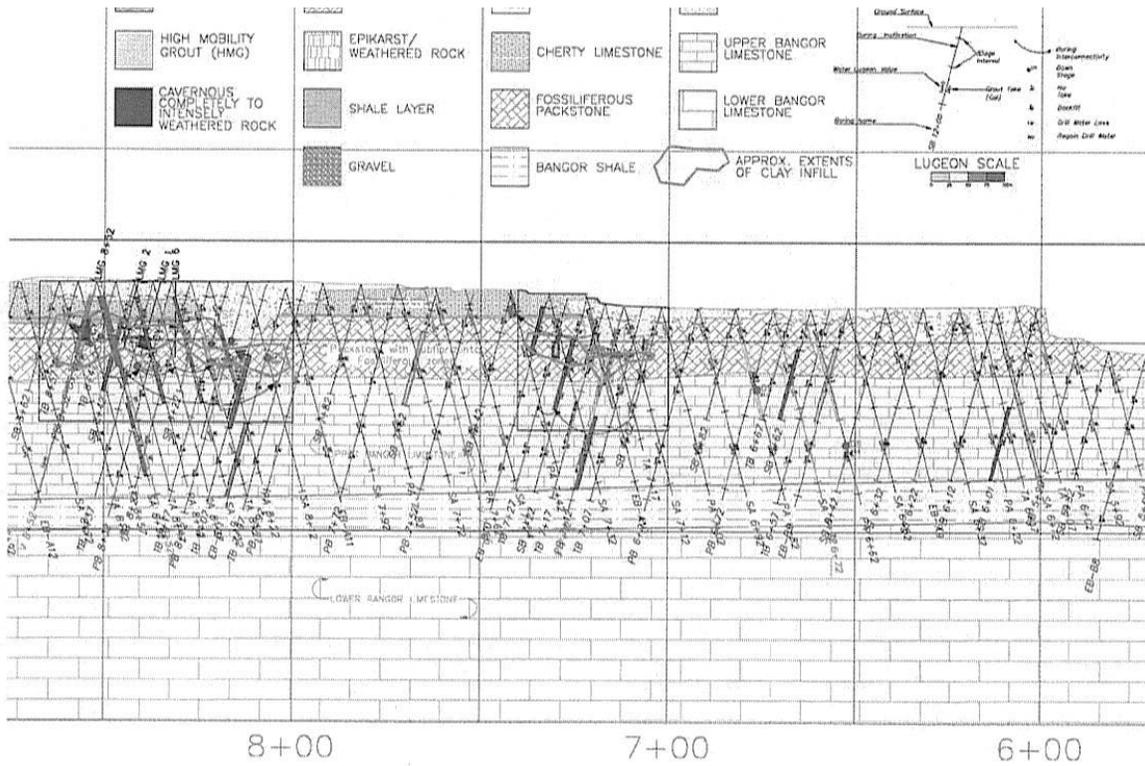
Figure 9. Typical drilling and grouting Record Chart (Ginther et al. 2009)

- Computer-controlled real-time data monitoring and control of all water pressure testing and grouting operations was conducted. Summary charts were updated (Figure 9) and reviewed on a daily basis to optimize tactical decisions.

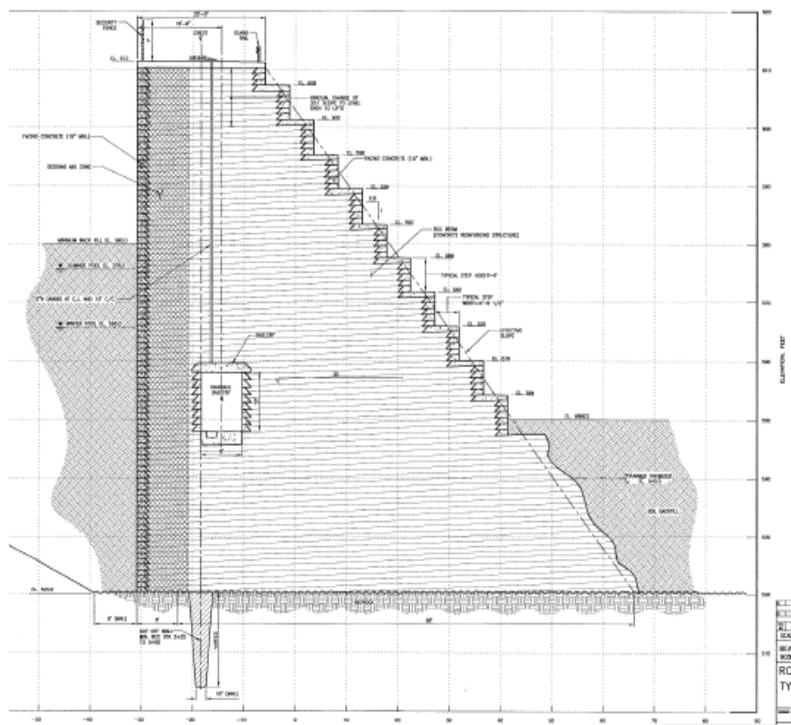
Figure 10. RCC Berm Cross Section

The cross section for the new berm was developed through a series of engineering evaluations and design reviews by the Board, TVA and the Engineer. Figure 10 represents the maximum height section and it engages the residual strength characteristics of the Bangor Shale Formation. The cross section was reduced in the upper left abutment area when the shale became deep enough to not adversely affect the stability calculations.

Overall the system of provisions in the dam and foundation design that provide for seepage control and safety include 1) the foundation grout curtain, cutoff panels, and excavated karst feature backfill treatment connected to the base of the dam, 2) an upstream facing on the dam of conventional concrete, 3) bedding mix treatment of each RCC lift surface immediately downstream of the conventional concrete facing, and 4) a drainage gallery that dam and foundation drain holes can be connected to should any seepage develop along lift surfaces, or uplift pressures in excess of the design pressures be measured by foundation instrumentation.

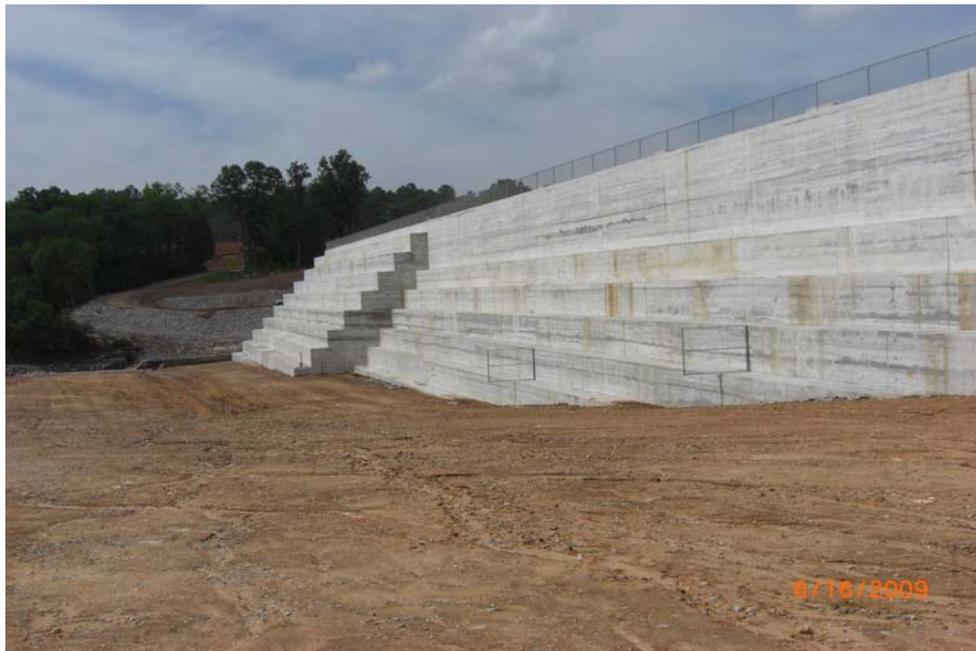
Figure 13. Photo of Downstream Face of Completed Berm

The downstream face of the completed berm is shown on Figure 13. A rigorous QA/QC program was performed by the Engineer during construction with periodic site visits and reviews by the members of the Board. To date, mix design and performance objectives have been met, a testimony to the thorough effort of all parties to achieve a high quality work product.
