Structural Repair by Grouting

by D.A. Bruce

1. INTRODUCTION

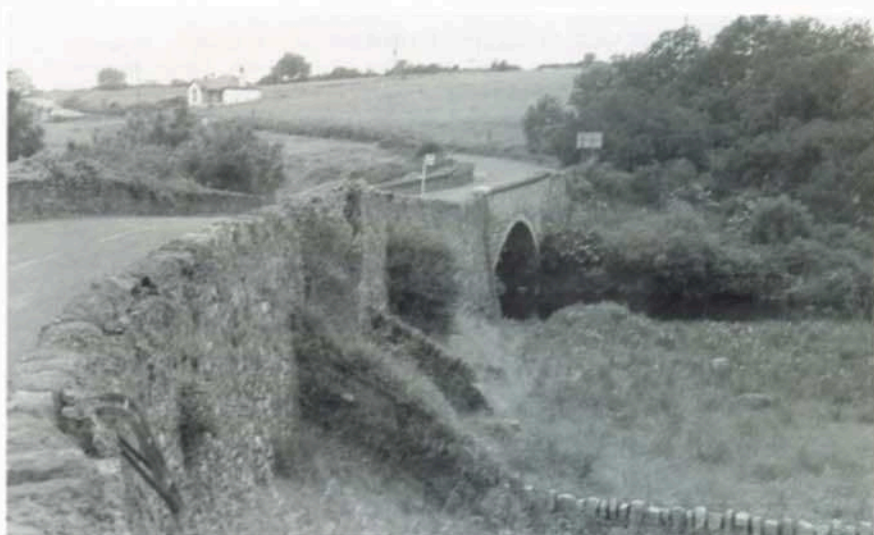
Photograph 1. View of Pont Rug, N. Wales

Throughout N. Wales, including Snowdonia National Park, there is a multiplicity of structures such as bridges and retaining walls built between 150 and 200 years ago (Photograph 1). Many are designated as National Monuments. They comprise blockwork skins to heartings consisting of a variety of materials from boulders to silts. The masonry usually consists of flat blocks up to 200mm thick and an average 150 x 300mm in elevation, but more variable for the bridge details. The blocks consist of hard fine to medium Palaeozoic sediments such as slates and greywackes.

general increase in vehicle loading and vibration levels, have led to deterioration and distress of certain structures: for example pointing has corroded and crumbled away (exploited by root networks) permitting easy access of water to the hearting, which now bears cavities; structural cracks develop, associated with outwards movements of spandrel walls or differential settlement of abutments.

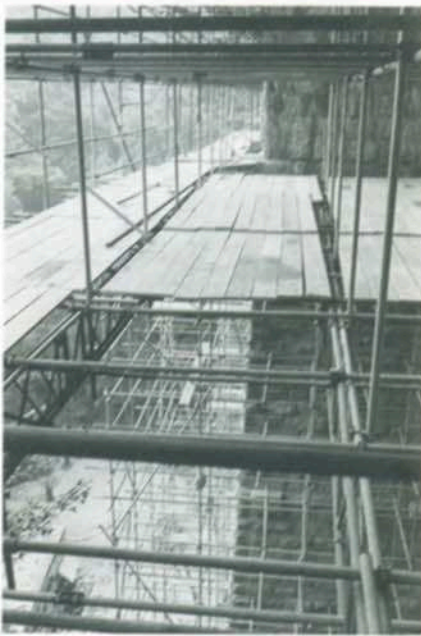
Photograph 2. Scaffold access at mid pier level, Kincardine Viaduct, Scotland

Investigation of the bridge confirmed that water from track level had penetrated through the whole structure. The action of this flowing water (and the ice effect in winter) had over the years led to a significant deterioration of the sandstone blockwork and a removal of fine granular material from the spandrel walls and piers, through the joints of the masonry. To maintain this major structure at an acceptable standard, a comprehensive scheme for both waterproofing and strengthening was therefore evolved.

Working programmes for the grouting were dictated by the intricacies of the scaffolding (Photograph 2), but generally about three piers were worked on at any one time, each at about the same level. Four lifts of primary drill holes

449m² of hand pointing was then conducted in selected areas, principally below the spring course level, and some cutting out and replacement of damaged masonry (with Fyfe-stone) carried out, mainly beneath arch soffits and pier covers.

As a final cosmetic step, the whole structure was cleaned with a 2000psi jetting pump to remove all grout stains and plant growth.

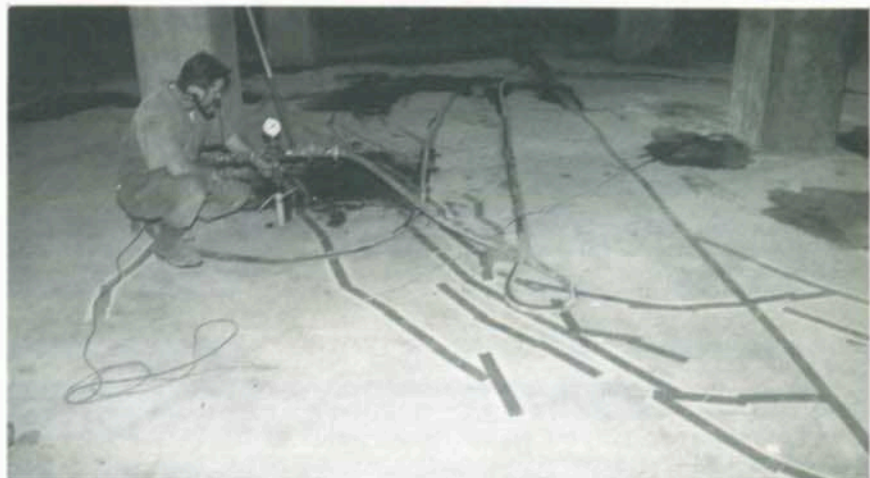
Photograph 5. Underslab grouting underway with return line injection system. Note adhesive tapes protecting the cracks in the concrete surface. Rod El Farag, Cairo

The head incorporated three valves and a pressure gauge/diaphragm unit, in order to control precisely the injection pressure. The grout injection crew working on the slab were equipped with radio headsets to enable direct communication with the grout mixing crew on the surface, both to control the works effectively and to determine the quantity of grout injected into each borehole (Photograph 5).

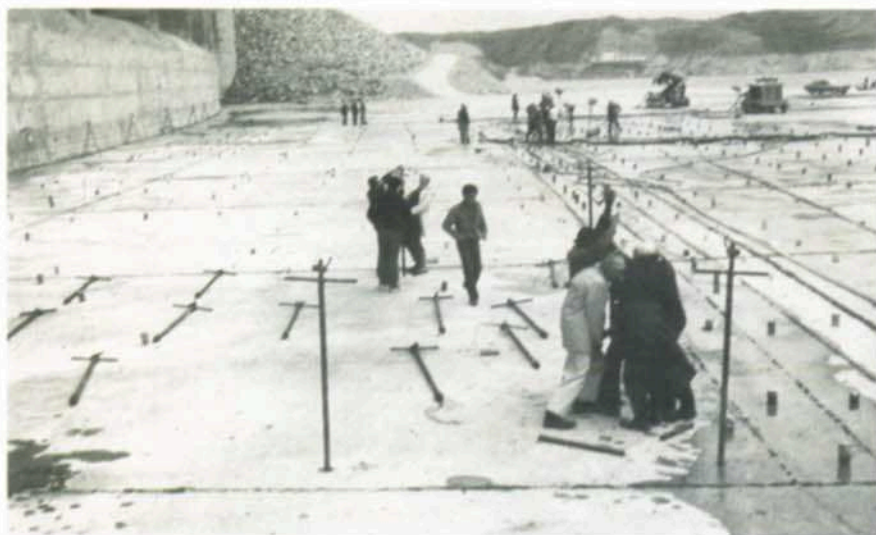
Monitoring of the structure/rock system for the few years after first impounding indicated that the blanket was not acting in an acceptably efficient manner. Further investigations led to the conclusion that a major contributory factor was the concrete apron. It was reasoned that the blanket had settled under reservoir water pressure but that the overlying apron was "hanging up" at the spillway structure, leading to the formation of a void to which reservoir water had access from both sides. This water had washed out areas of fill leading to irregular settlements of certain panels by 30-180mm at

Photograph 6. Packers being placed in holes drilled in concrete apron, adjacent to upstream face of Auxiliary Spillway, Tarbela Dam, Pakistan

distances of 6-18m from the headworks. There was therefore also concern that the differential movements could have given rise to voids beneath "hanging" slabs and could be distressing the rubber waterstops to the point of failure, leading to the complete ineffectiveness of the crucial protective apron.

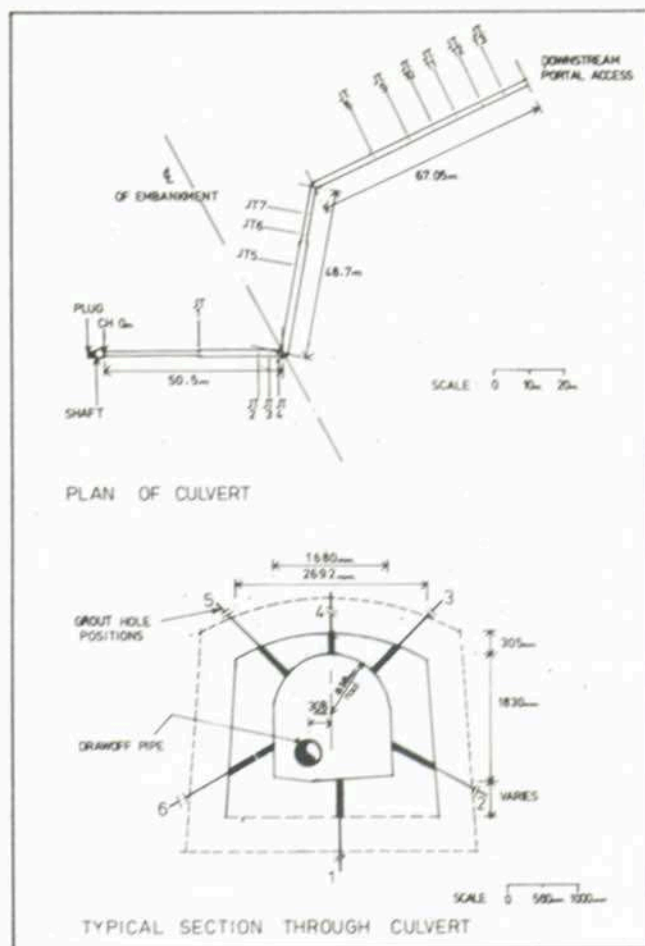
Fig 19. Details of drawoff culvert, Glenlatterach Dam, Scotland

The periodic reservoir inspection required under the Reservoir (Safety Provisions) Act 1930 showed unacceptable levels of leakage drawing in silt and clay fines in the valve tower and draw off culvert, particularly through the culvert construction joints. Flows through individual joints ranged from slight seepage to about 400 litres/hour. The work could only be conducted under normal service conditions and so the treatment had to be executed from inside the concrete structures.

b) **Contact Grouting.** It had been postulated that the silt wash in had created a void between the outside of the culvert and the surrounding fill. Downstream of the cut off, for a length of 90m, a pattern of 3 holes was drilled at 4m intervals (Figure 19) positions 1, 3 and 5 alternating with positions 2, 4 and 6 on adjacent rings. The same mix was used, to a 500Kg limit and pressures of up to 4 bars. High average primary grout consumptions (210Kg/hole) necessitated secondary (186Kg/hole) and tertiary (147Kg/hole) treatments with cement whilst final tightening involved the phenol grout. In total 248 holes were drilled and almost 39 tonnes of cement injected in order to complete the treatment.

The tests also showed that holes up to 3m long in positions 1 and 6 (Figure 19) gave valuable information on the rock profile around the culvert and concluded that grout-beds were confined to the area immediately around the culvert concrete. So, rings of 6 holes were drilled to a depth of 3m, and grouted as in the test. Four phases of treatment were necessary, with 82% of the total of 250 holes being Primaries and absorbing 94% of the total cement injected (62.6 tonnes). Average hole takes ranged from 265Kg (Primary) to 73Kg (Secondary) and 54Kg (Quarternary).

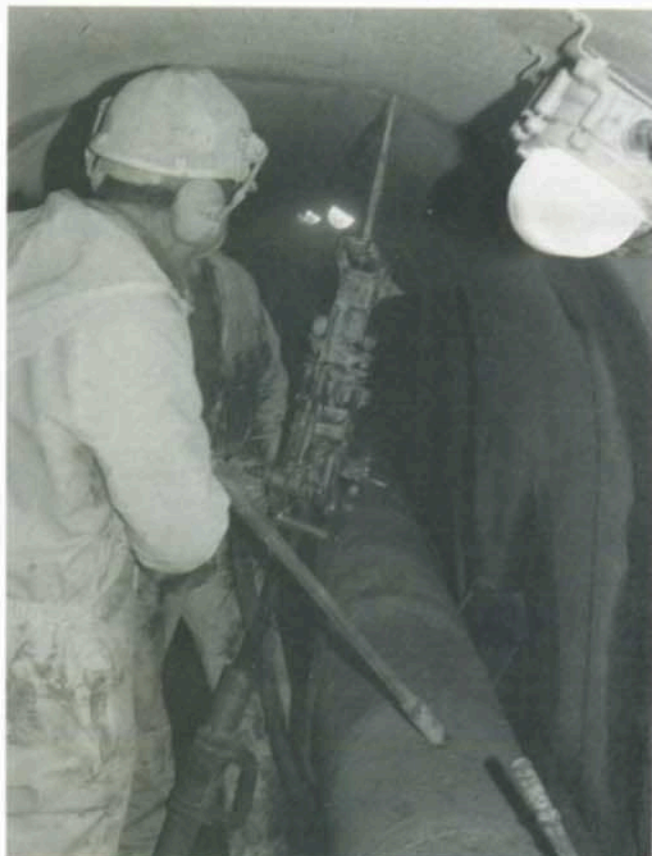
Photograph 7. Hand held drilling equipment being used for grout holes in the culvert of Glenlatterach Dam, Scotland

Drilling of the 40mm diameter holes was conducted with air powered rotary percussive hand held drills (Photograph 7). Grout, mixed in a colloidal mixer/pump unit, was passed to a holding tank located on a platform at the base of the lower. From here, it was distributed to the injection point with a piston pump.

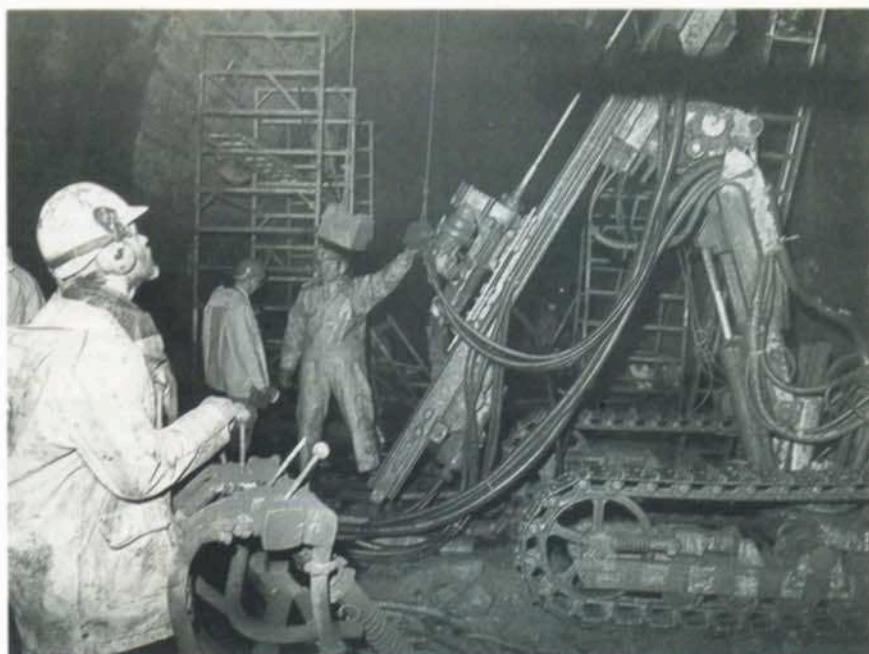
After the fire had burned out three days later, and the worst of the wreckage removed, a television camera scan survey of the tunnel confirmed predictably that the worst affected area was Shafts 8 and 9 and the intermediate tunnel section, although generally the tunnel had resisted well. In this region the brick lining had vitrified and the sleepers burned to ash. Temperatures had reached approximately 1200°C. There was also evidence of spalling and separation of some unbonded layers of brick. It was therefore suspected that the lining of this section of the tunnel and the shafts could be in a potentially unstable state. British Rail's Regional Civil Engineer appointed a specialist consultant, James Williamson & Partners, to investigate the

Photograph 8. Air powered trackrig being used for grout and bolt-hole drilling, Summit Tunnel, Yorkshire

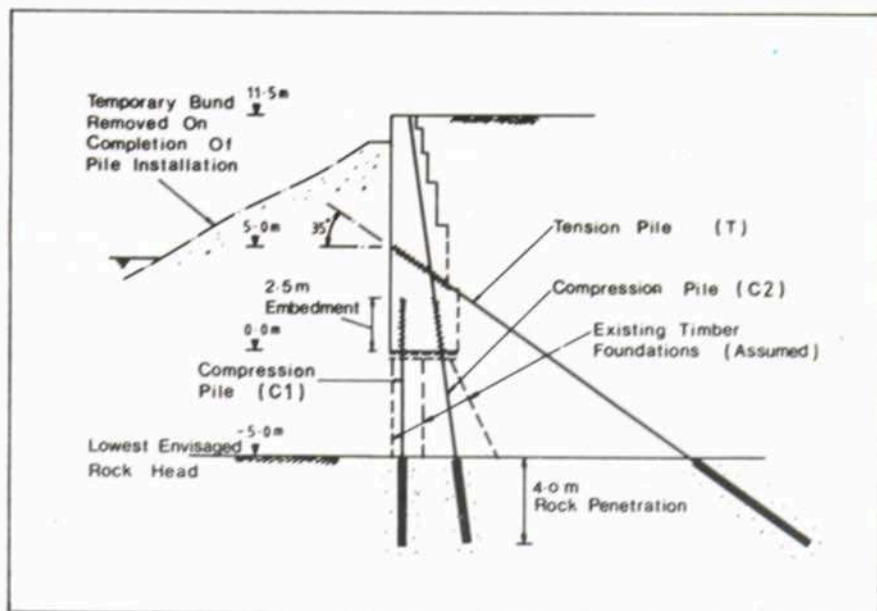
Fig 25. General arrangement of minipiles, Canning Dock, Liverpool

However, survey had shown that the structural stability of the Canning Dock wall was highly suspect, and, as a temporary measure, a bund was placed, almost to coping level, in the dock to prevent outwards displacement.

be removed to permit the dock to allow vessels to enter, and tie up against the quay, and so an alternative, permanent, in situ solution was necessary.
