The Use of Post-tensioned Tendons at Stewart Mountain Dam, Arizona: a Case Study Involving Precision Drilling

R.H. Bianchi
Bureau of Reclamation, Denver, Colorado

D.A. Bruce
Nicholson Construction of America, Bridgeville, Pennsylvania

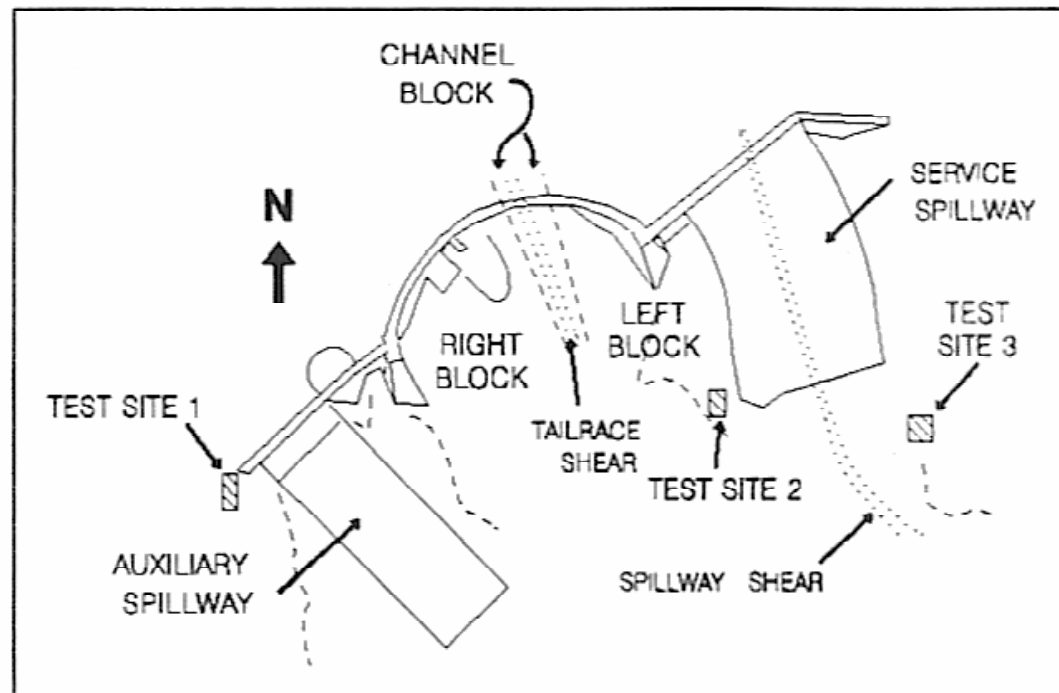
Figure 1 - Location of Main Structural Features & Anchor Test Sites

The dam was built on Precambrian intrusive rocks, principally quartz diorite cut by irregular dikes of granite (GR) and smaller diabase (DI) and silicic dikes. From the right to the left abutments, the rock becomes increasingly more fractured and sheared. Two major shears are in the foundation area (Figure 1). The original river channel follows one of these shear zones, and the other is beneath the service spillway. Rock weathering is typically deep except within the active scour areas. Intense rock weathering often extends to a depth of 100 feet except in areas of active scouring. The shear zones are weathered and intensely fractured with clay infilling.

Bond length determination test. - Prior to any production drilling of tendon holes, a full scale anchor test was required (Scott and Bruce, 1992). Three sites were selected to reflect major rock mass categories (Figures 1 and 2). The intent of the test program was to determine the anchoring requirements within different bedrock conditions. Other benefits from the test program included providing an opportunity to identify and correct any unforeseen construction difficulties through a full-scale trial run and to provide the field and design staff with an opportunity to become familiar with the procedures and capabilities of the equipment.
