THE REHABILITATION OF BEAVER DAM: A MAJOR SEEPAGE CUT-OFF WALL

D.A. Bruce * and G. Dugnani†

Abstract

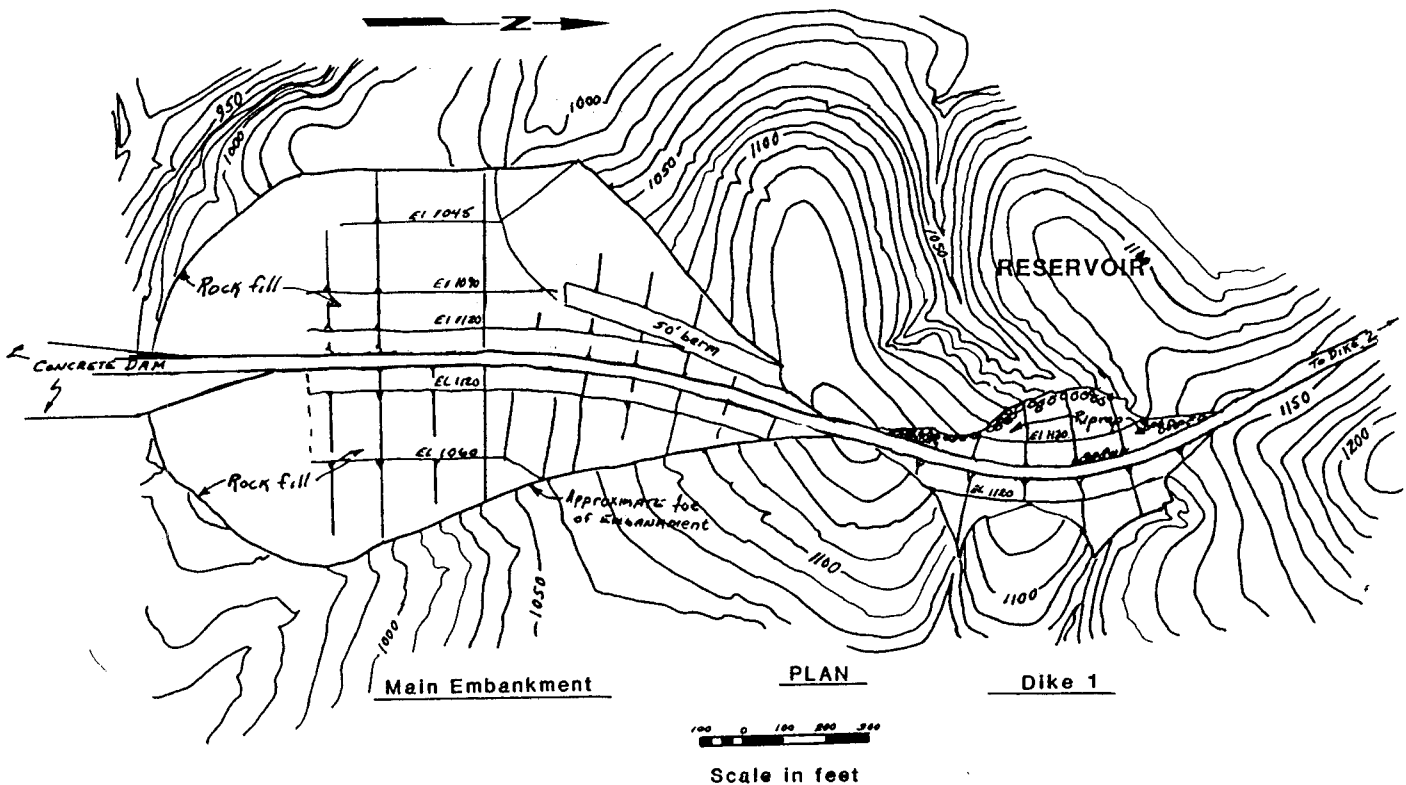
Figure 1. Location of Dike 1 relative to the concrete dam and the Main Embankment (Llopis et al., 1988).

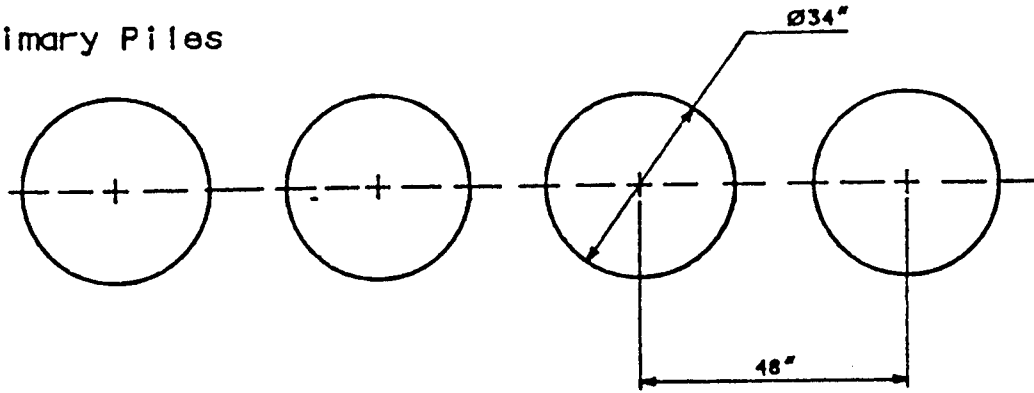
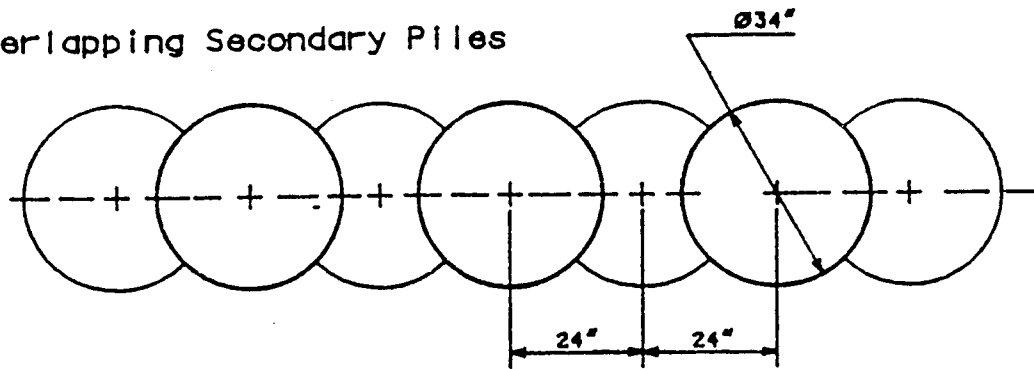
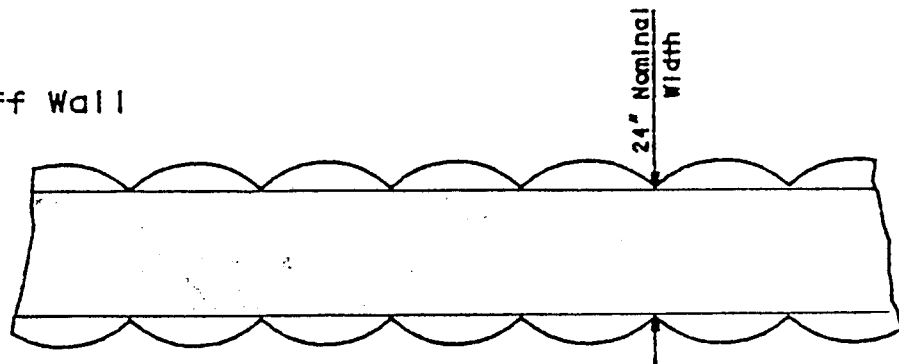
Figure 4. Construction sequence of the cut-off wall.

The individual piles were located at 24 inch centers, yielding (Figure 4) a nominal chordal joint width of 24 inches. This overlapping pile method is executed in two stages:

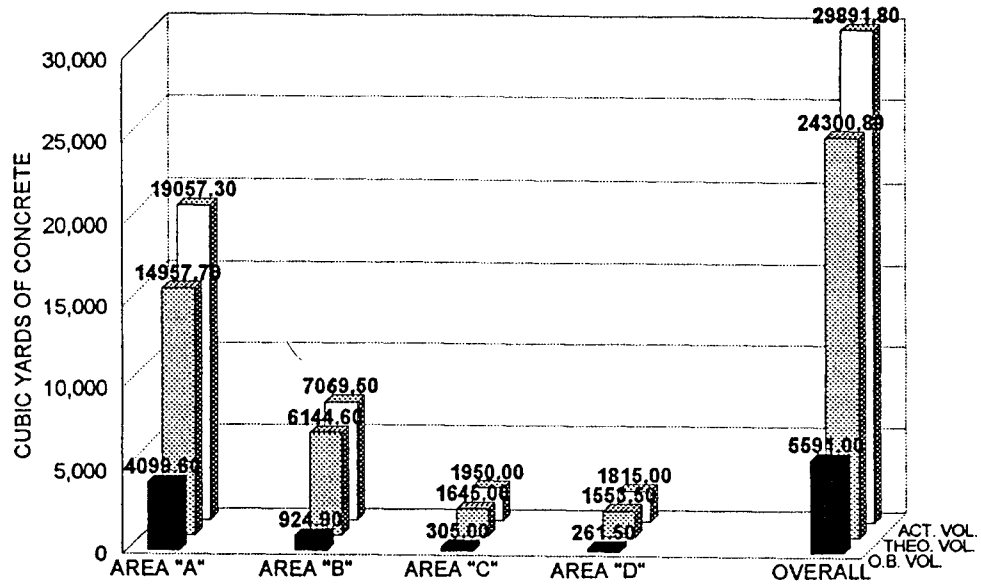
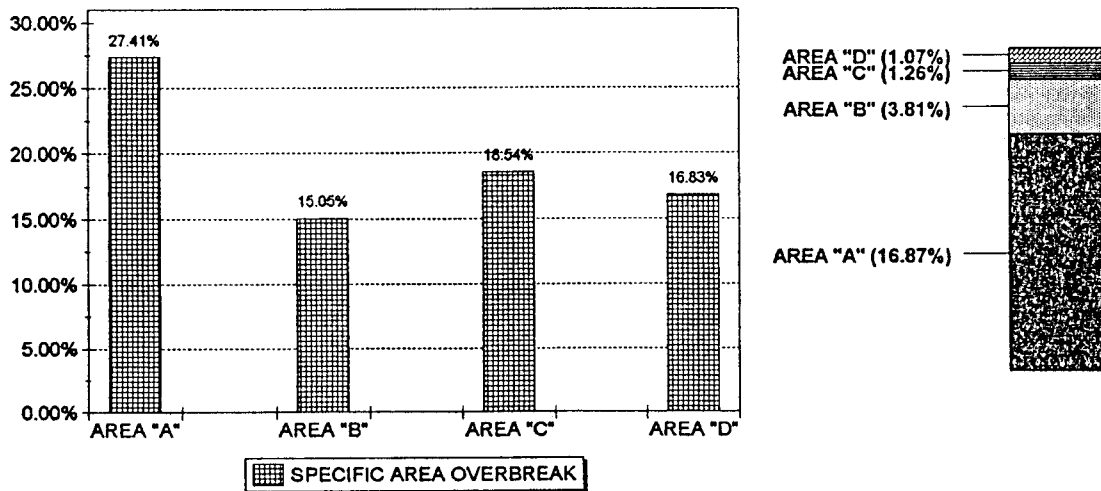
Figure 5. Quantities of final concrete used in the cut-off wall.

Water was heated or chilled, depending on the other material, and ambient, temperatures. Final concrete placement data for cut-off wall construction are shown in Figure 5. Total quantities of work conducted are summarized in Table 2.

OVERBREAK PERCENTAGE WEIGHTED
TOTAL OVERBREAK = 23.01%
