MONITORING AND REMEDIATION OF RESERVOIR RIM LEAKAGE AT TVA'S TIMS FORD DAM

James A. Hamby¹ and Donald A. Bruce²

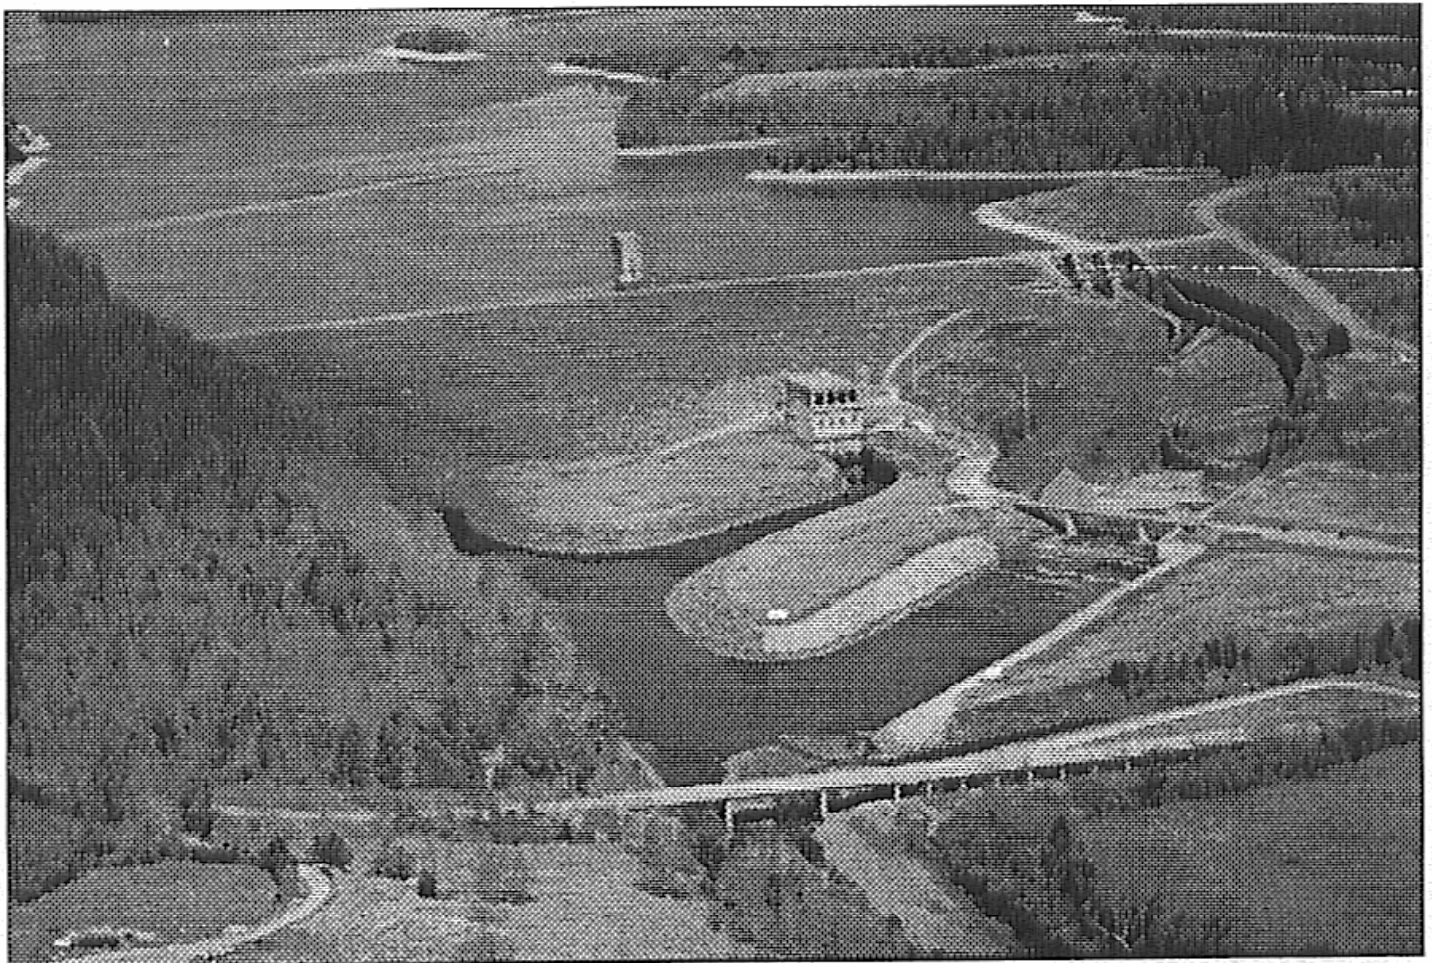
Figure 1. Tims Ford Dam and Reservoir

The Tennessee Valley Authority's (TVA) Tims Ford Dam (Figure 1) is a 175-foot high compacted rock-fill dam with a sloping rolled earth fill core. It is located on the Elk River about 9 miles west of Winchester, Tennessee. The embankment is 1,500 feet long and has a crest elevation of 910 feet. At its normal maximum pool elevation of 888 feet, the reservoir comprises an area of 10,600 acres and a total storage volume of about 608,000 acre-feet.

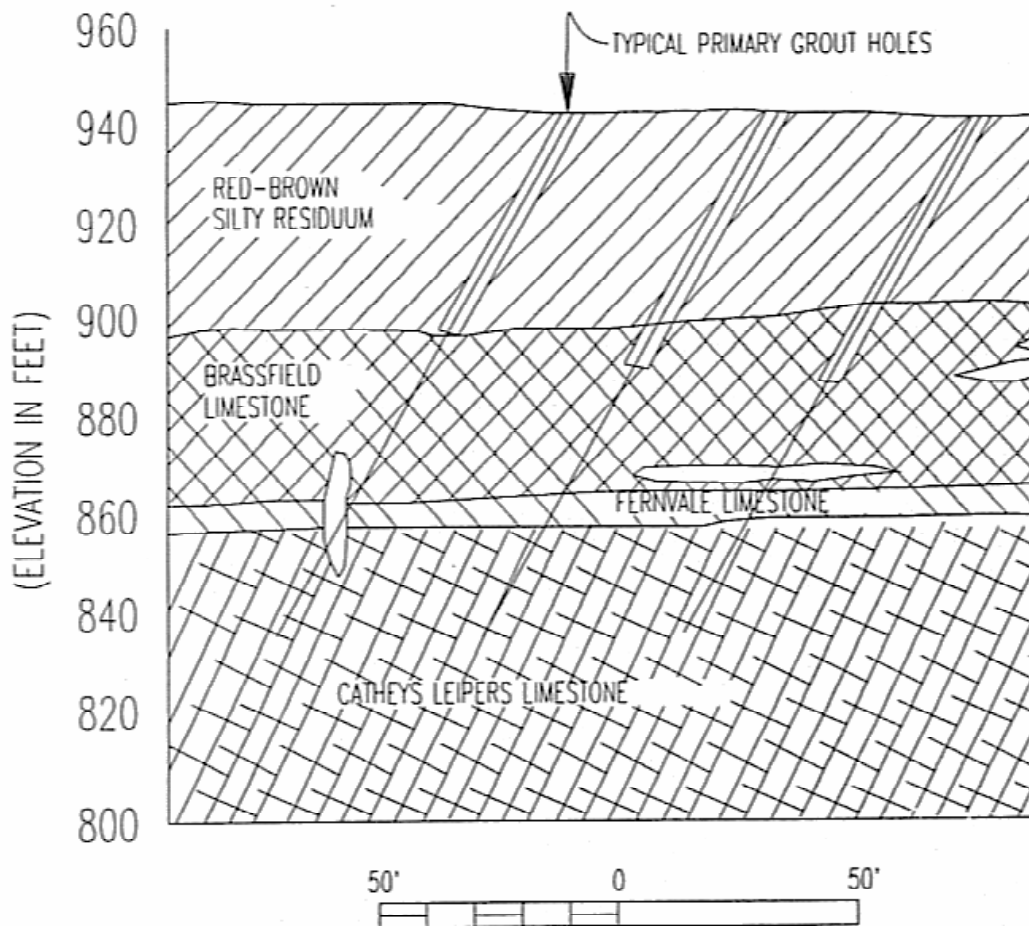
Figure 2. Tims Ford Reservoir Right Rim simplified geological elevation

The rock at the Tims Ford site consists of thinly bedded, nearly horizontal layers of limestone and shale. The right rim near the abutment of the rock-filled dam is comprised of:

- Overburden of red clay and chert mostly residuum from the Fort Payne Formation;
- Brassfield limestone, a coarse-grained, gray limestone, cherty, shaley, and glauconitic, containing numerous

- Fernvale limestone, a coarse-grained, gray to red crystalline limestone, also containing solution cavities along bedding planes and joints; and
- Catheys-Liepers limestone, a fine- to coarse-grained limestone containing shale lenses and fossiliferous layers and displaying a prominence of clay seams.

rows. Primary holes in each row were foreseen at 40-foot centers, with conventional split spacing methods to be employed (to reduce interhole spacings to 10-foot centers). The central tightening row was vertical. The grouting was to be executed between Elevations 888 and 840 feet and locally deeper if dictated by the stage of permeability tests conducted prior to the grouting of each stage (Figure 2).
