THE SEALING OF CONCRETE DAMS AND THEIR FOUNDATIONS: TWO NEW TECHNIQUES

Dr. Donald A. Bruce, Technical Director
Nicholson Construction of America

Presented at:
10th Annual USCOLD Lecture Series
March 6-7, 1990
New Orleans, Louisiana

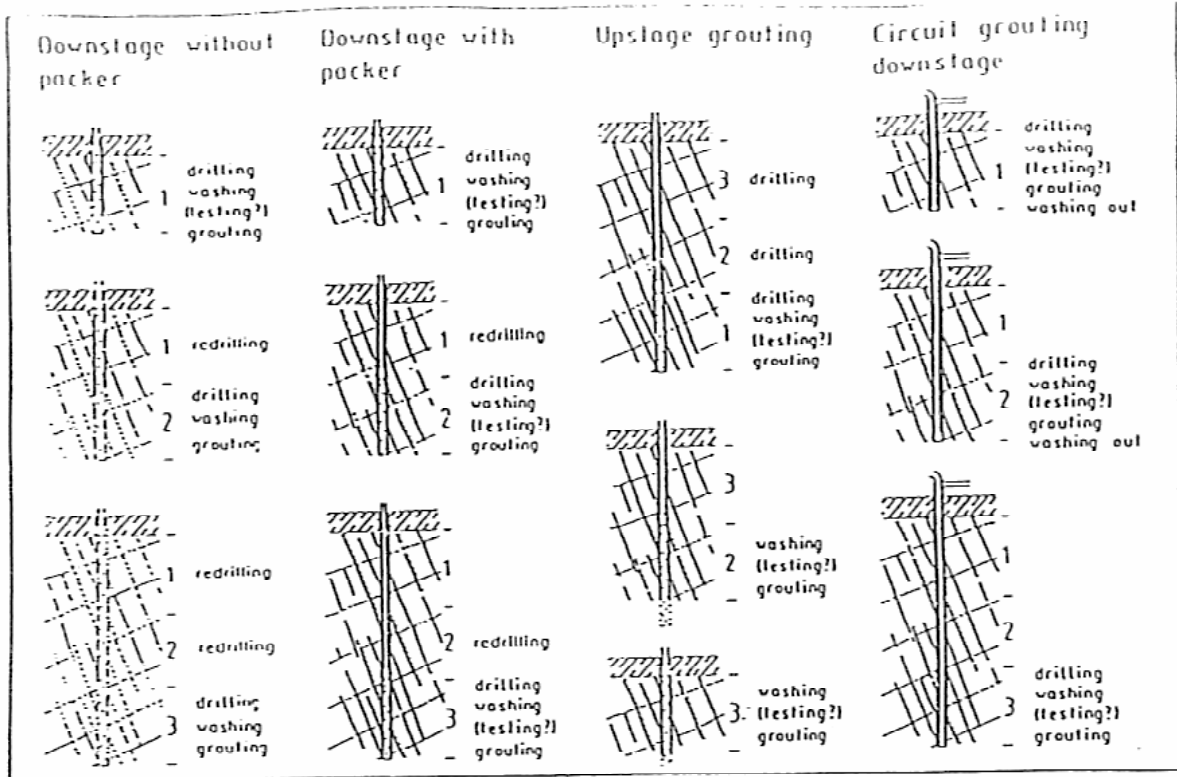
Figure 1. Conventional stage grouting methods for rock (Ewart, 1985, after Houlsby, 1982).

The fissure grouting of rock masses is typically conducted by some type of stage grouting procedure (Figure 1). In "downstage grouting," grout holes are advanced by drilling a certain length, usually 3-5 m, grouting it, and then repeating the process after the grout has set, until final depth is reached. The packer may be kept at the top of the hole, or moved successively downwards to the top of each new stage in turn. In "upstage grouting," the hole is drilled to full depth in one pass and injected progressively in successive stages from the bottom upwards through a down-the-hole packer. Houlsby (1982) also describes "circuit grouting, downstage," which is not dissimilar to downstage without packer. This system has proponents in the U.S.A. (e.g. Burwell, 1958) although Ewart (1985) views the method's effectiveness "with some skepticism," being concerned about hydraulic fracturing "somewhere in the upper stages." Houlsby (1982) also describes it as "difficult, prone to blockages and very expensive." The major advantages and disadvantages of the two basic approaches - upstage and downstage - are summarized in Table 1. Their technical or financial balance on any particular site should logically dictate the final choice of method, but it would seem that tradition and bias often prove at least as decisive.
