THE PRACTICE AND POTENTIAL OF GROUTING IN MAJOR DAM REHABILITATION

Dr. Donald A. Bruce
Nicholson Construction of America
P.O. Box 308
Bridgeville, PA 15017

This paper provides a compendium of summary case histories of dam rehabilitation by grouting. The overall intention of the paper is to reassert the viability and potential of grouting as a reliable engineering tool for dam rehabilitation.

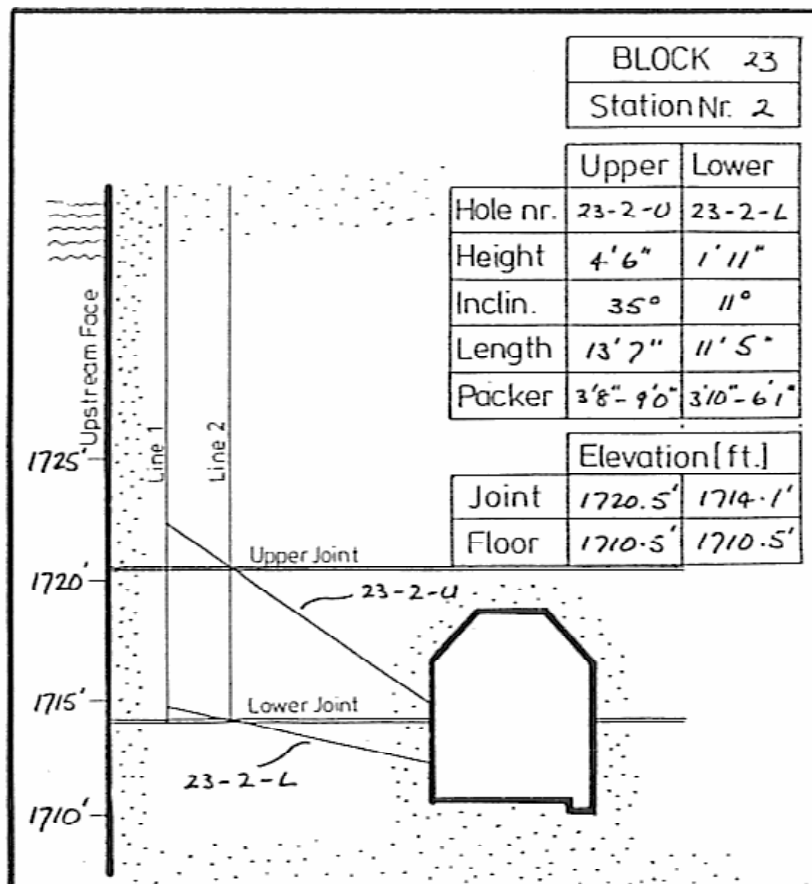
Figure 4. Typical section showing intended joint interceptions at one station, Santeetlah Dam (25).

- Core Primary holes upstream from the Lower Gallery (approximately 2.1m wide x 2.5m high) to intersect each fissure in a regular pattern close to the lake (Figure 4). The special electro-hydraulic drill rig provided holes of 46mm diameter and cores of 36mm diameter.
- Observe water flows and establish flow paths, pressures, interconnections, etc.
- Inject Primary holes with relatively viscous RODURsm resin
- Core intermediate Secondary holes in a regular pattern with specific "problem areas" given additional holes.
- Grout Secondary holes with thinner resin
- Core a limited number of Tertiary holes, to demonstrate uniformity and effectiveness of treatment, and to act as long-term drainage holes.

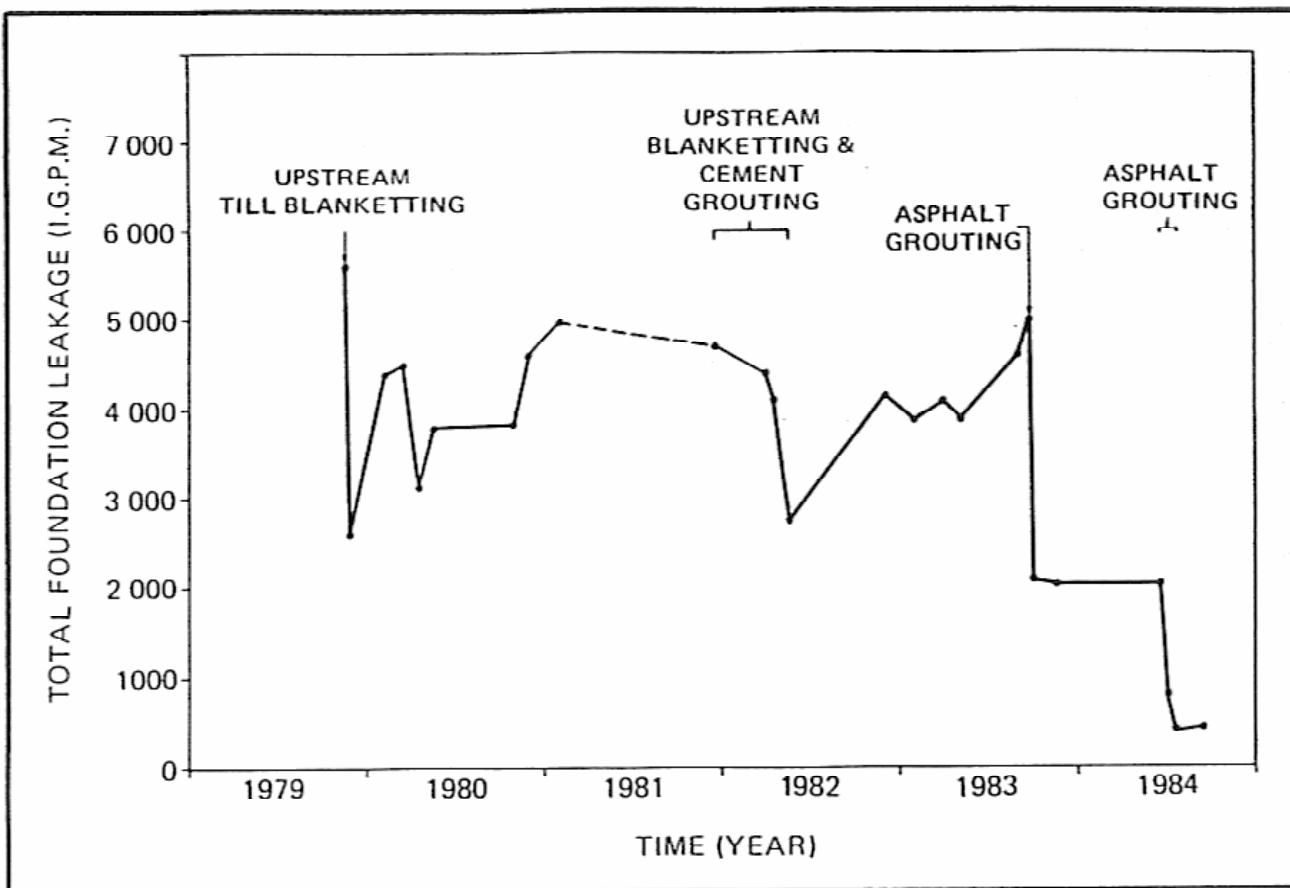
Figure 10. Effect of asphaltic grout treatment on leakage, Stewartville Dam (33).

By 1974, despite periodic upstream blanketing, the flow into the inspection tunnel had exceeded 4.5m³/min. Further testing identified two major areas of leakage and additional conventional cement grouting was conducted, but without success (Figure 10), and flows increased. A program was established to determine the fissure geometry, and seepage velocity, and to investigate alternative grouting materials. Core holes, borehole T.V. and tracers helped pinpoint the conditions in the two zones:
