THE USE OF POST-TENSIONED ANCHORAGES ON THE
ARCH PORTION OF STEWART MOUNTAIN DAM, ARIZONA

ABSTRACT

Post-tensioned rock anchorages were selected by the Bureau of Reclamation (Reclamation) to stabilize Stewart Mountain Dam against potential seismic loadings. The use of such anchorages in a high, thin arch is thought to be unique. The paper addresses the design, construction and performance of the 62 anchorages installed through the arch section, highlighting special measures undertaken to reduce the risk of damage to the structure during the execution of the work.

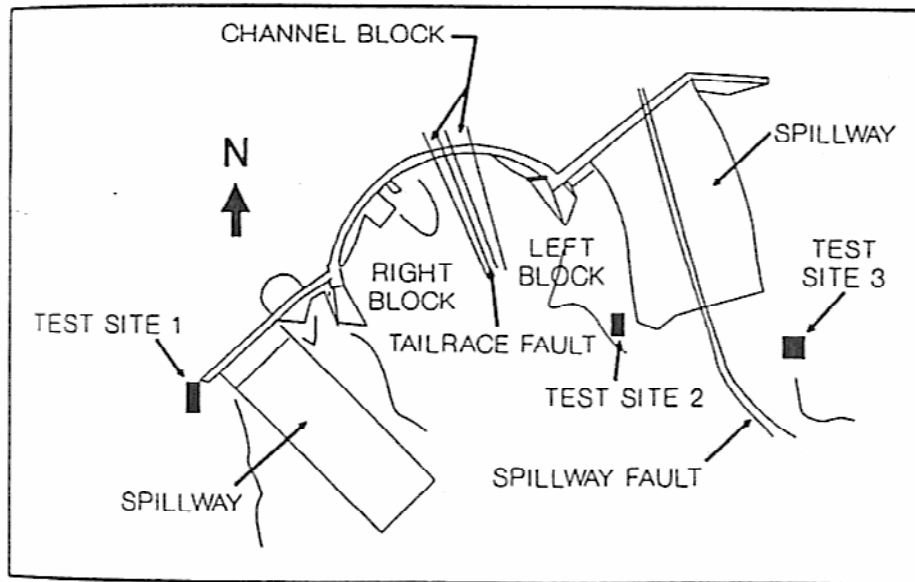
Figure 2. Major features of Stewart Mountain Dam.

Stewart Mountain Dam is located about thirty miles east of Phoenix, Arizona, and was built on the Salt River in the early 1930's. The central portion is a thin arch, 583 feet long and 8 feet wide at its crest. It has a maximum structural height of 212 feet and is up to 34 feet thick at its base. It is flanked by gravity thrust blocks, two spillways (one of which was recently added in a separate safety modification program) and wing dams extending into each abutment (Figures 1 and 2).

Most of the arch dam foundation consists of hard, Precambrian quartz diorite. The diorite is cut by irregular dikes of mostly hard, medium grained granite, which vary in orientation and thickness. A fault divides the arch dam foundation into three blocks (Figure 2) - the block to the right of the fault (Right Block), the block to the left of the fault (Left Block), and the fault zone itself (Channel Block). Each block has distinct mechanical properties, fracture systems, and permeabilities. The rock underlying the right portion of the dam is mostly hard, slightly weathered to fresh quartz diorite, and generally of excellent quality. The rock to the left of the fault (which includes the Left Thrust Block foundation) was slightly inferior, being more fractured, sheared and weathered quartz diorite with dikes of granite. The fault and the surrounding fractured zone were very intensely fractured and moderately to slightly weathered quartz diorite with a diabase dike.

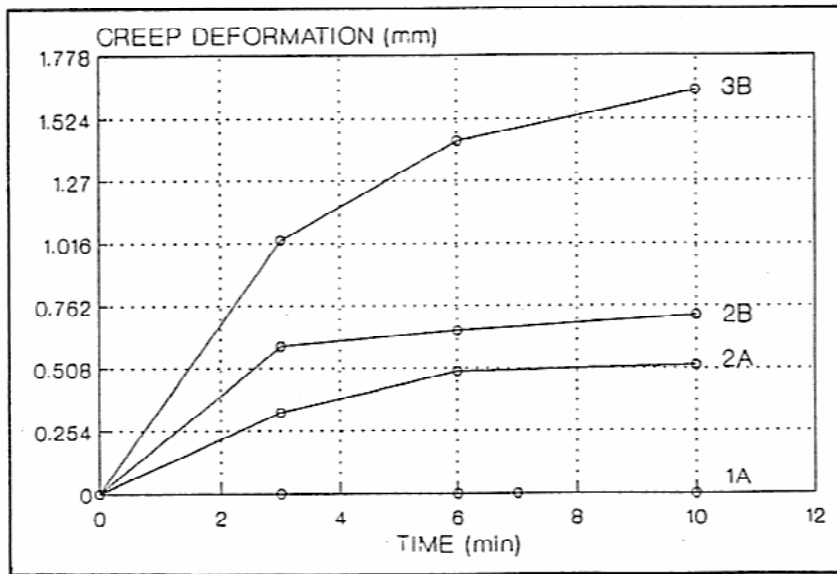
Figure 3. Typical short term creep data for test anchorages at Design Load (DL). NOTE: 1B data not valid; 3A did not reach DL.

feet apart in each of the three different structural blocks (Table 2 and Figure 1). In each pair, one anchorage, designated 'A', was intended to have a 10 foot long bond length, while the other, 'B', was to have a 20 foot long bond length. They were cyclically loaded to investigate load holding phenomena including the amount of apparent tendon debonding (Table 3) and creep (Figure 3).

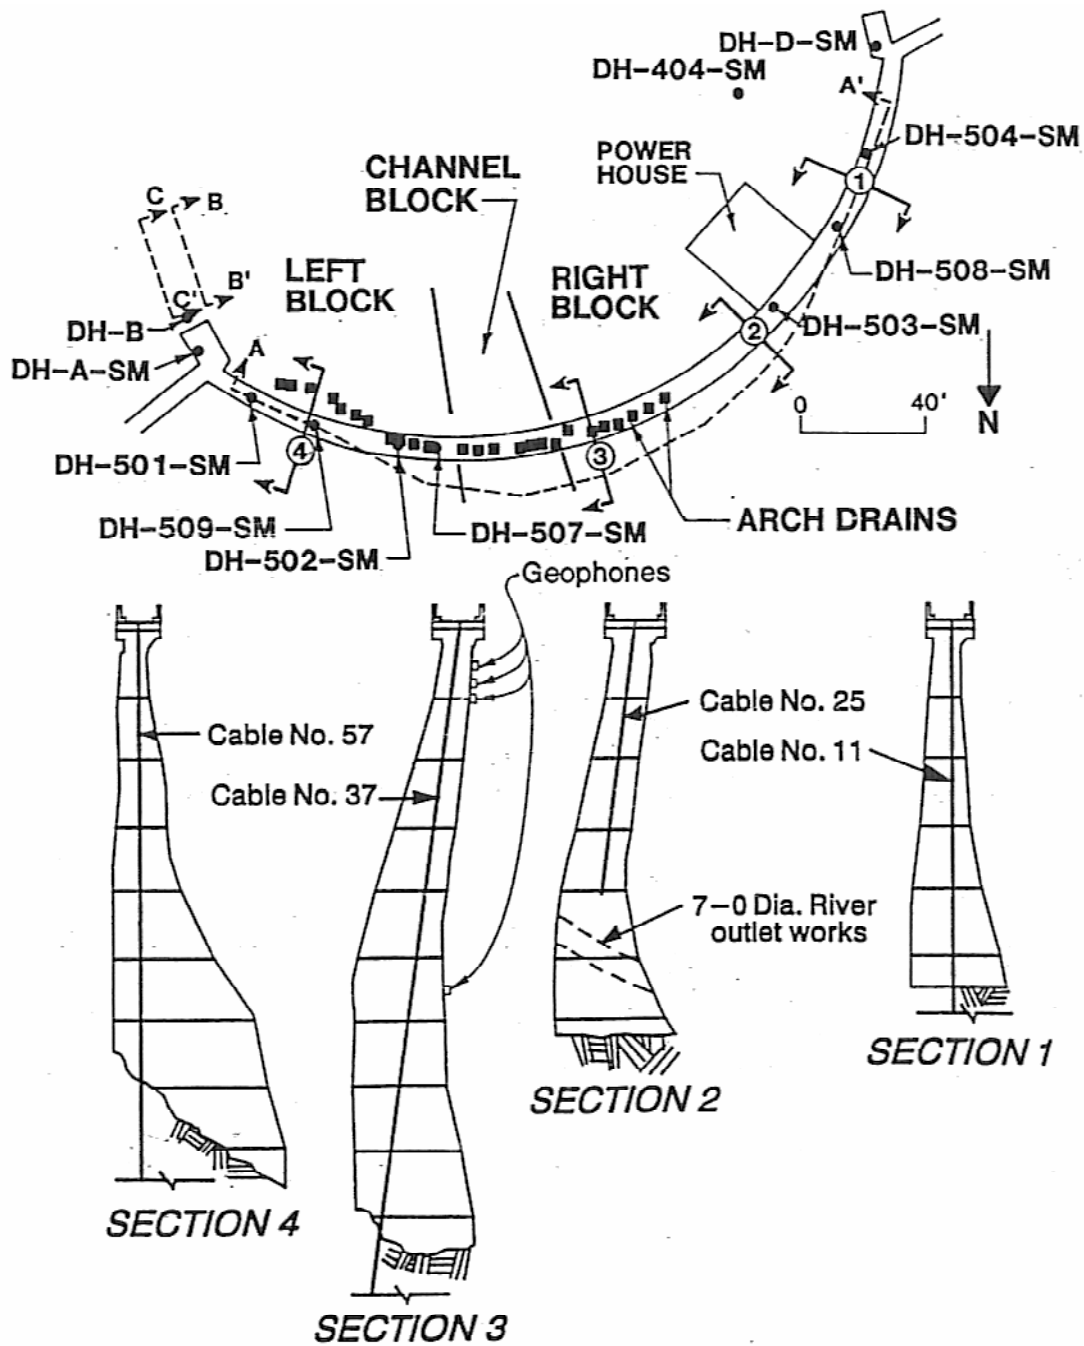
Figure 4. Typical sections through the arch, showing inclination of anchorages, positions of toe drains, and locations of geophones.

Sixty-two tendons were designed for installation at approximately 8 foot centers along the crest. Free lengths varied to over 222 feet, while bond lengths ranged from 30 to 46 feet. Inclination varied along the dam, from vertical to 8° 40' upstream (Figure 4). All but 7 of the tendons (located immediately above the river outlet work openings through the dam) were founded into the dam foundation bedrock (32 in the right foundation zone, 15 in the left foundation zone, and 8 in the fault zone). Each tendon consisted of twenty-two 0.6 inch diameter epoxy coated strands. Design working loads (DL) averaged 630 kips (range 550 to 750), equivalent to about 50% GUTS (Guaranteed Ultimate Tensile Strength).

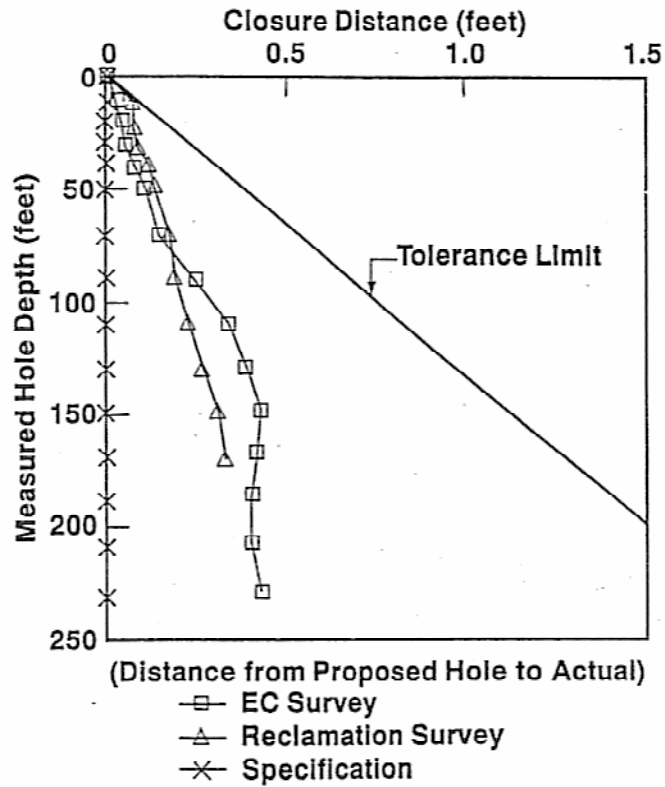
Figure 5. Typical hole deviation data, as monitored in Hole 37.

As a further check, Reclamation ran random, independent precision optical surveys in completed holes, using a Pentaprism instrument. These surveys invariably showed that even the rate gyro instrument overestimated the amount of deviation (Figure 5) while every hole proved to be within specified tolerances even despite old steel beams encountered in the concrete in certain places (Bianchi and Bruce, 1992).

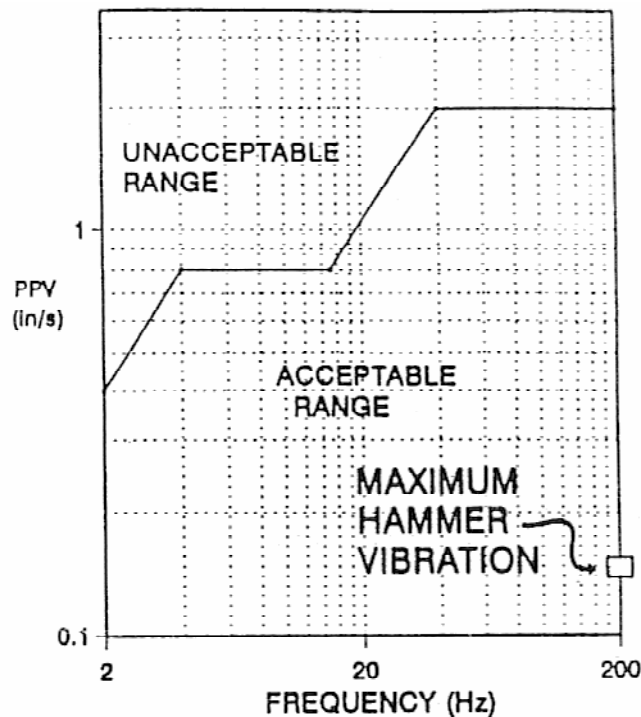
Figure 6. Data from geophone monitoring during down-the-hole drilling through concrete. Stewart Mountain Dam, AZ (Reclamation Acceptability Criterion).

During the drilling of Hole 37, in a more sensitive part of the arch, close instrumentation of the structure's downstream face was conducted. Crack meters placed across the lift joints indicated tiny movements at most (Table 4) while the geophones indicated equally insignificant peak particle velocities (Figure 6). During every drilling (and grouting) activity, the dam's underdrain system was flushed with water and monitored closely to ensure that the drains were not compromised. As shown in Figure 7, the short term impact of the drilling and water testing activities on piezometric levels was dissipated soon after these were completed. Various other structural, environmental and personnel safety issues were addressed, as described by Bruce and Triplett (1992).

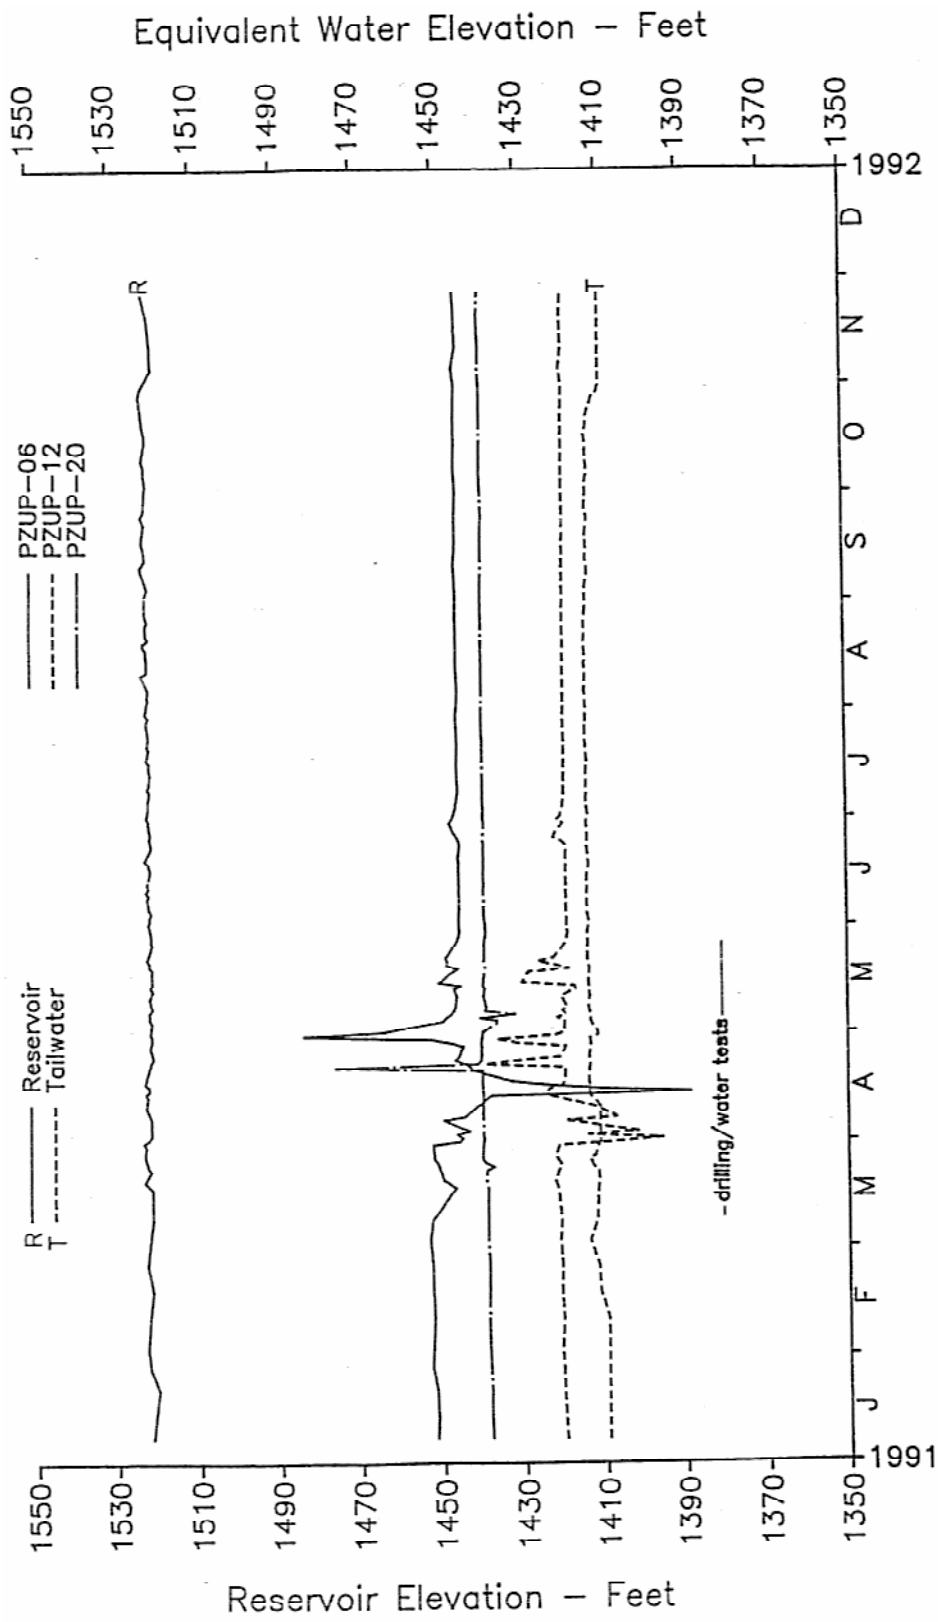
Figure 7. Arch drain piezometer records during anchorage construction.
