Epoxy Protected Strand

A Historical Review of its Use for Prestressed Rock Anchors

Part II

Collated by Dr. D.A. Bruce based on input from the ADSC Epoxy Coated Strand Task Force

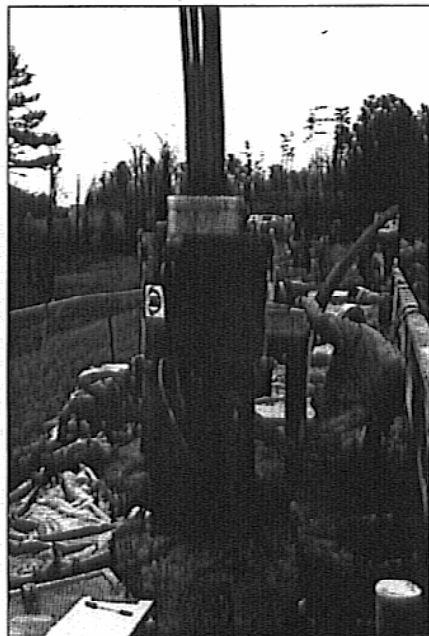
Anchor undergoes rigorous testing.

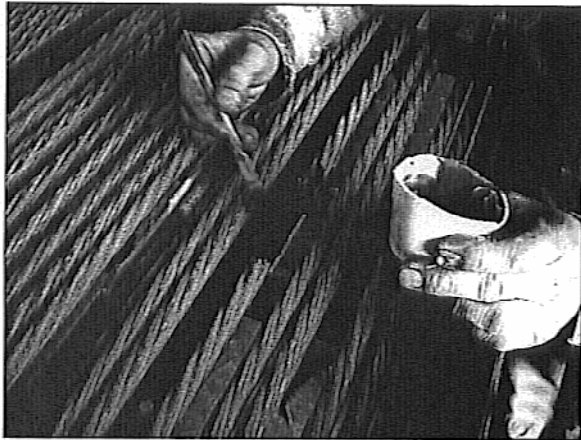
Attention to fabricating details are essential for product dependability.

3. Exercise special care in the assembly, and transportation of the assembled tendons to avoid significant damage to the coating.
