Major Dam Rehabilitation by Specialist Geotechnical Construction Techniques: A State of Practice Review

DONALD A. BRUCE
*Nicholson Construction of America
Bridgeville, Pennsylvania*

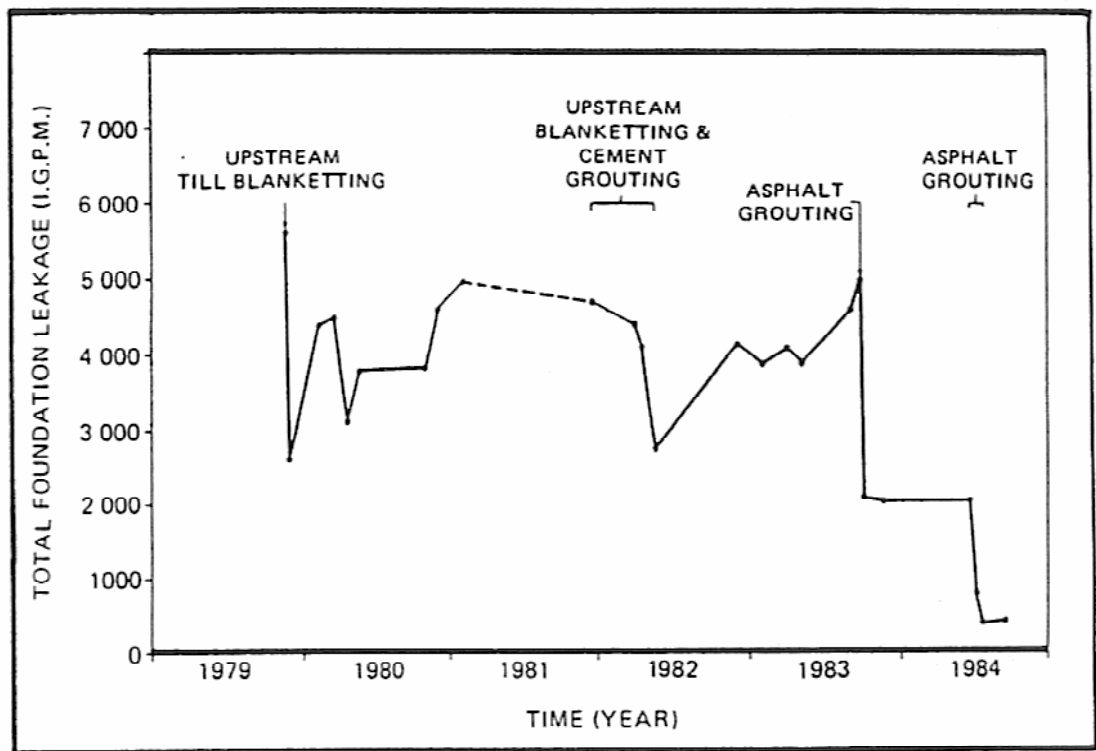
Figure 12. Effect of asphaltic grout treatment on leakage, Stewartville Dam (43).

By 1974, despite periodic upstream blanketing, the flow into the inspection tunnel had exceeded 4.5m³/min. Further testing identified two major areas of leakage and additional conventional cement grouting was conducted, but without success (Figure 12), and flows increased. A program was established to determine the fissure geometry, and seepage velocity, and to investigate alternative grouting materials. Core holes, borehole T.V. and tracers helped pinpoint the conditions in the two zones:

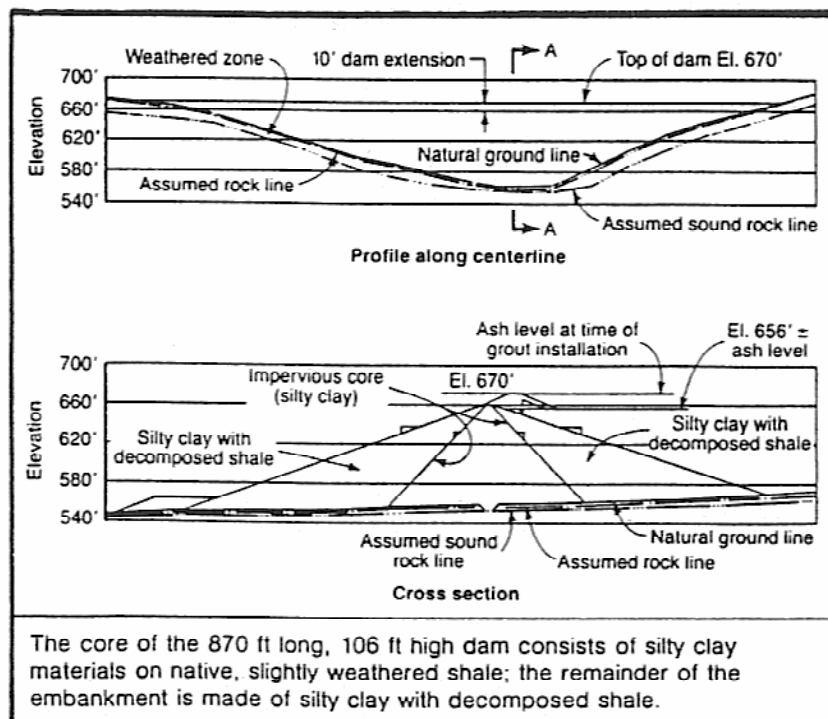
Figure 15. Layout of Ash Basin No. 2 (48).

The basin was built in 1955 to store residual flyash. Due to rapid infilling, it was raised twice - by 3m and by a further 9m. However, by 1982 a seepage problem had developed, with attention focused on the weathered rock zone just below the dam (and the contact), the lower embankment, just above the interface, and the upper embankment (Figure 15).
