DESIGN, CONSTRUCTION AND PERFORMANCE OF SEEPAGE BARRIERS FOR DAMS ON CARBONATE FOUNDATIONS

Dr. Donald A. Bruce, C.Eng.¹
Trent L. Dreese, P.E.²
David B. Wilson, P.E.³

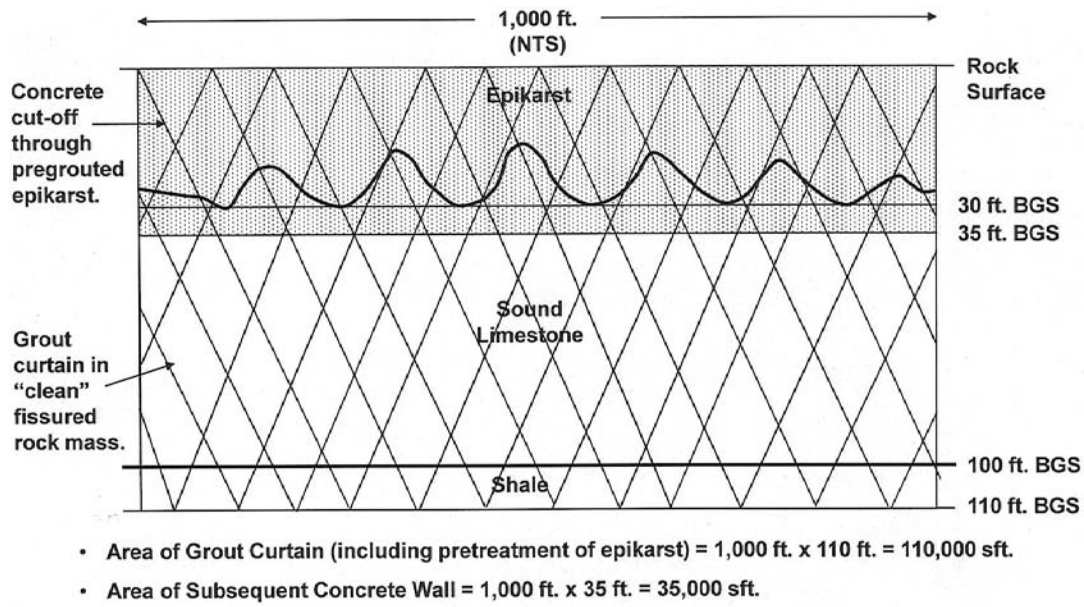
Figure 1 a). Epikarst is found during pregrouting to an average of 30 feet b.g.s. The concrete cut-off needs only to be installed to 35 feet b.g.s.

With one eye on the immediate future requirements of seepage remediation involving cut-offs under dams, it may be stated that karst is either stratigraphically driven, or structurally related. Figure 1 a) shows a case where the major horizon of long-term seepage and erosion concern is limited to the 30 feet or so of epikarst; Figure 1 b) is the case where the seepage and erosion concern is in a particular deep stratigraphic member; and Figure 1 c) shows the condition where the karstification has developed along discrete structural discontinuities. For the sake of argument, assume that the cut-off has to be 1,000 feet long, the cost of drilling and grouting is \$30 per square foot, the concrete wall costs \$120 per square foot and the maximum vertical extent of the cut-off is 110 feet (a massive shale aquiclude exists at 100 feet). The dam itself is “invisible” in this exercise.

For the configuration of Figure 1 a), the original design features a concrete cut-off wall extending 10 feet into the aquiclude. The cost would therefore be 1,000 feet x 110 feet x \$120 = \$13.2 million. (This would, however, assume that construction of the wall through the epikarst would be feasible without pretreatment.) Alternatively, if the entire alignment were to be pregrouted, it would be revealed that there was no need to construct the wall deeper than, say 35 feet. The total cost of this composite wall would therefore be:

Drill and Grout: 1,000 feet x 110 feet x \$30/sft. =	\$3.3 million
Plus Wall: 1,000 feet x 35 feet x \$120/sft. =	<u>\$4.2 million</u>
	\$7.5 million

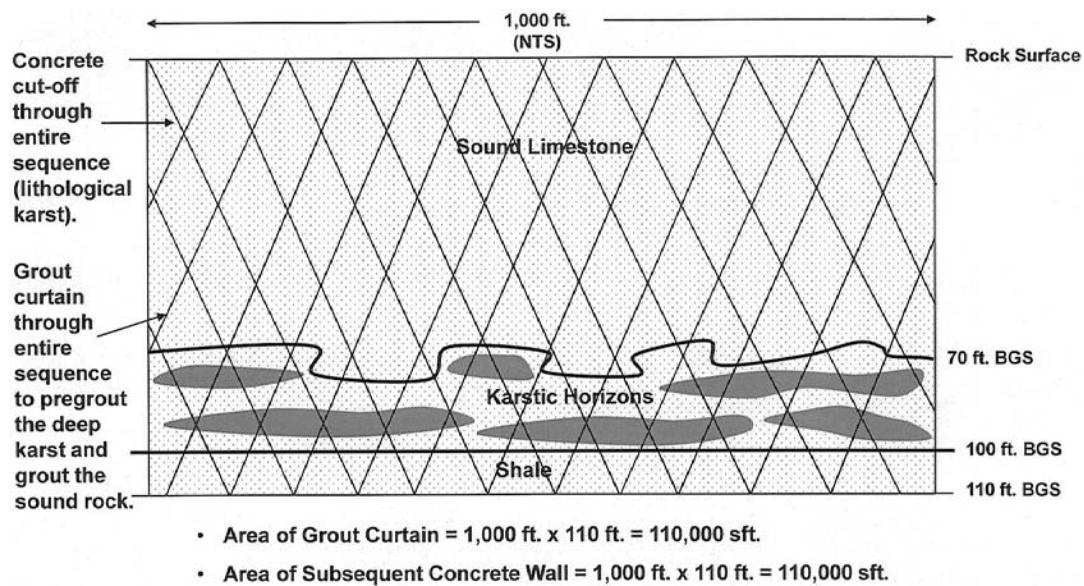
Figure 1 b). Heavily karstified horizons are found at depth. Therefore the concrete cut-off is required for the full extent. The grouting has pretreated the karstic horizons to permit safe concrete cut-off construction.

- For configuration 1 b), the cost of the predrilling and grouting would be the same, i.e., \$3.3 million. However, in this case, the concrete wall would have to be \$13.2 million. The overall cost of the cut-off would therefore be \$16.5 million. However, the pretreatment in advance of the concrete wall would assure that the wall could in fact be built in a cost-effective and timely fashion, i.e., without interruptions caused by massive slurry loss. The overall (high) project cost would simply be a reflection of a uniquely challenging geological situation, i.e., a continuous bed of erodible material at depth.

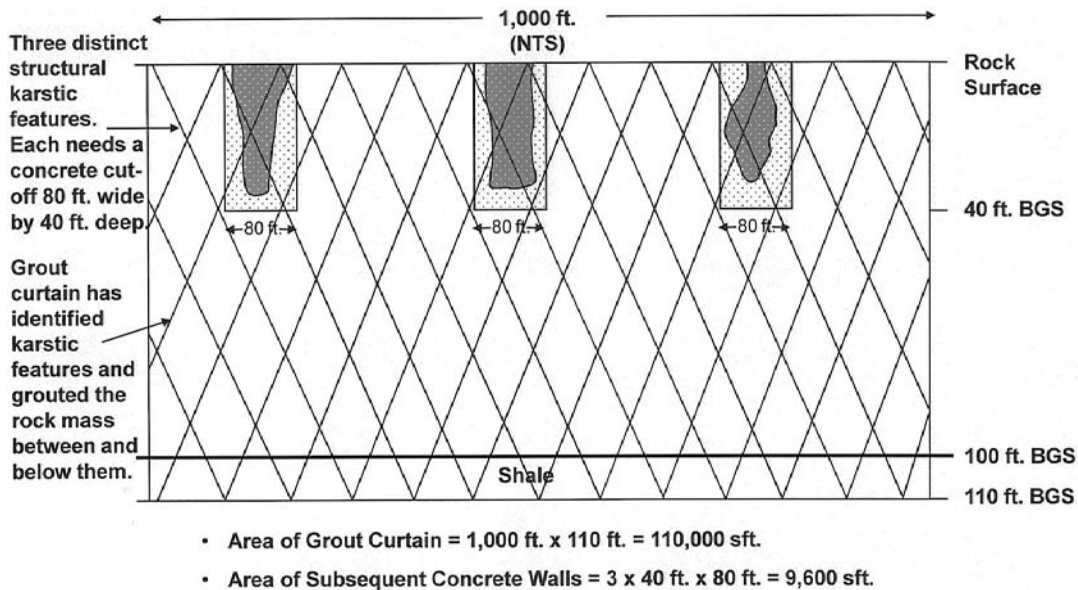
Figure 1 c). Discrete karstic features have been found, structurally driven. Thus, individual concrete cut-offs can be installed, after drilling and grouting have confirmed the extent of these features and have pretreated them to permit safe concrete cut-off construction.

- For configuration 1 c), the pretreatment would again cost \$3.3 million. It would result in the identification of three discrete zones of structurally defined karst of combined area 3 x 80 feet x 40 feet = 9,600 sq ft. Therefore, the cost of the concrete wall actually needed to cut these features off would be 9,600 sq ft. x \$120/sq ft. = \$1,152,000. Thus, the total cost of the composite wall is \$3,300,000 + \$1,152,000 = \$4.5 million.
